Carbonlite Retrofit Demo

Tim Martel and Bill Butcher

AECB Conference 2016

This presentation covers two examples from case Study 10, one of these is explained as an example in 5.16 of the course.

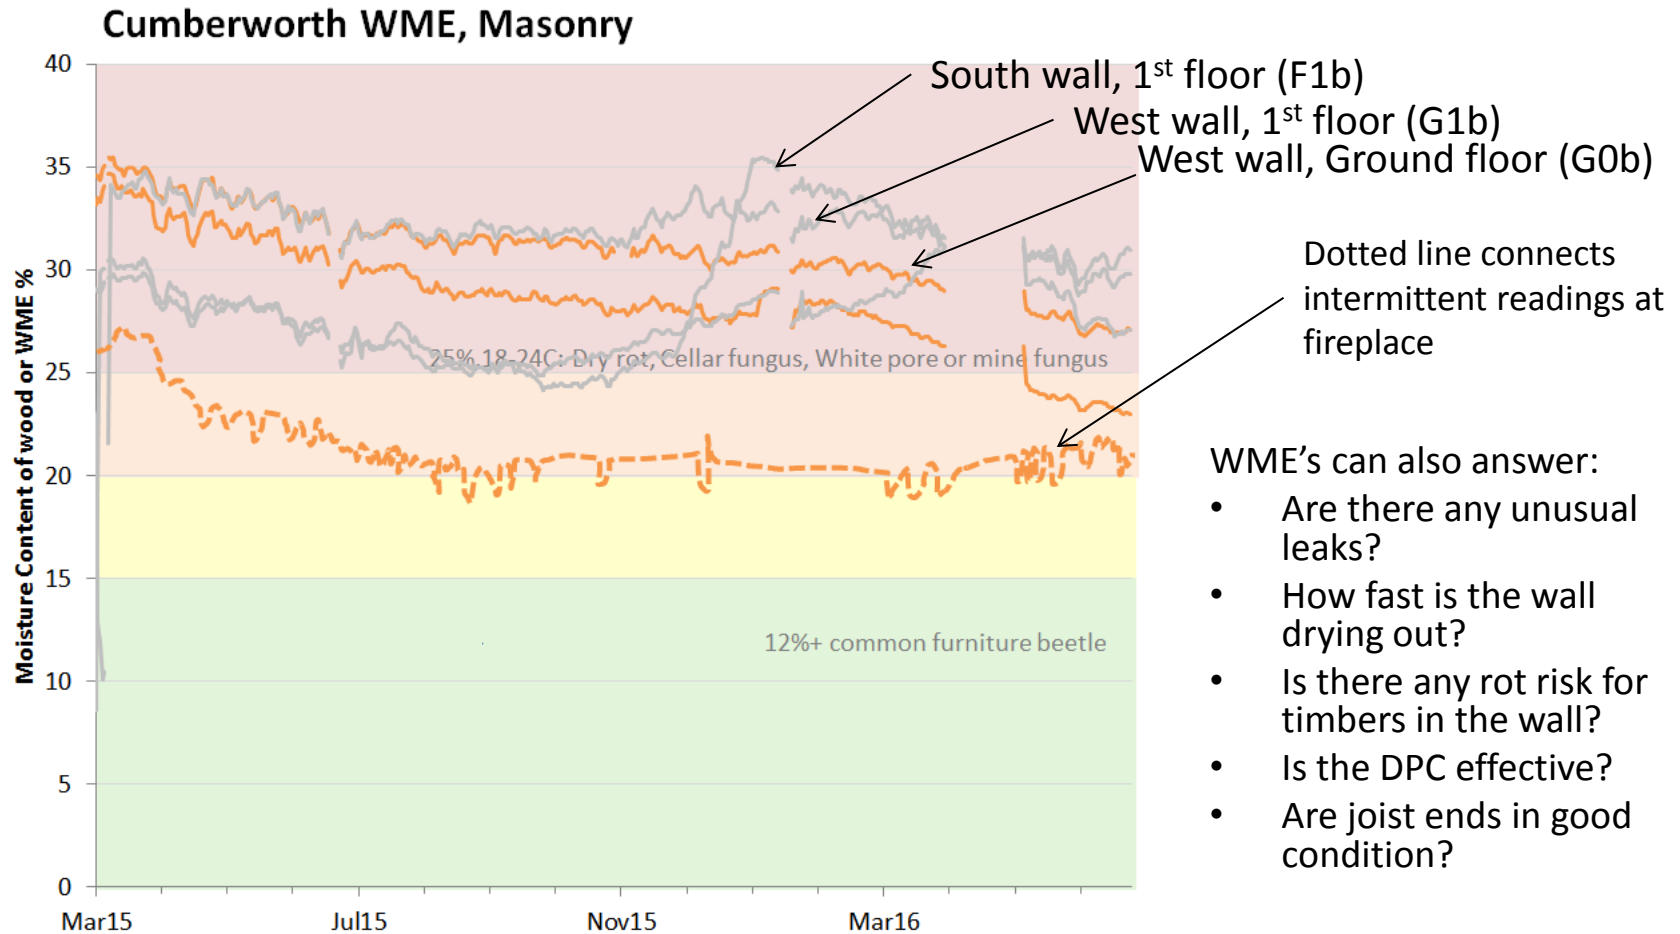
a. What is the moisture content inside the wall?

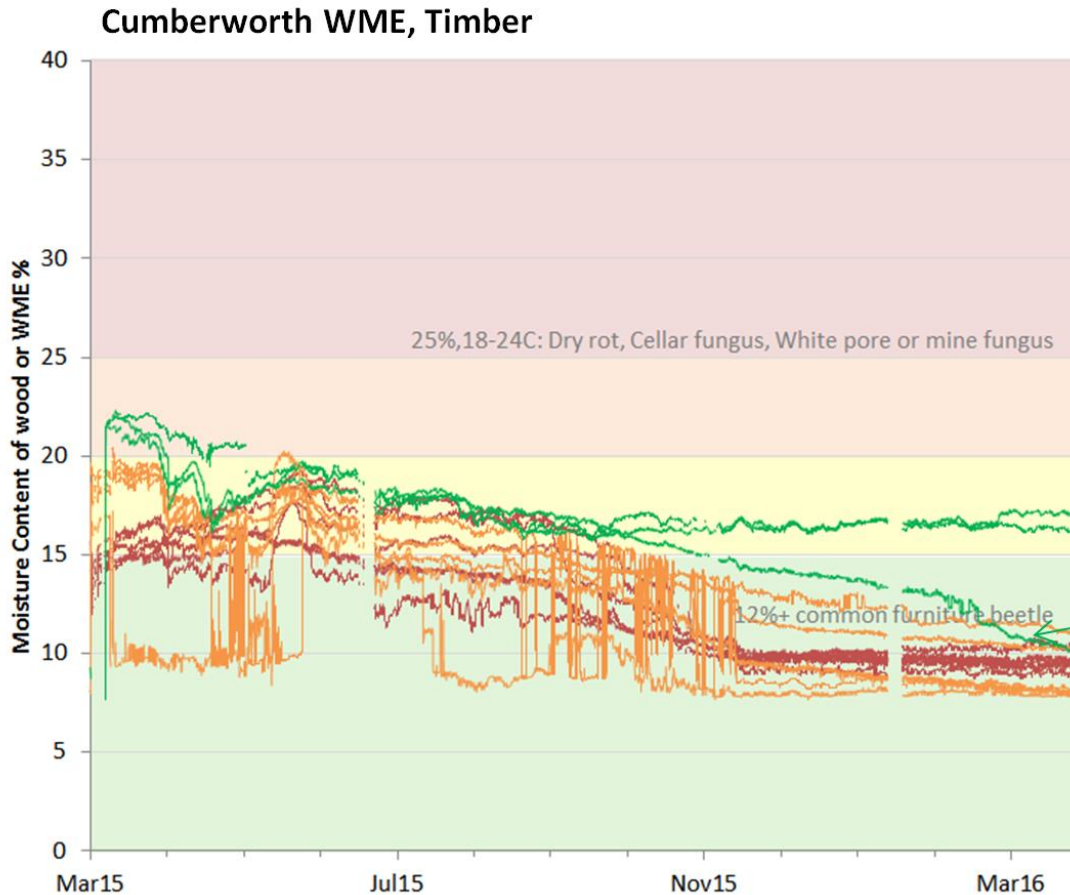
- OSB has dried to safe levels
- Joists not under VVR have dried to safe levels (though have to be careful because 1 has poor connection)
- Two Joists haven't dried so well, both under VVR, J1 on West ext wall, J3 on cross wall

J1,J3 under VVR

J5 under VVR

Joists not under VVR and layer a: OSB

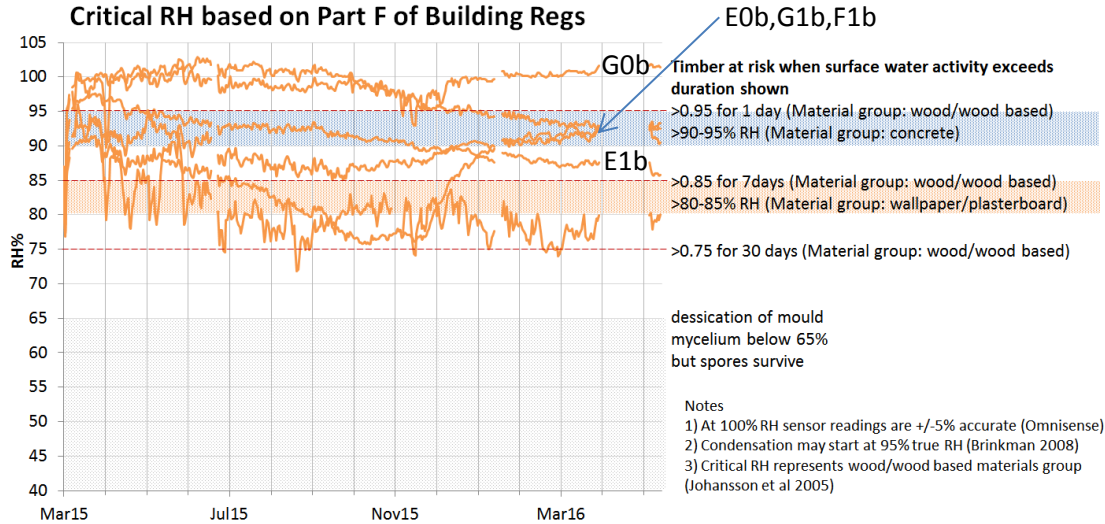
- Building regs RH based mould risk, only valid near 20C
- Suggests a problem for G0b, E0b,G1b and F1b
- Some parts have high RH but temperature is low

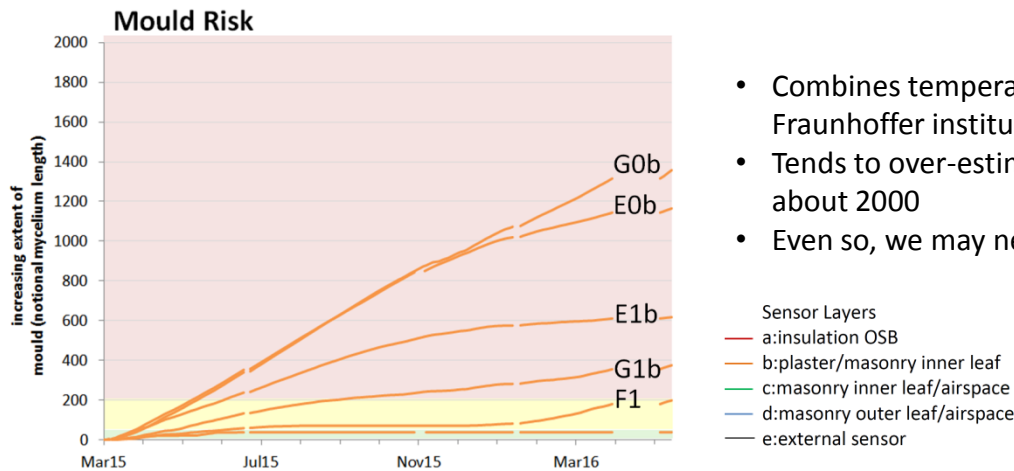
- Combines temperature, RH and substrate in an algorithm published by the Fraunhofer institute for WUFI Bio
- Tends to over-estimate risk, actual measurements suggest no mould up to about 2000
- Even so, we may need to be careful for G0b and E0b

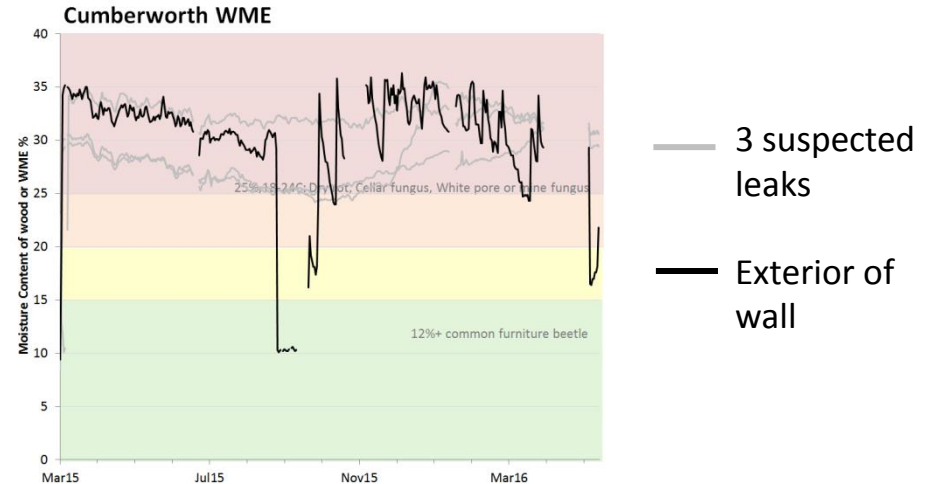
snapshot of WME at 31/3/16

There could be leaks at these 3 sensor positions,
 the moisture content for the leaks is similar to
 the exterior of the wall:
 South wall 1st floor (F1)
 West wall Ground floor (G0)
 West wall 1st floor (G1)

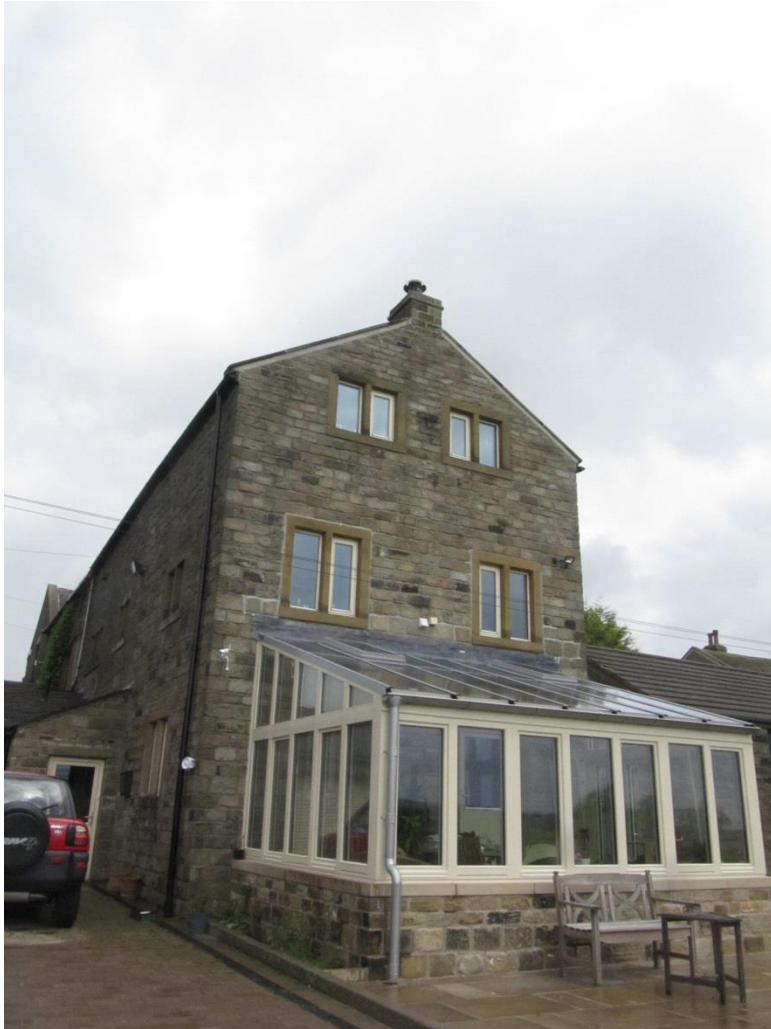
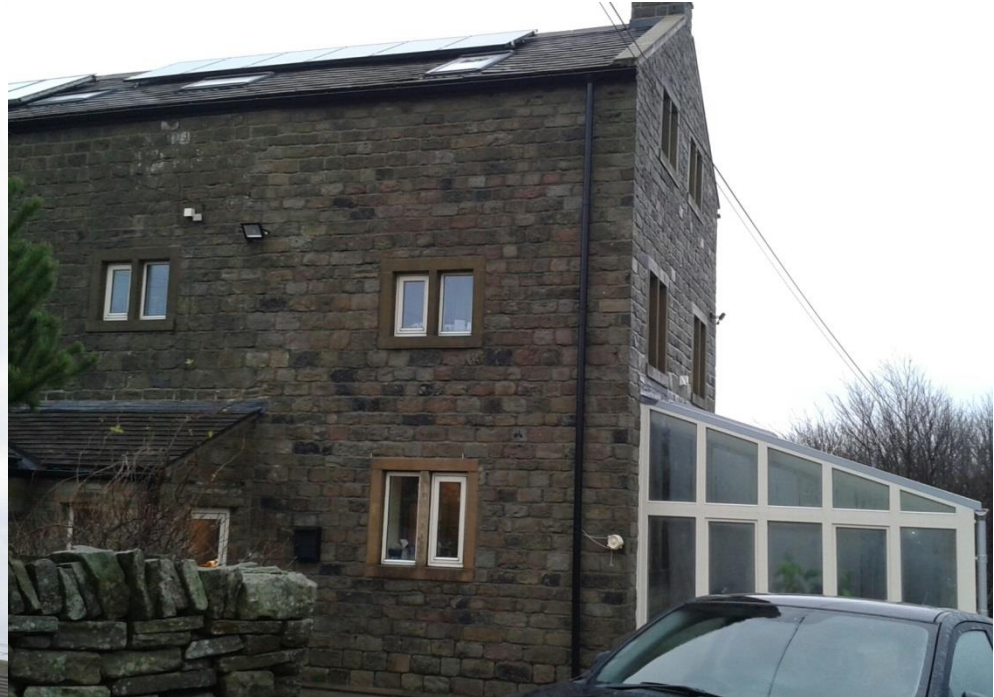
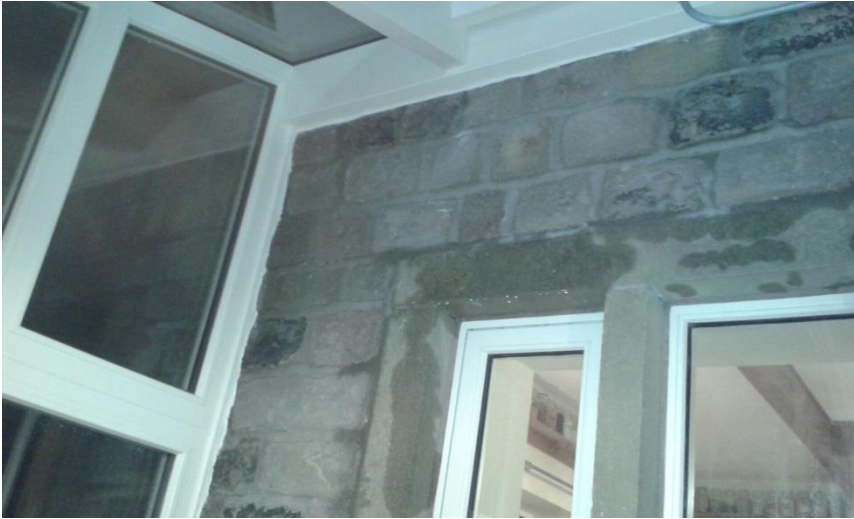
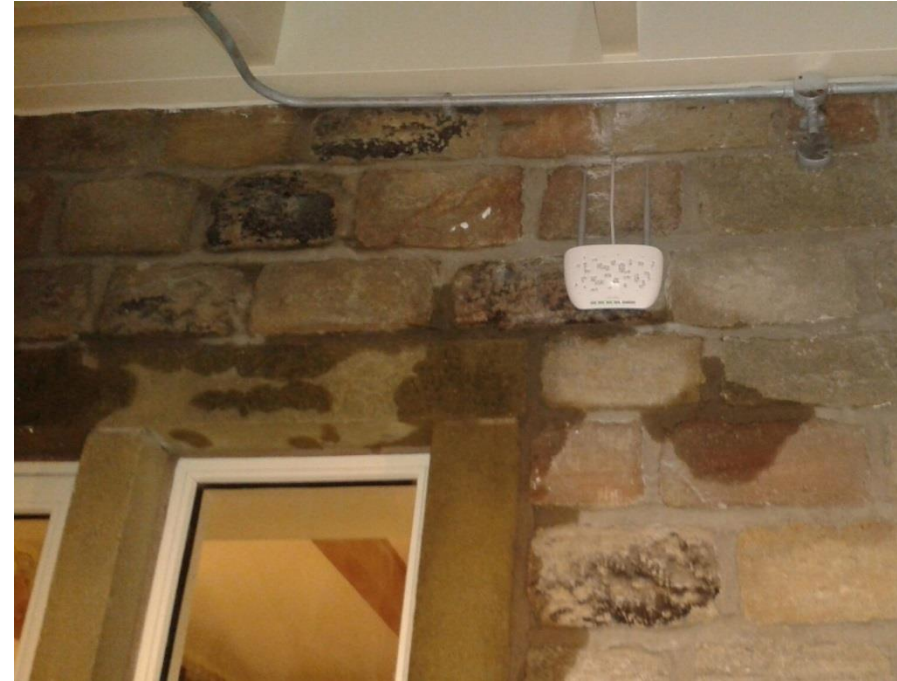
Photos of south wall under new extension

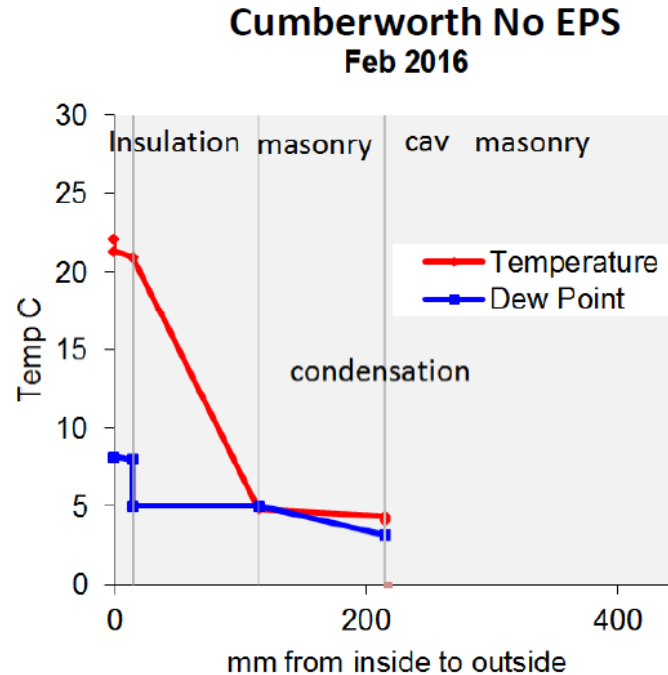
Condensation is borderline on the masonry for Feb 2016.

- Glaser suggests there could be some Interstitial condensation where there is no EPS in winter

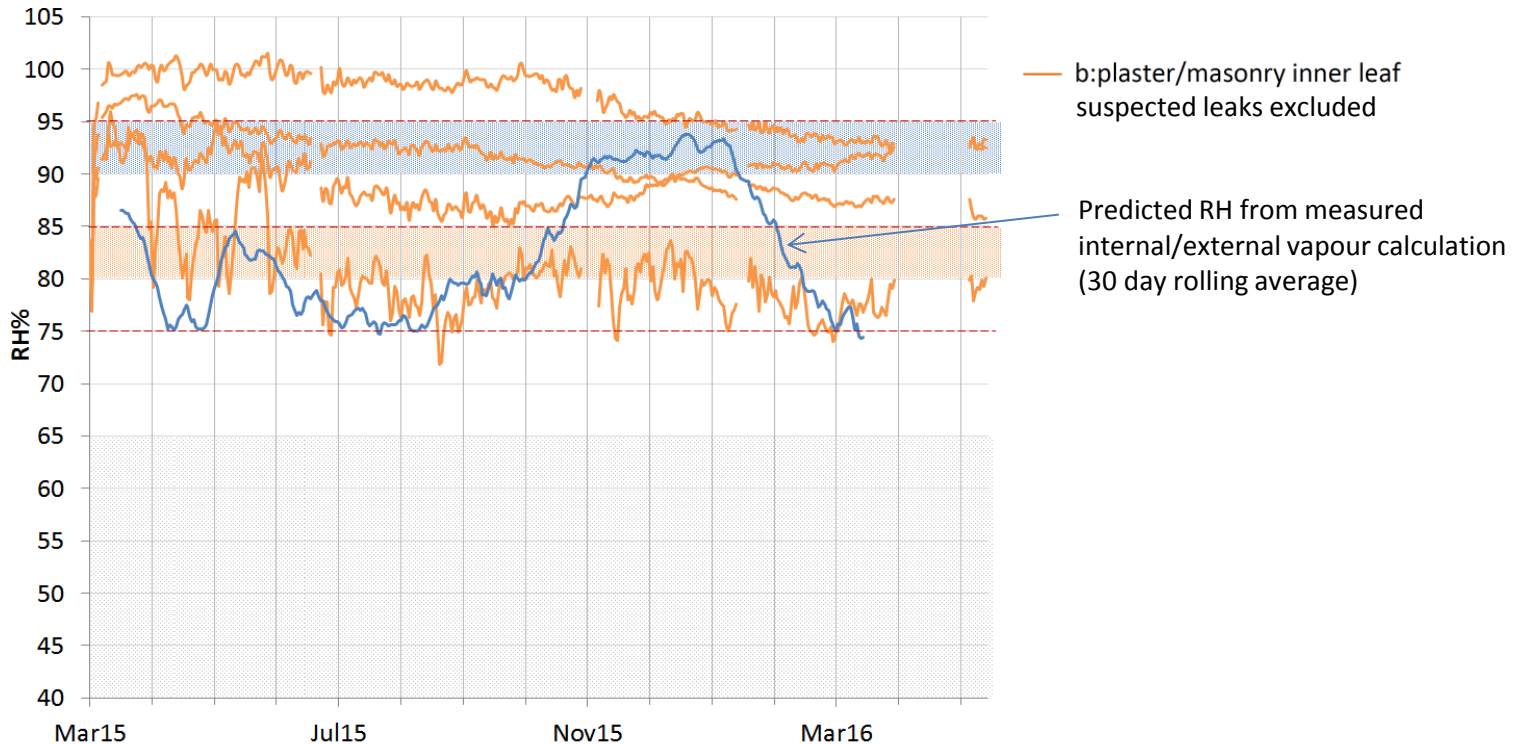
- Trend in plaster/masonry inner leaf moisture content does not follow what we would expect from simple vapour calculations (using Glaser).

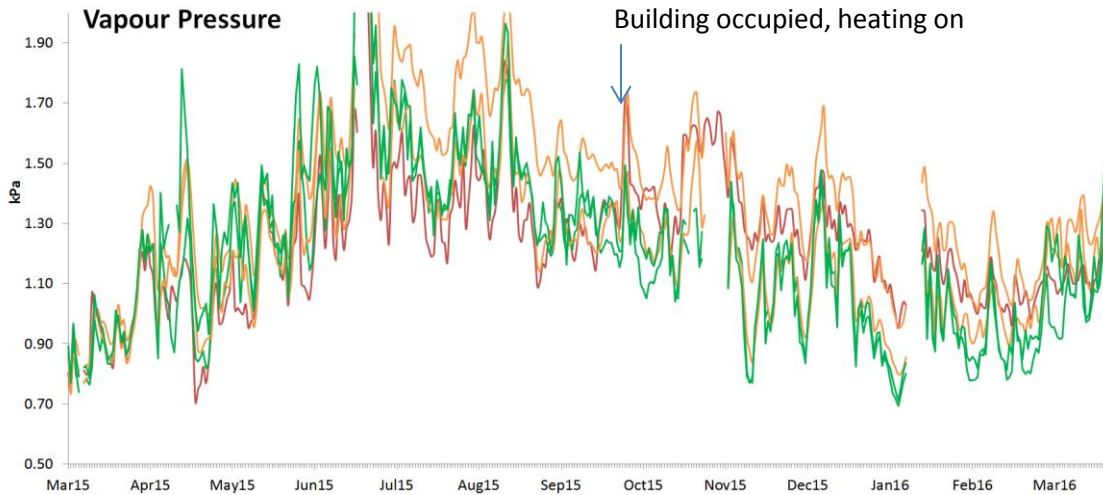
- Vapour pressure from ground floor sensors (excluding suspected leak) suggests variable direction
- sometimes drying inwards and outwards from the centre of the wall.
- occasionally moving from the house interior into the wall.

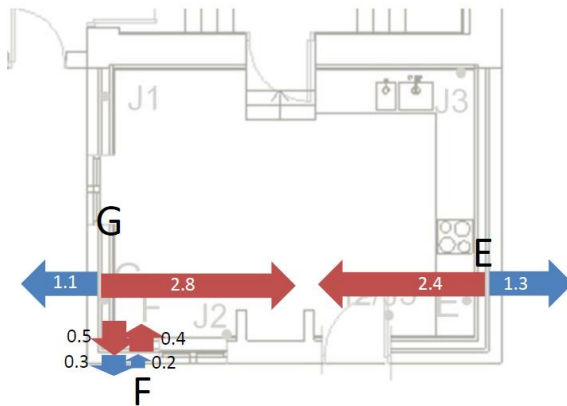
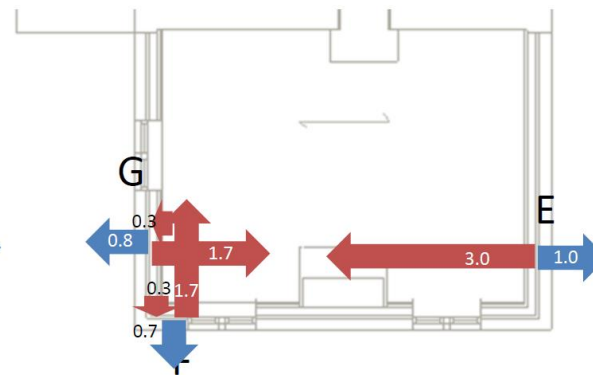
- Overall there has been a lot of inward drying, but most of it before the insulation was installed

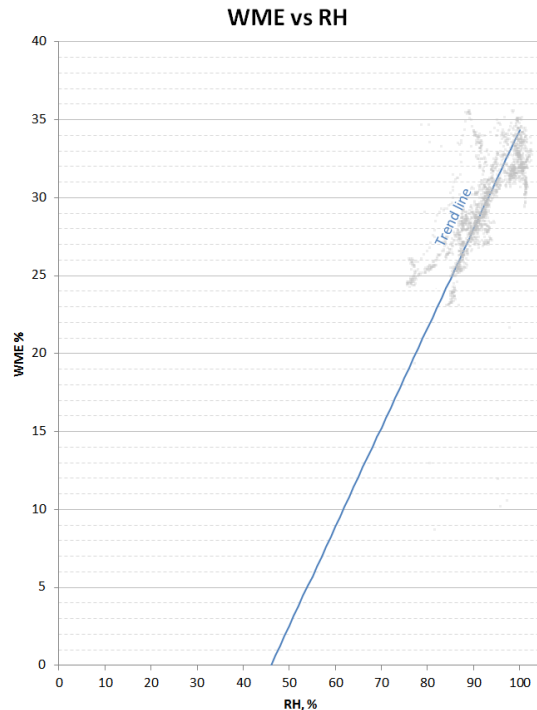
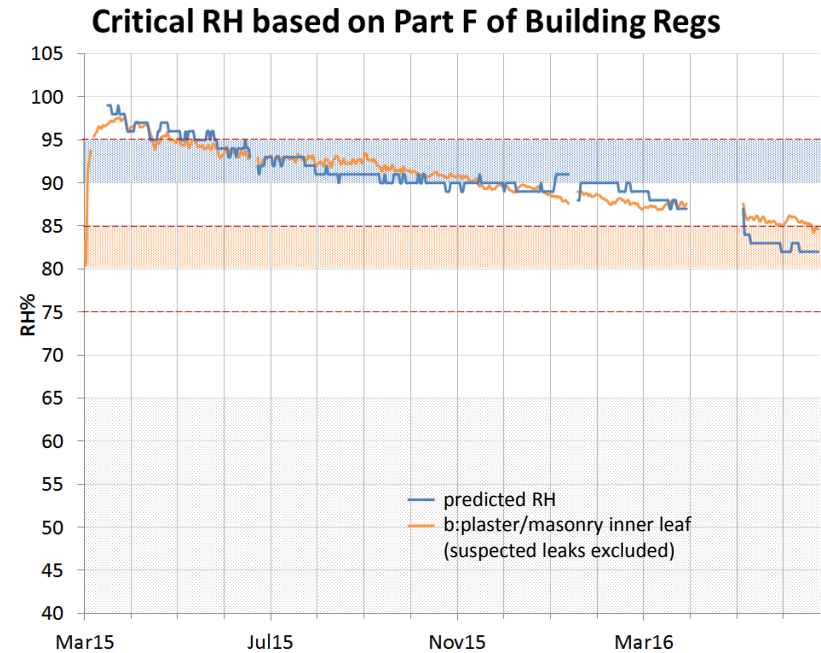
- WME and RH affect each other in a curve
- F0b excluded because it has intermittent data
- F1b is excluded because it has an odd shape and is a proven leak.

- When RH's for E1b are predicted from WME's using this curve there is a good correlation
- This means the initial moisture content of the brick combined with hygroscopic effects (equilibrium of WME with RH) explain the RH much better than vapour (Glaser) effects.

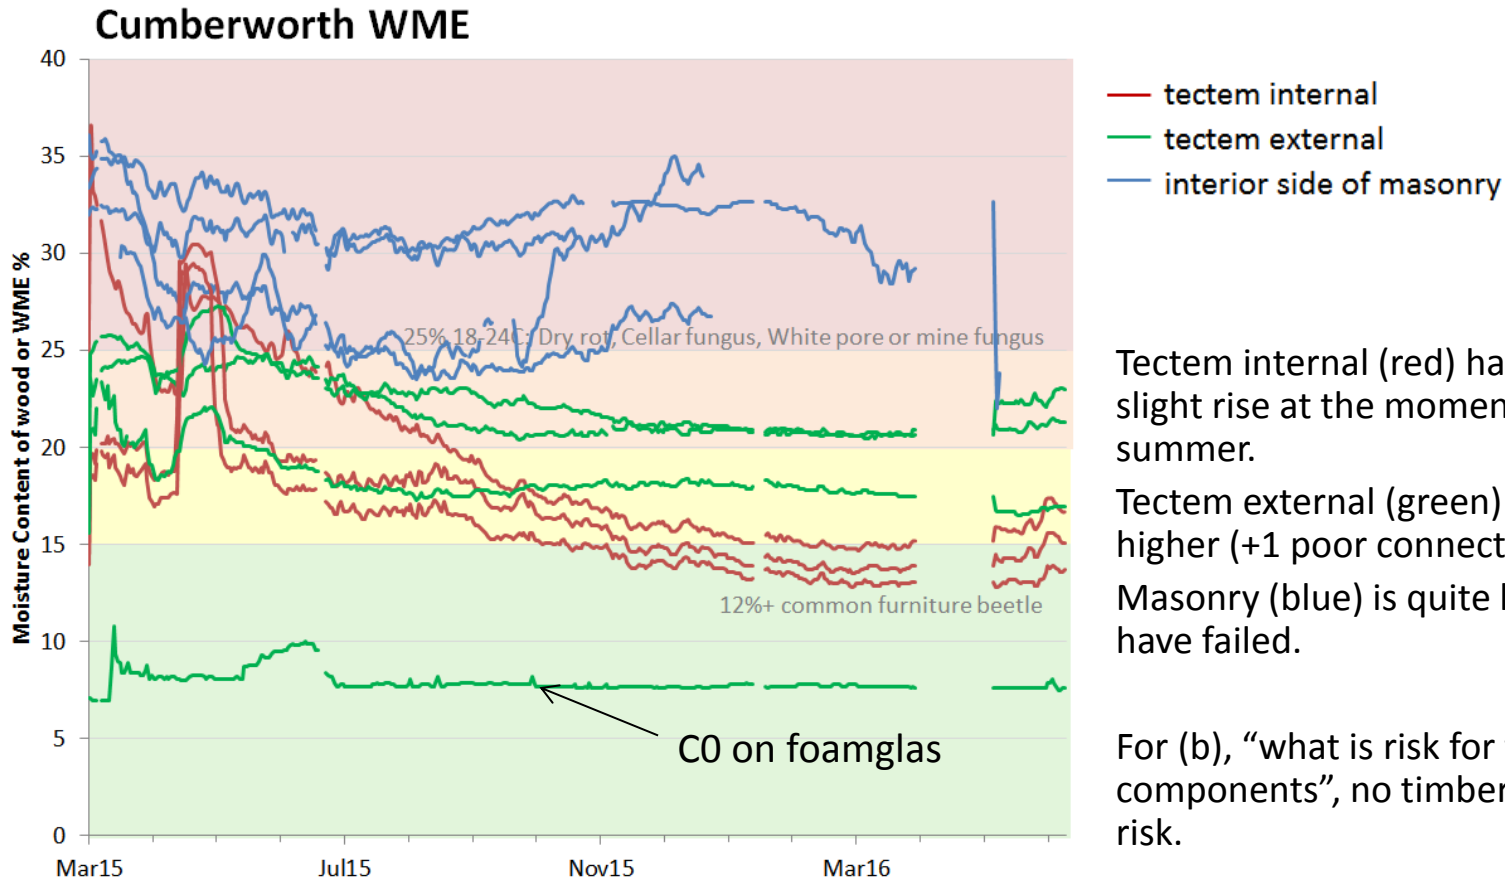
Tectem internal (red) has dried well, slight rise at the moment for summer.

Tectem external (green) a little higher (+1 poor connection)

Masonry (blue) is quite high, all 3 have failed.

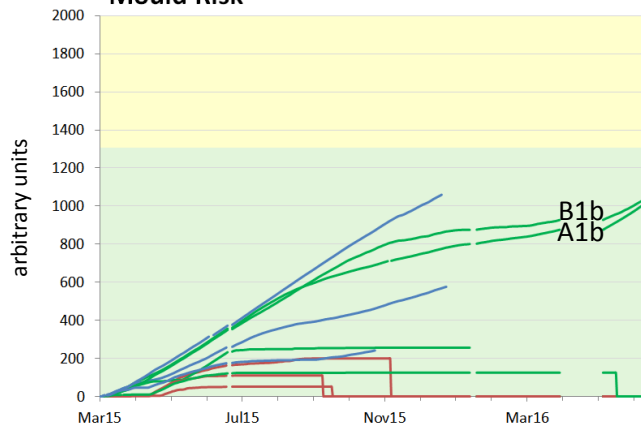
Mould Risk

- Masonry sensors have failed, and one in tectem external, they have had a rather high RH, near 100%.
- There is a mould risk but it is not particularly high

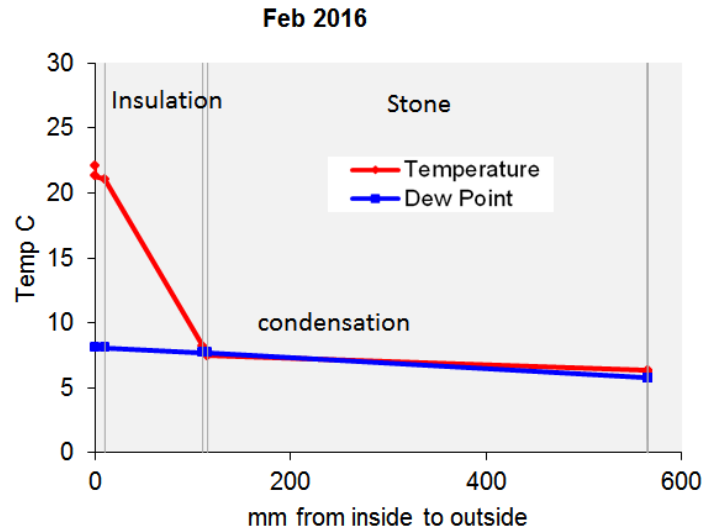
- Glaser suggests it is very close to 100% RH on the cold side of the Tectem, there would be condensation, but the tectem is designed to cope with this.

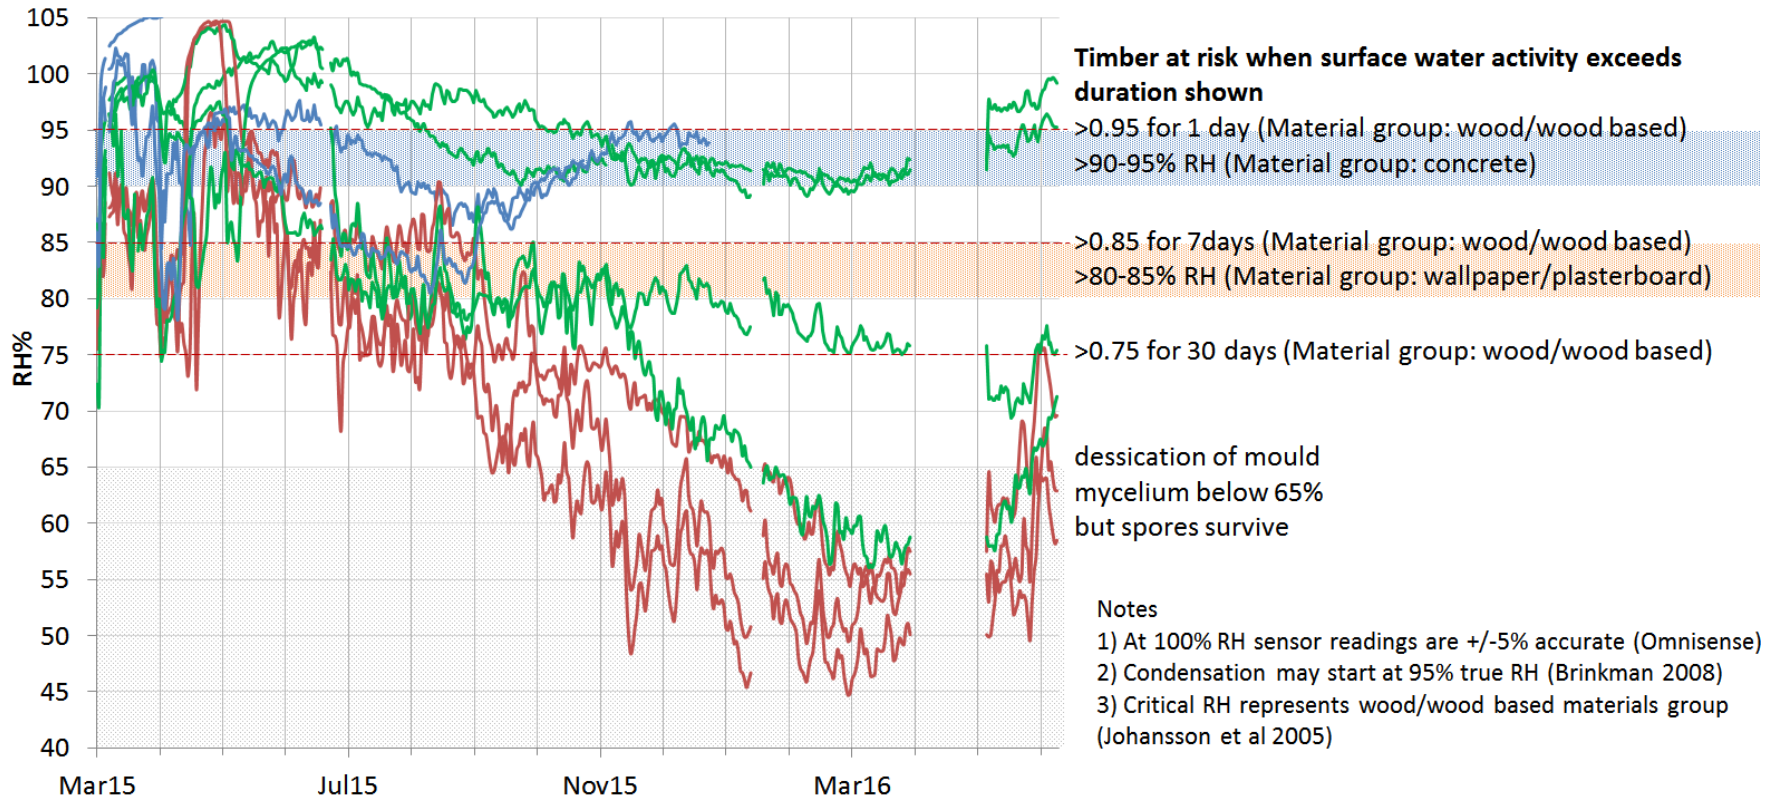
- We are getting high RH's inside the wall, particularly on the masonry
