Common Leakage Sites no.6

Along the top and bottom edges of skirting boards.

Building Fabric Leakage 6: Along the top and bottom edges of skirting boards

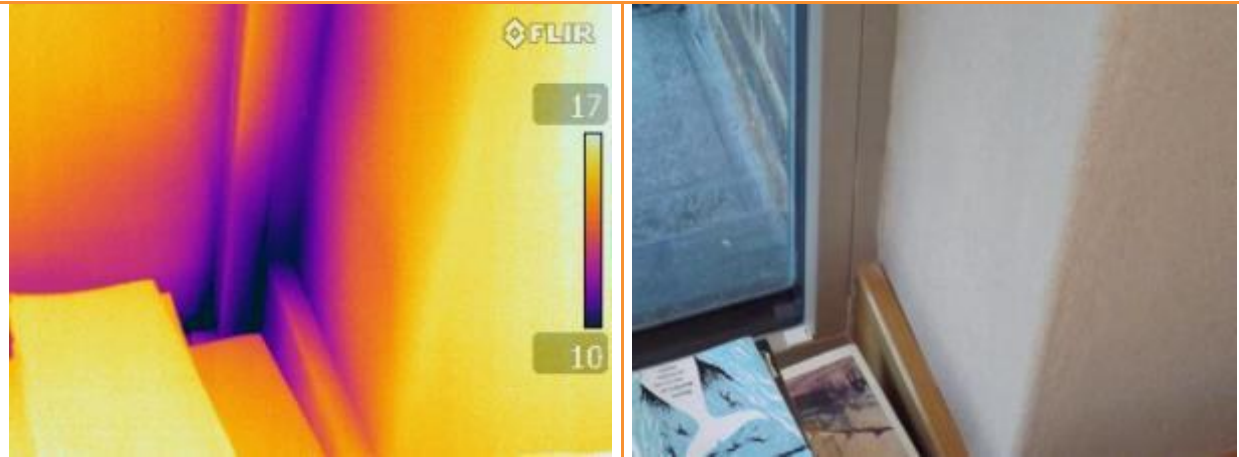
6.01: Internal thermographic image whilst dwelling is depressurised showing leakage showing leakage around skirting board at side of window.

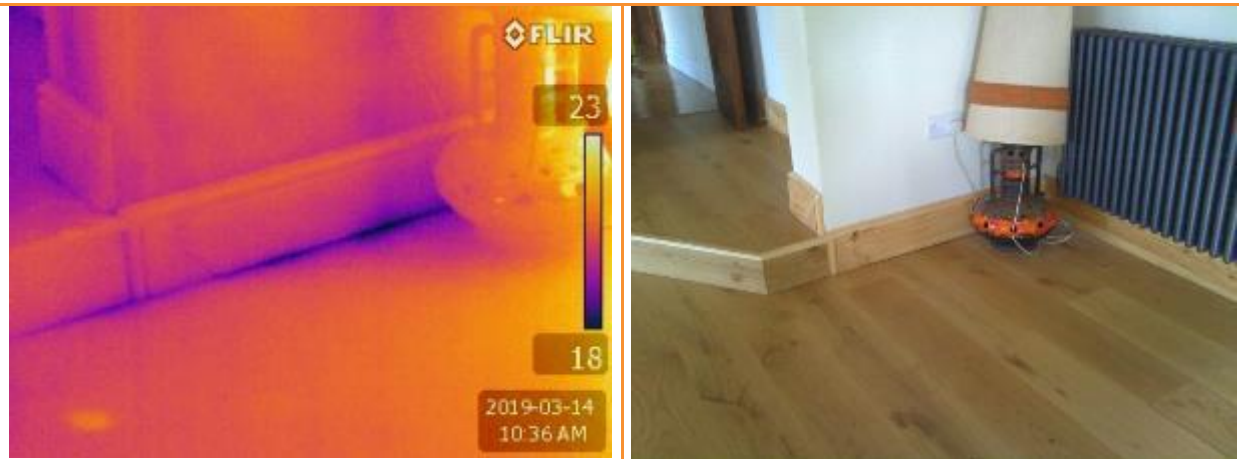
6.02: Internal thermographic image whilst house is depressurised showing leakage along bottom edge of skirting board along internal partition wall.

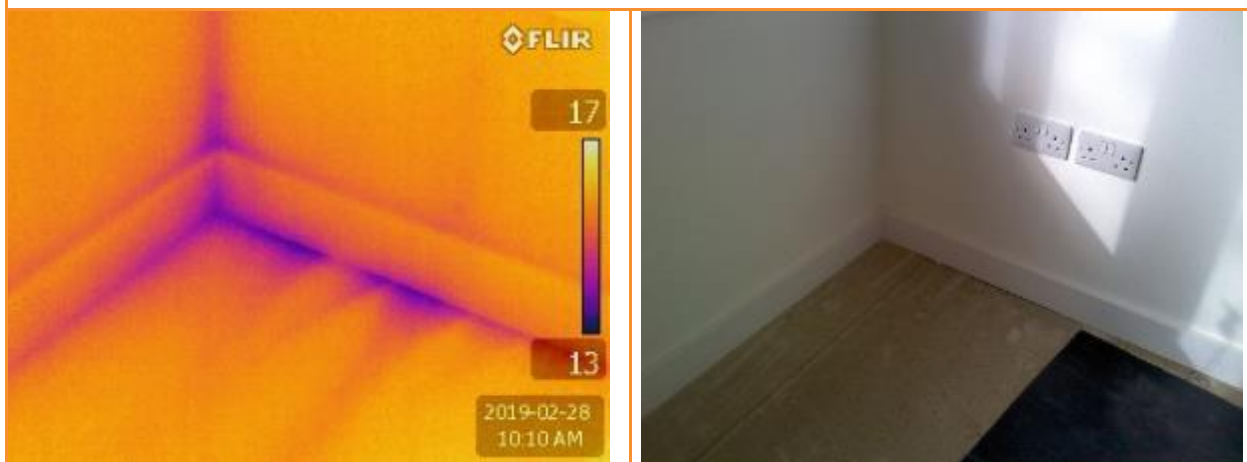
6.03: Internal thermographic image whilst house is depressurised showing leakage along base of skirting board on the first floor.

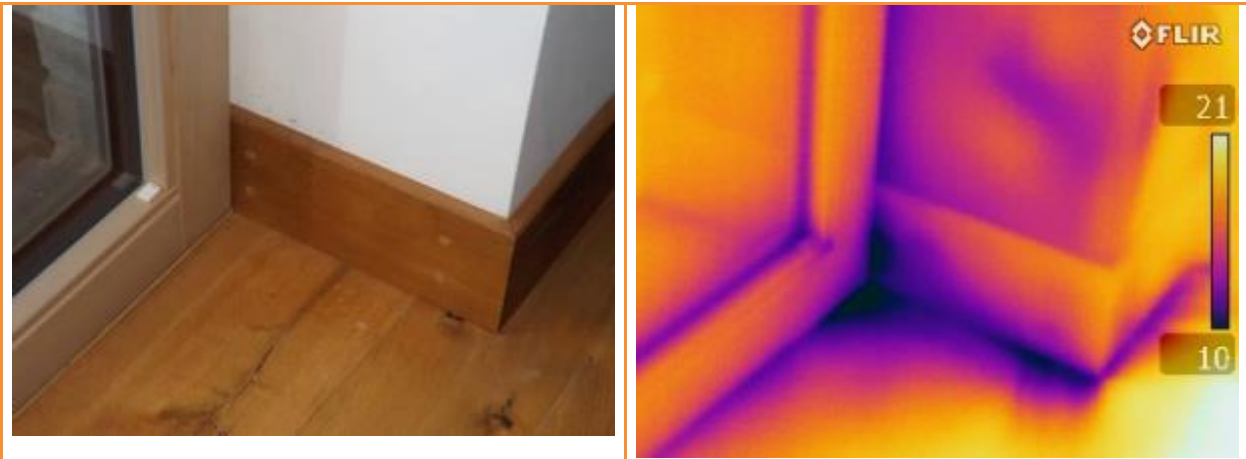
6.04: Internal thermographic image whilst dwelling is depressurised showing leakage beneath skirting at lower corner of opening.

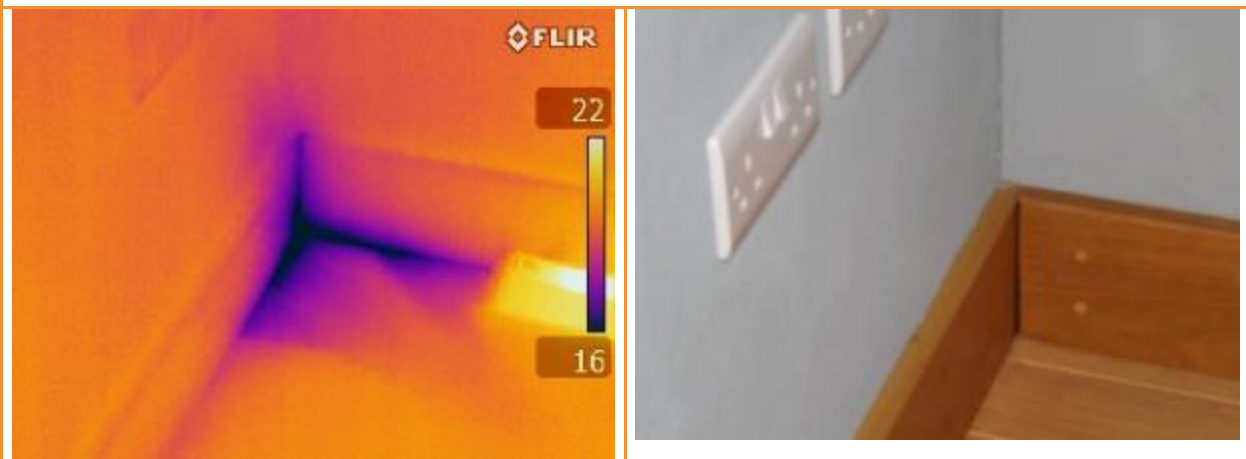
6.05: Internal thermographic image whilst house is depressurised showing leakage in corner at joint in skirting boards.

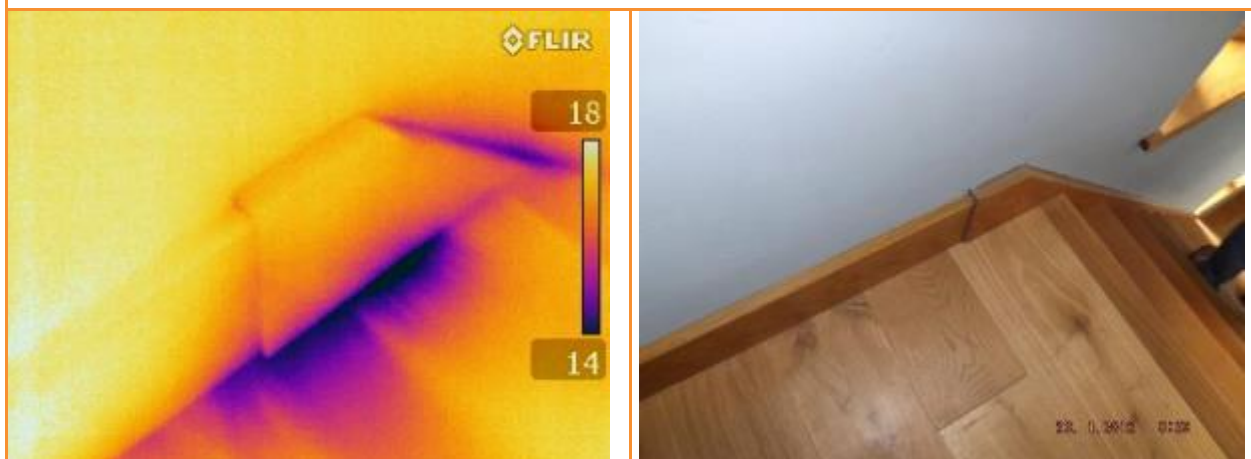
6.06: Internal thermographic image whilst dwelling is depressurised showing leakage at side of stairs outside bedroom.

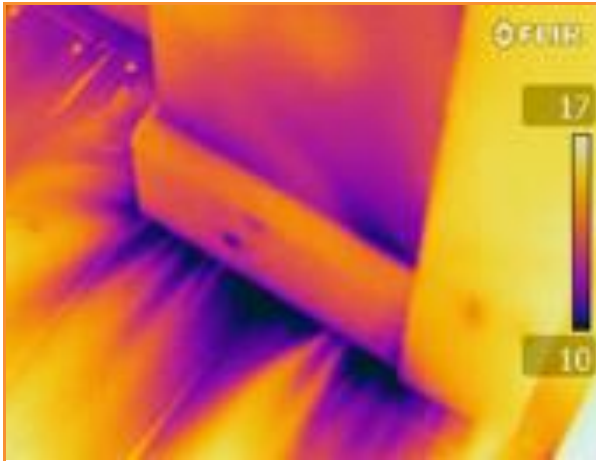
6.07: Internal thermographic image whilst house is depressurised showing substantial leakage at base of first floor internal partition wall to master bedroom – location where extension abuts original dwellings.

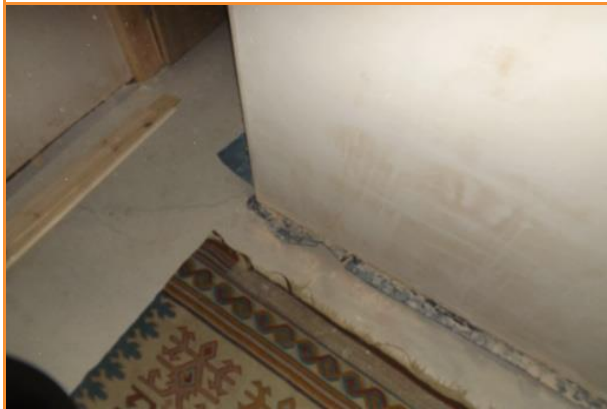
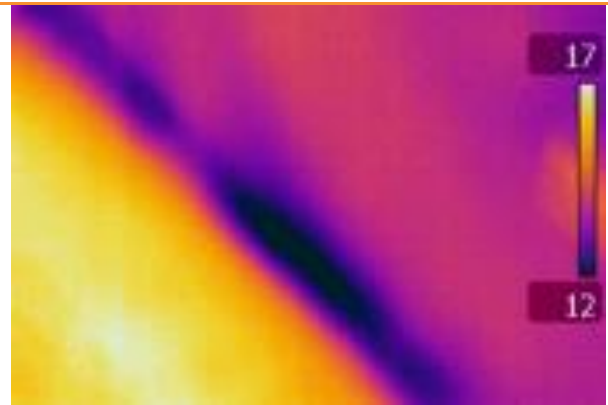
6.08: Internal thermographic image whilst house is depressurised showing substantial leakage along the base of an internal partition wall.

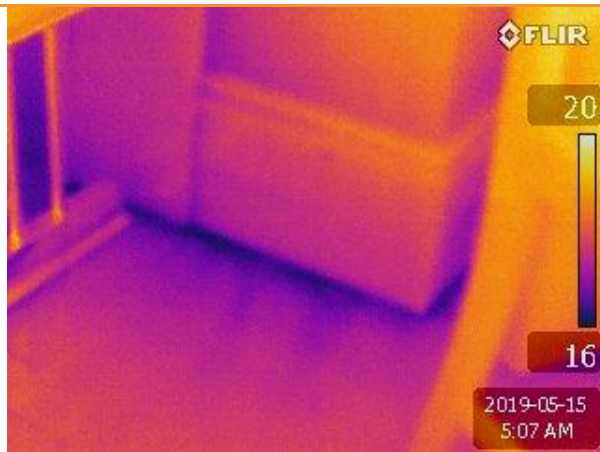
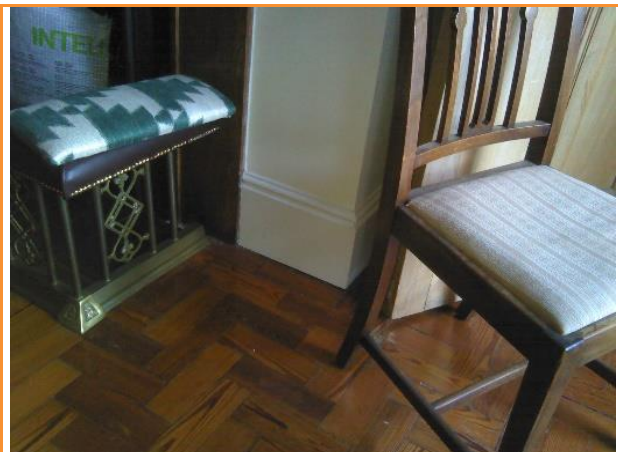
6.09: Internal thermographic image whilst house depressurised, showing leakage at bottom edge of skirting board next to internal fireplace in centre of house, ground floor

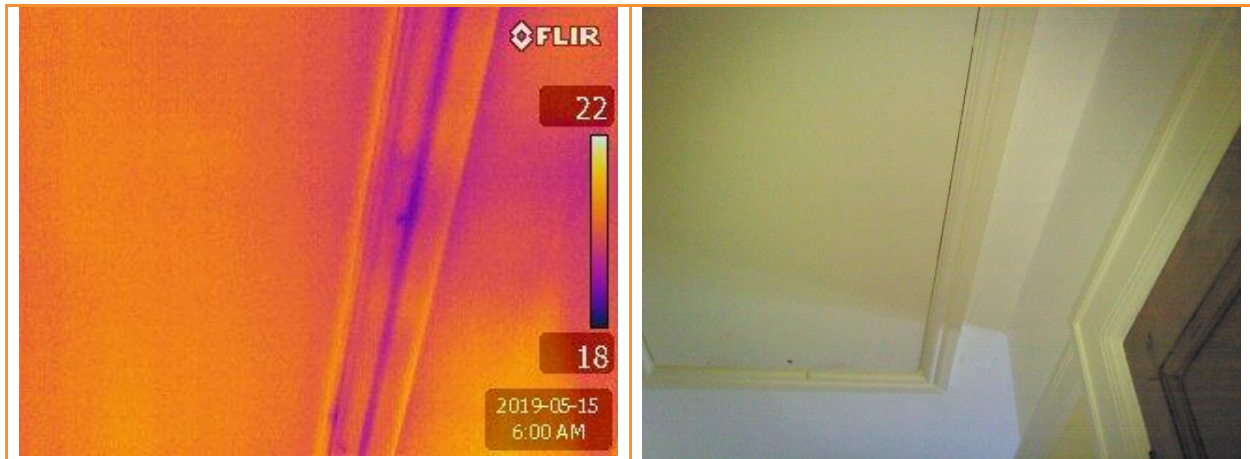
6.10: Internal thermographic image whilst house depressurised showing leakage along edge of decorative coving under ceiling, ground floor

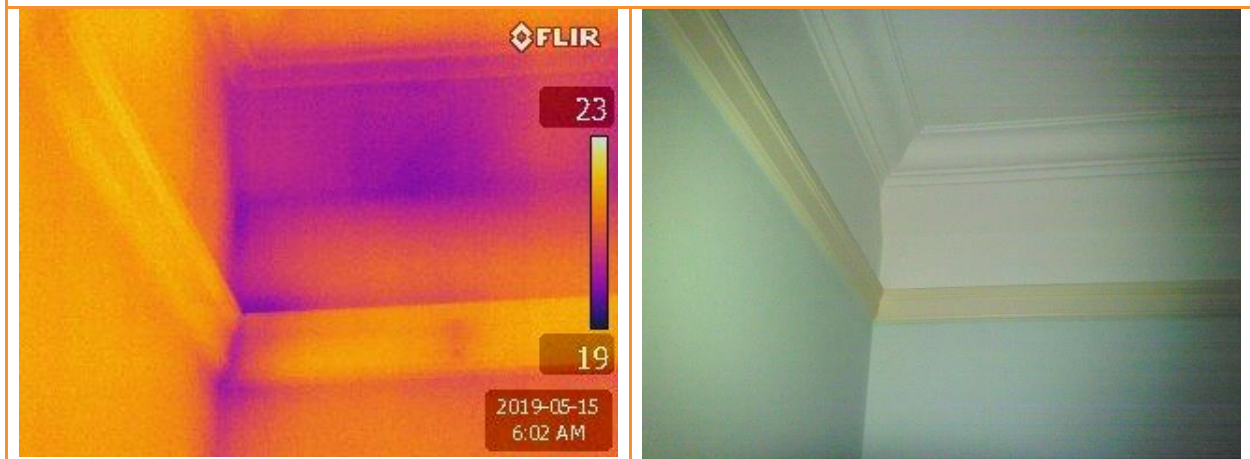
6.11: Internal thermographic image whilst house depressurised showing leakage in corner above architrave, ground floor. Also, cold section in wall suggesting missing insulation

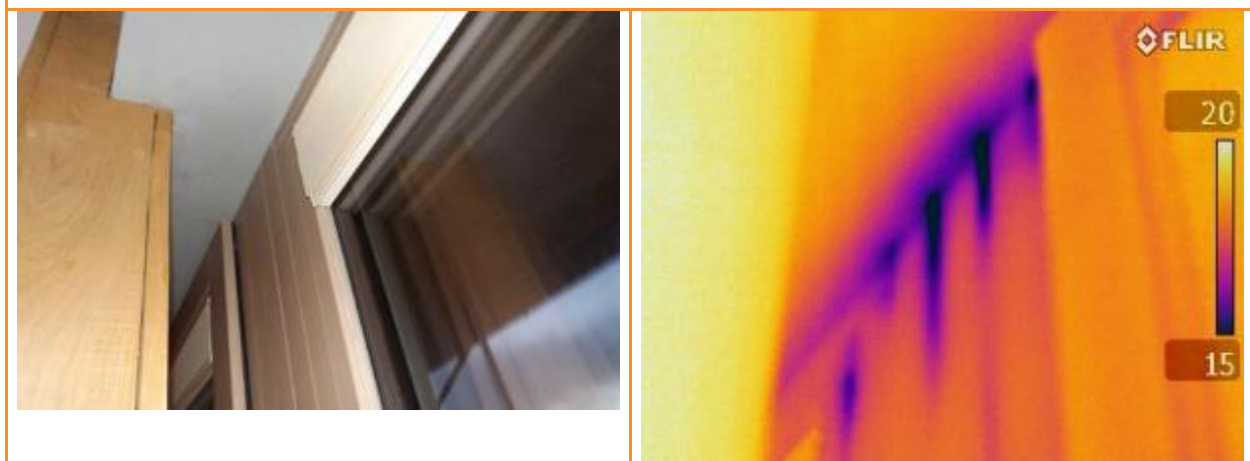
6.12: Internal thermographic image whilst house is depressurised showing leakage between sections of vertical timber in kitchen wall.

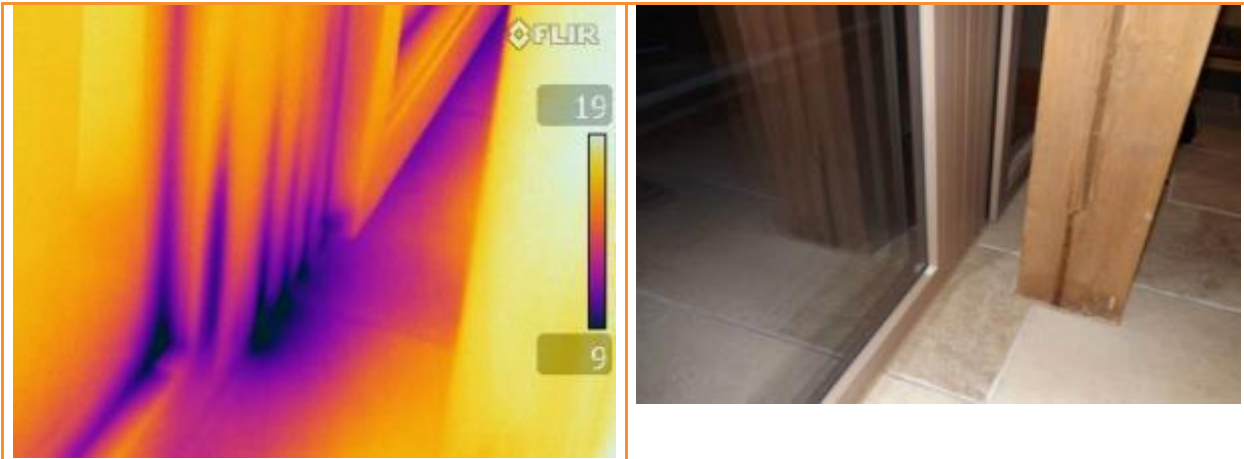
6.13: Internal thermographic image whilst house is depressurised showing leakage between sections of infill panel in glazing in kit.

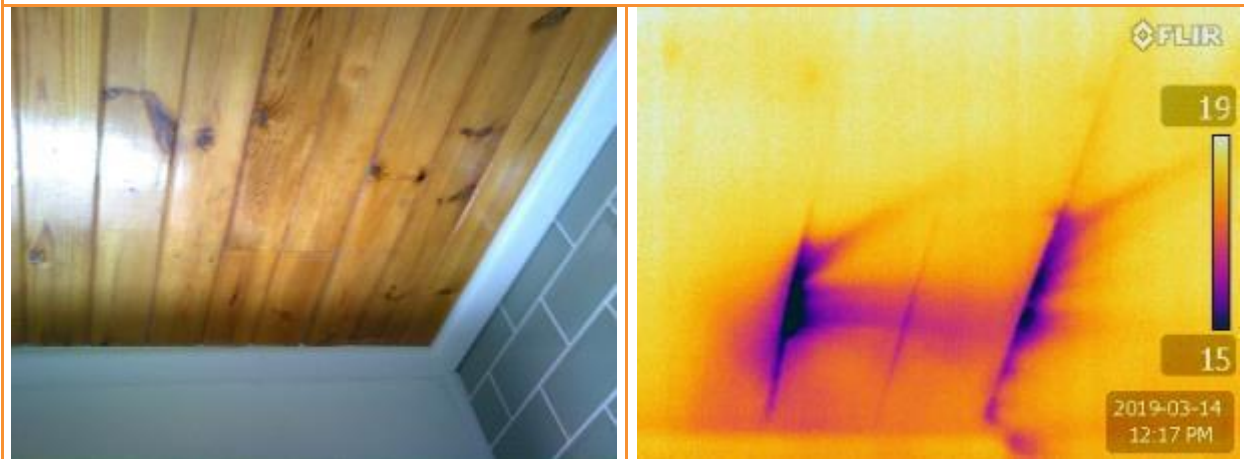
6.14: Internal thermographic image showing leakage on joints in timber ceiling whilst house depressurised.

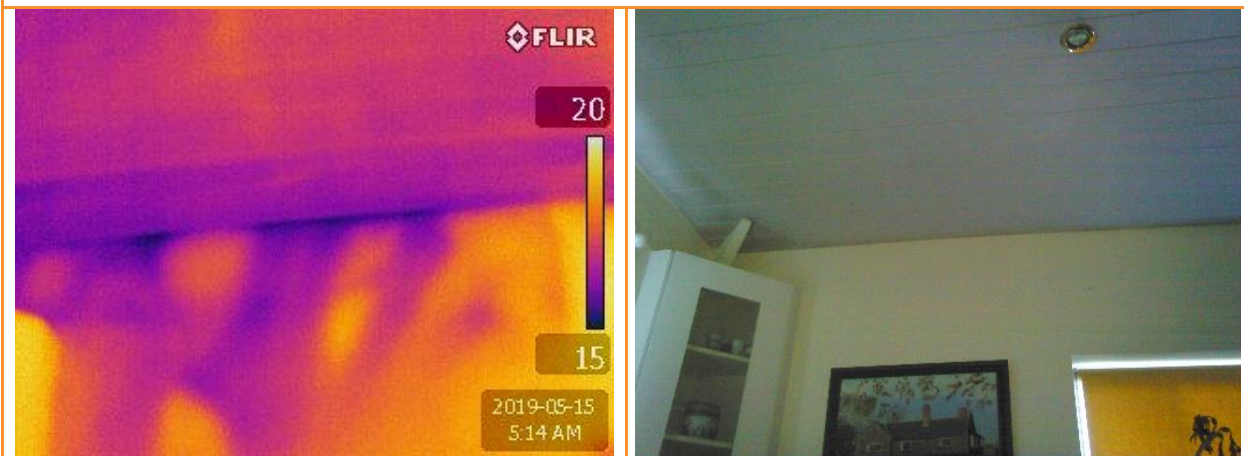
6.15: Internal thermographic image whilst house depressurised, showing leakage around edge of timber ceiling in single-storey section off kitchen

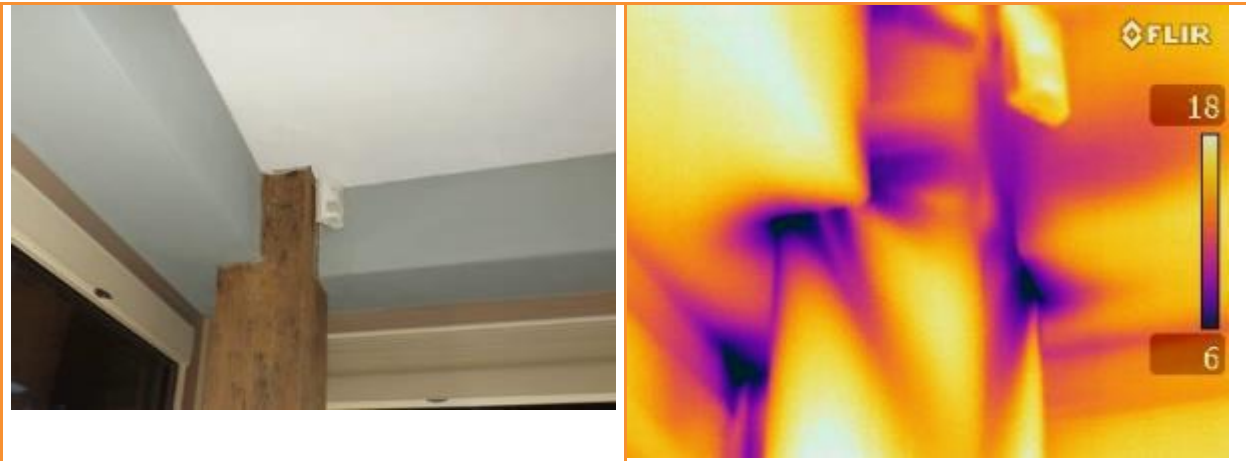
6.16: Internal thermographic image whilst dwelling is depressurised showing numerous leakage points between oak frame and adjacent plasterboard boxing.

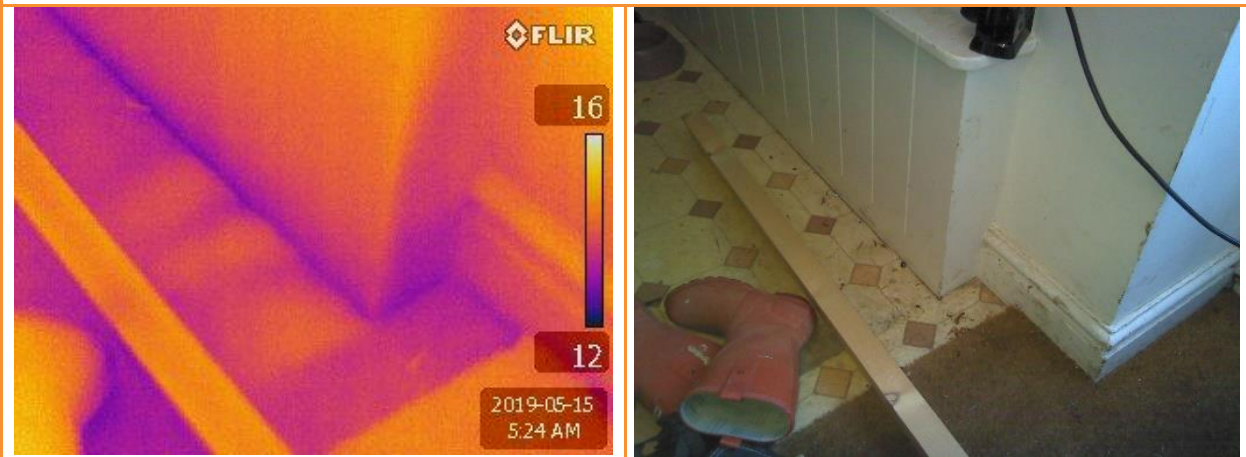
6.17: Internal thermographic image whilst house depressurised, showing leakage along bottom edge boxing in boot room, ground floor rear

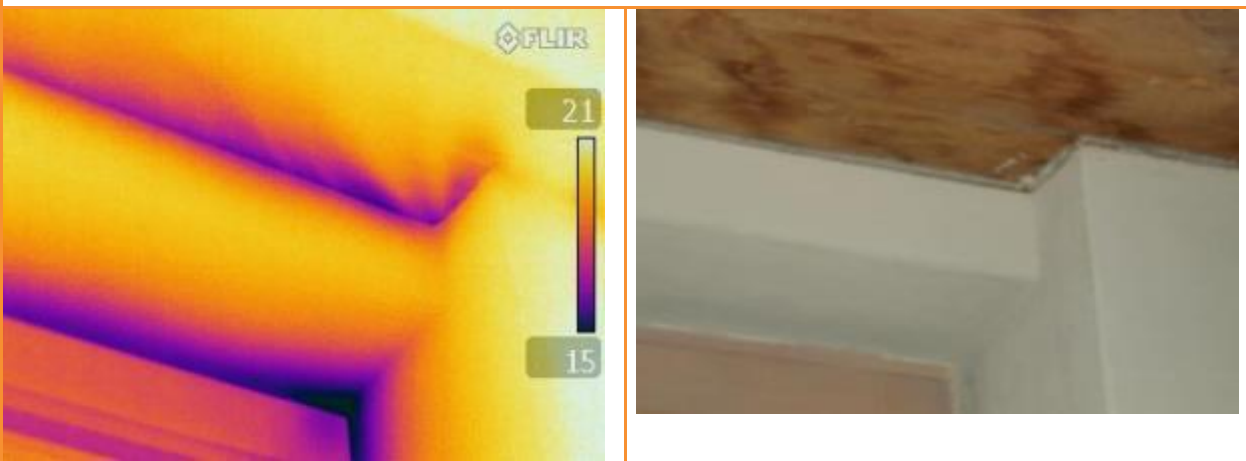
6.18: Internal thermographic image whilst dwelling is depressurised showing leakage around window and along edges of boxing above opening.

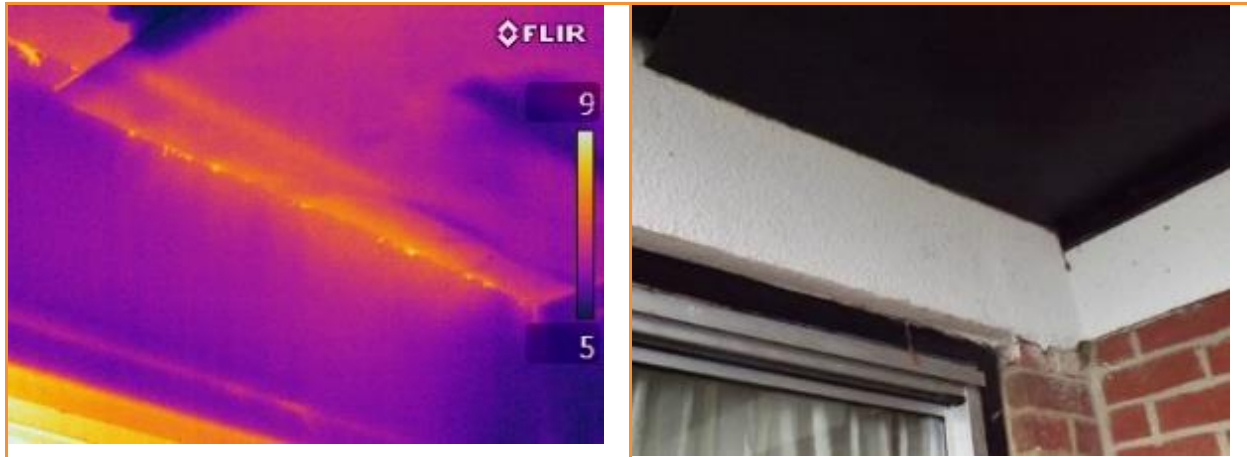
6.19: External thermographic image whilst house is pressurised showing leakage along the bottom edge of an overhanging access balcony.

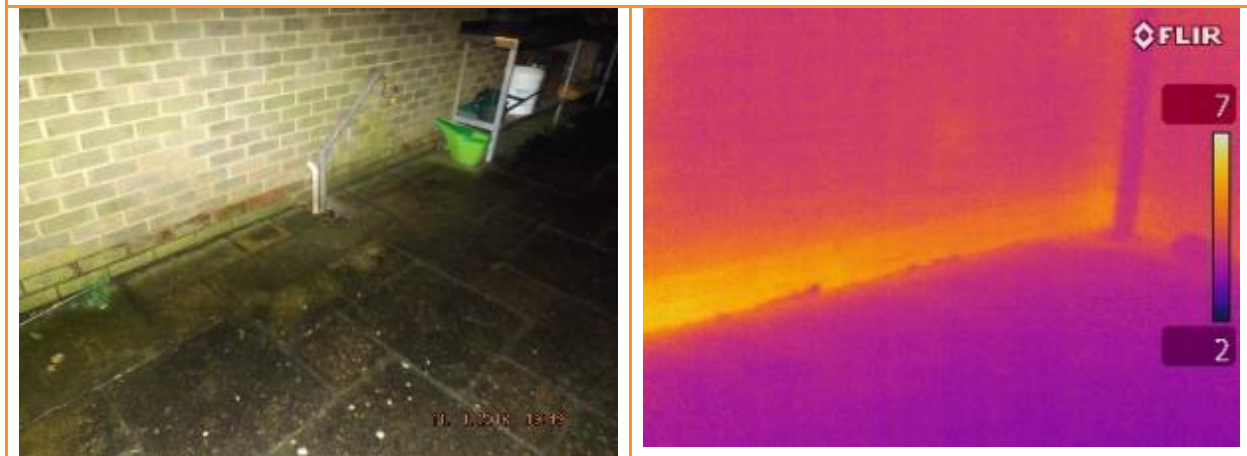
6.20: Thermographic image showing heat loss along the edge of the ground floor slab, viewed externally whilst house is pressurised

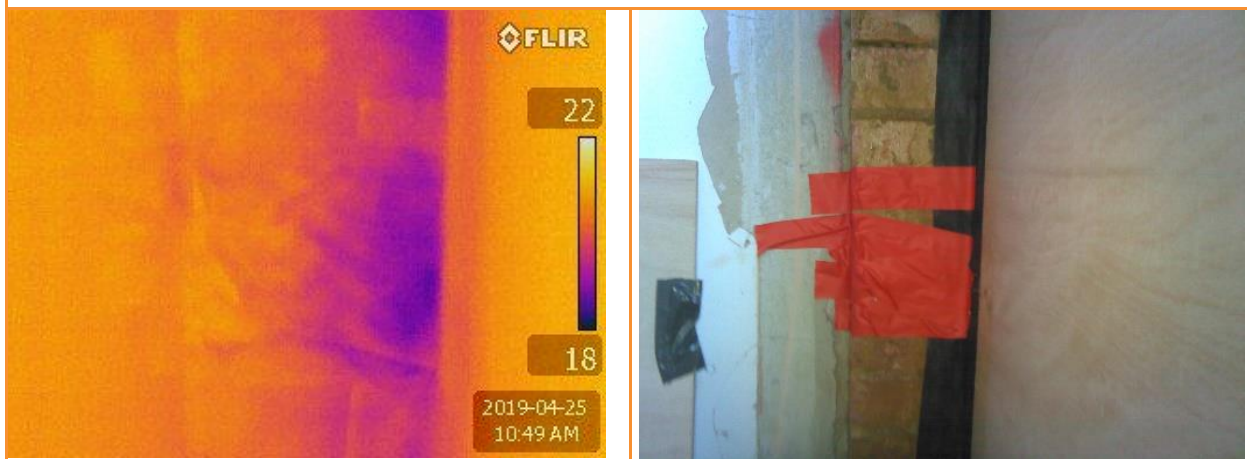
6.21: Thermographic image showing leakage at vertical joint in existing masonry beside opening, despite temporary remedial sealing undertaken after the initial leakage check

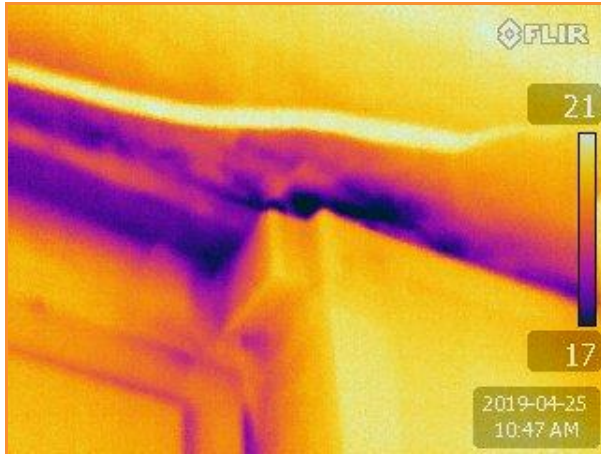
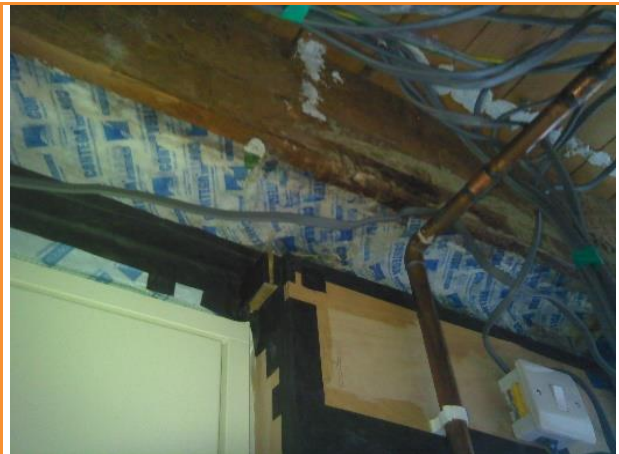
6.22: Thermographic image showing substantial leakage at top of wall

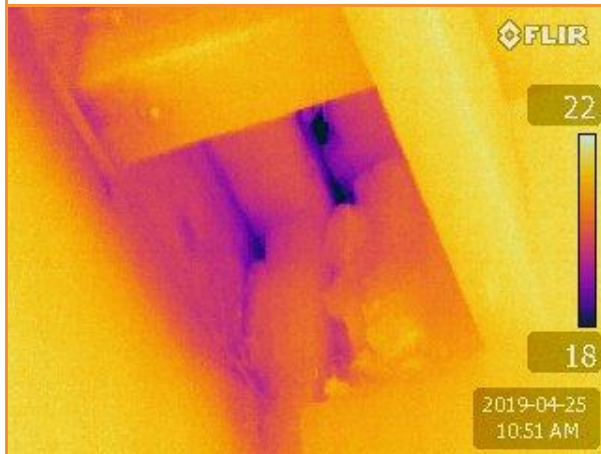
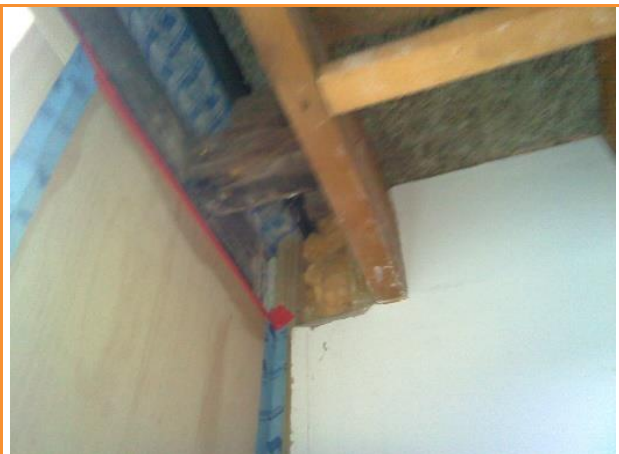
6.23: Thermographic image showing substantial high-level leakage at top of wall section

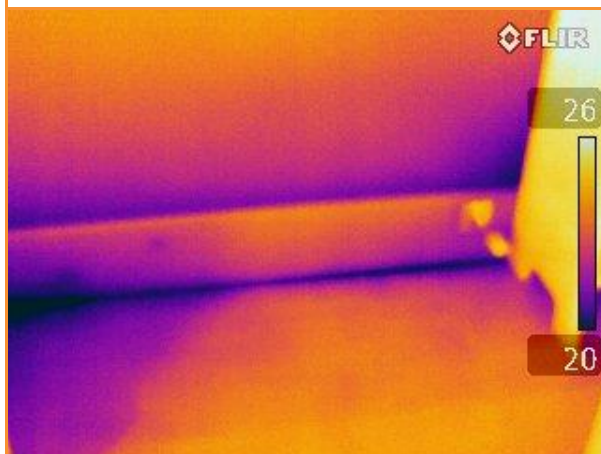
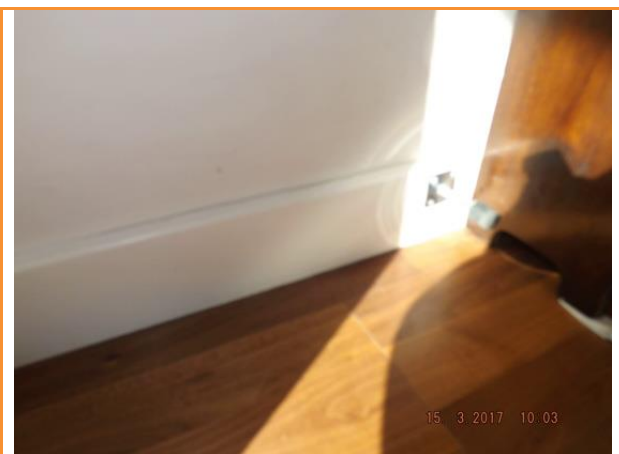
6.24: Thermographic image showing leakage along top and base of skirting

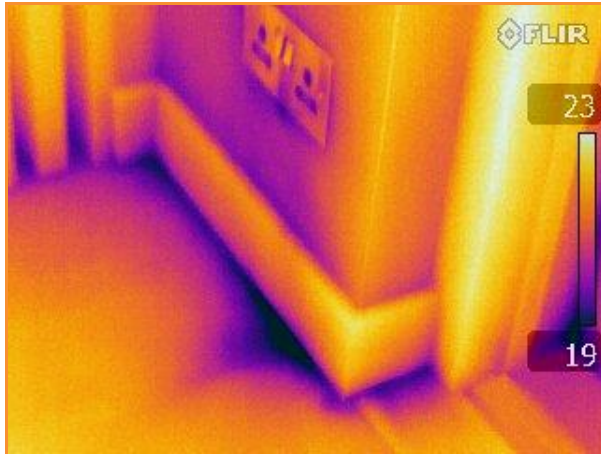
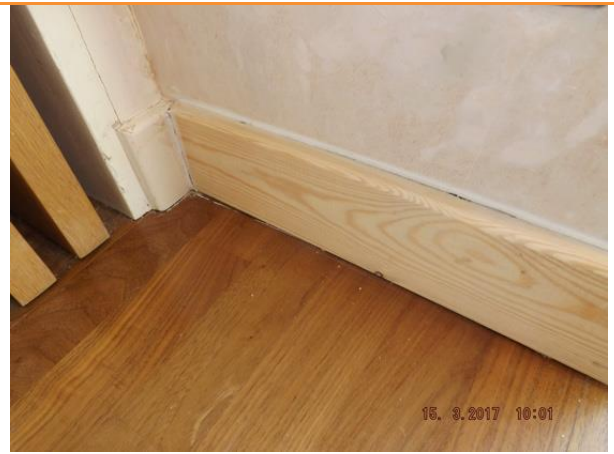
6.25: Thermographic image showing leakage beneath skirting, also through electrical sockets

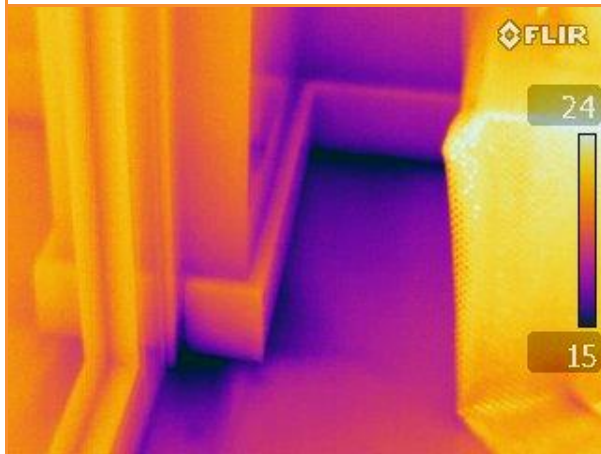
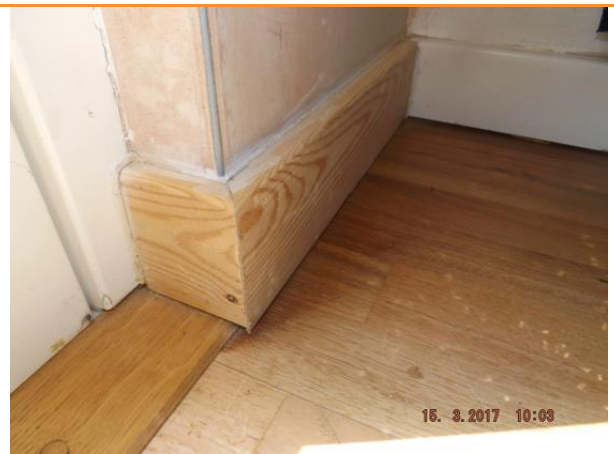
6.26: Thermographic image showing extensive leakage beneath skirting

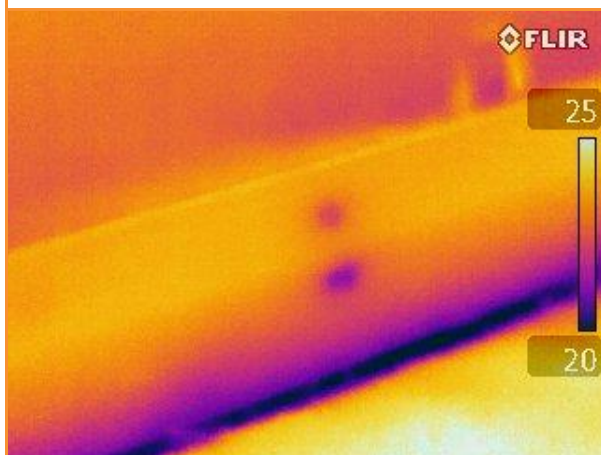
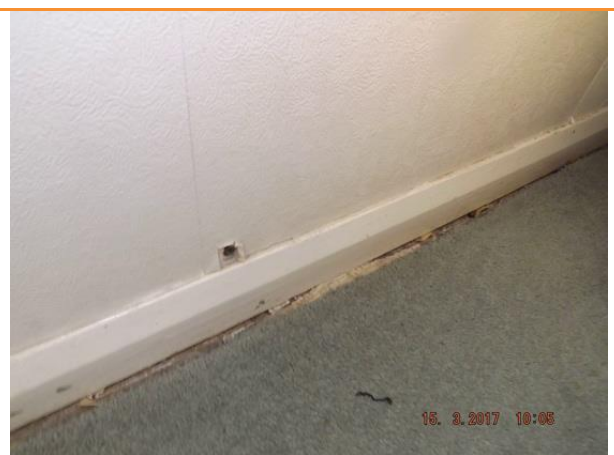
6.27: Thermographic image of leakage along edge of floor at rear of lounge

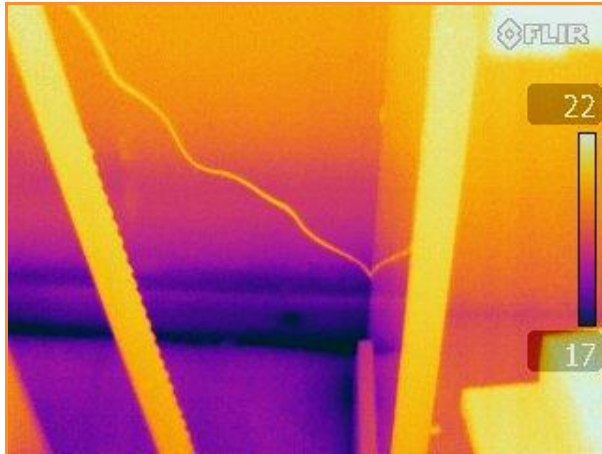
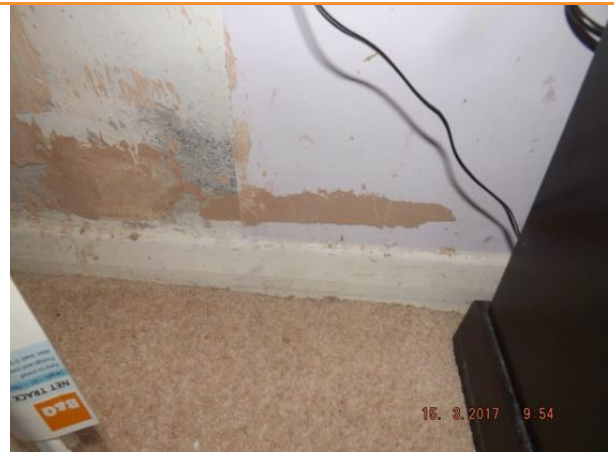
6.28: Thermographic image showing leakage across base of skirting in garage extension

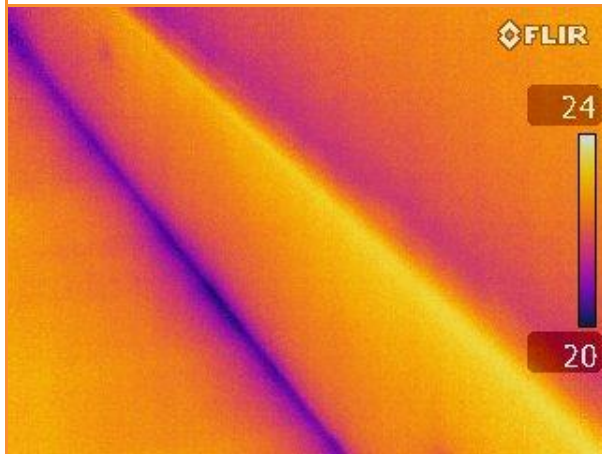
6.29: Thermographic image showing leakage along bottom of skirting in garden extension

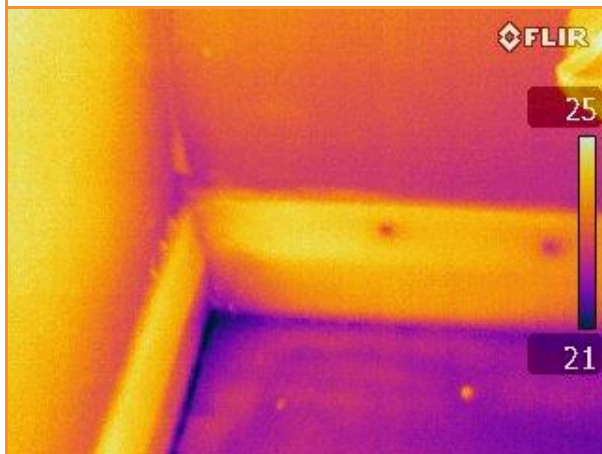
6.30: Thermographic image showing leakage in corner beneath junction of skirting

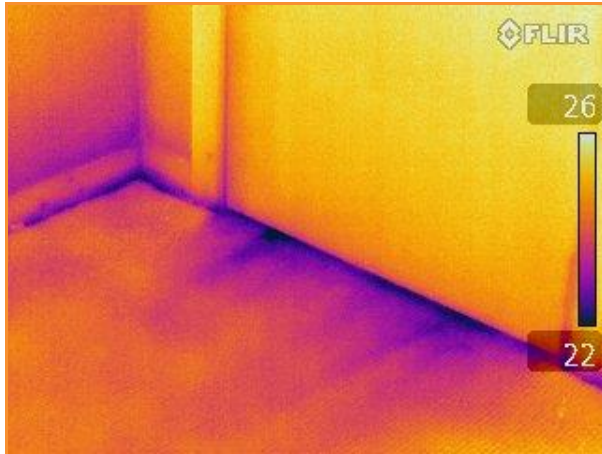
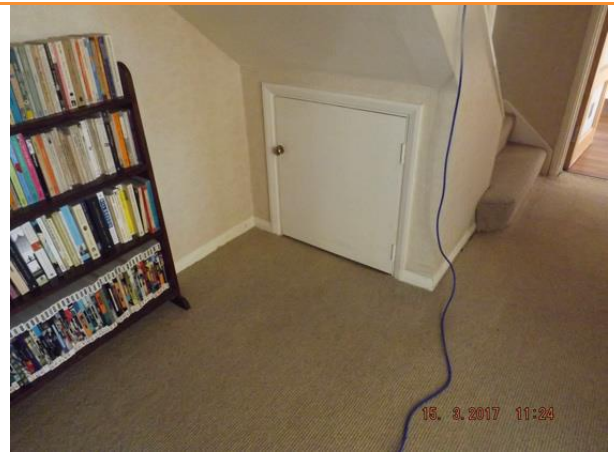
6.31: Thermographic image showing substantial leakage across base of access, also on skirting nearby indicating that the leakage from the access is likely to be coming from the same source

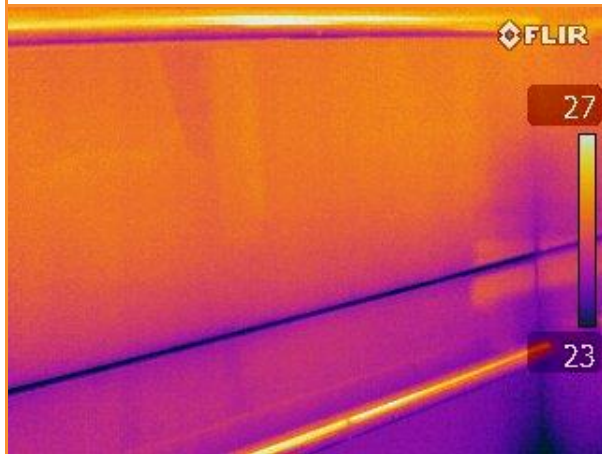
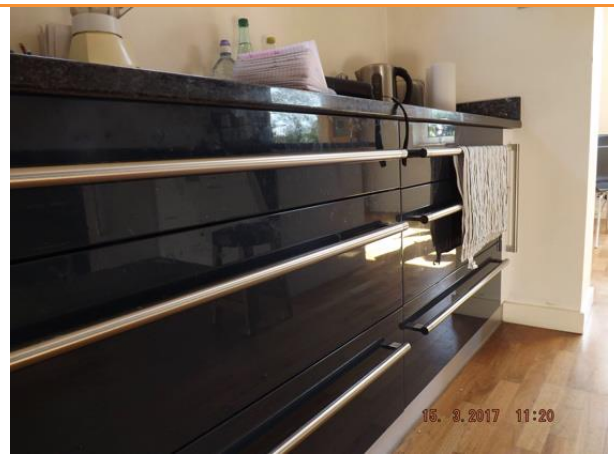
6.32: Thermographic image showing leakage at gap between kitchen drawers

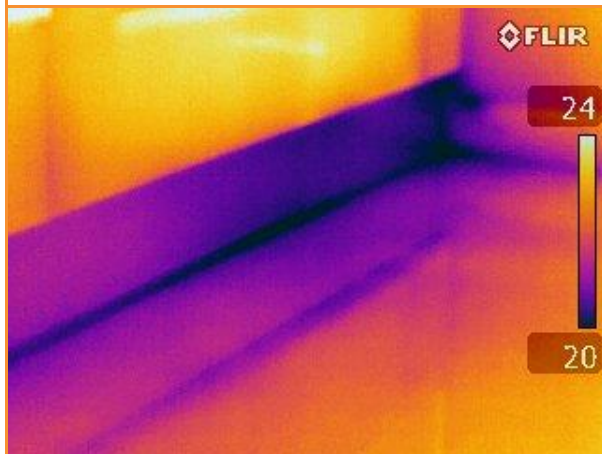
6.33: Thermographic image showing leakage across base of kitchen units

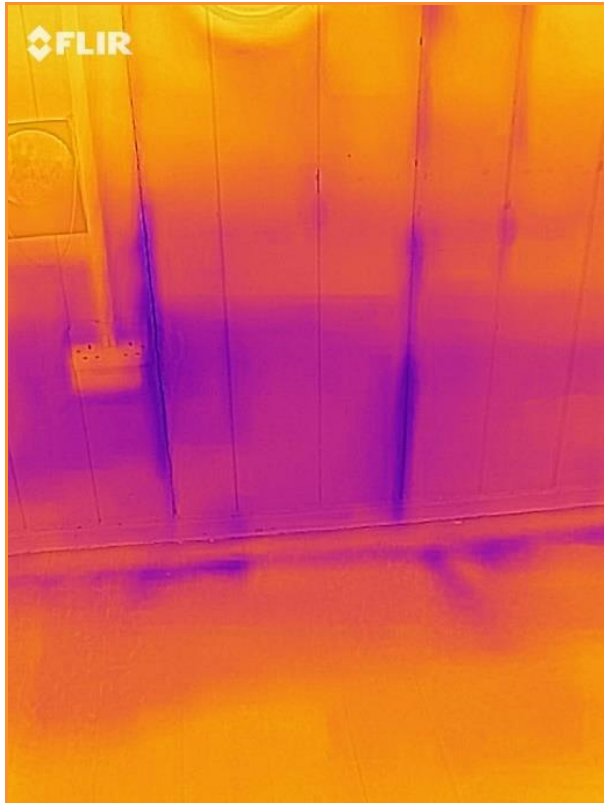
6.34: Internal thermographic image whilst building depressurised, showing heat loss between boards along (1) base of side wall to main hall and (2) along the bottom edge of the skirting board

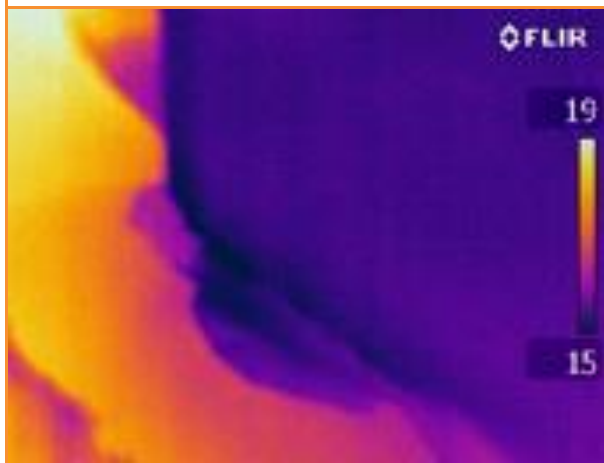
6.34: Thermographic image showing extensive leakage at side of opening where floorboards meet cavity wall

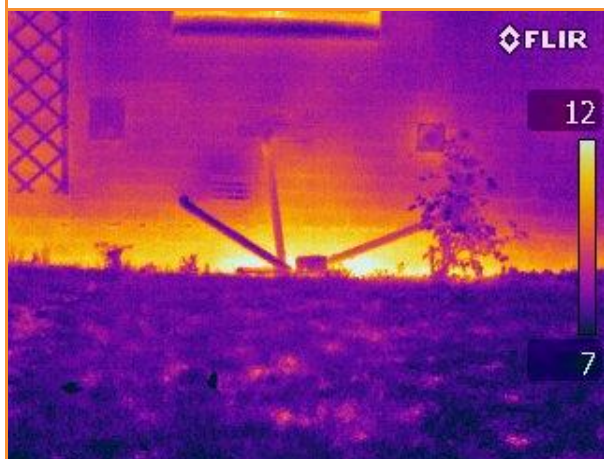
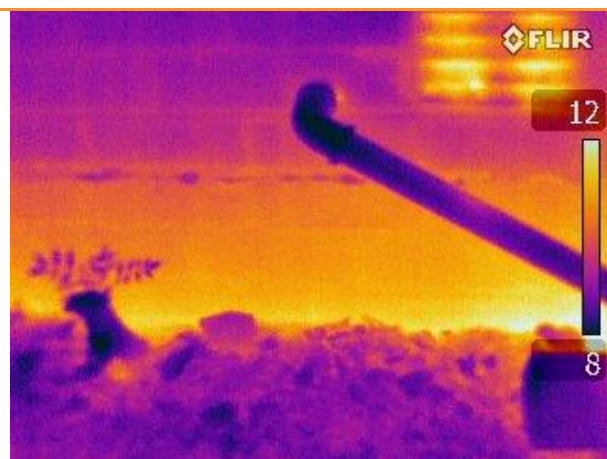
6.35: Thermographic images showing leakage along base of kitchen wall

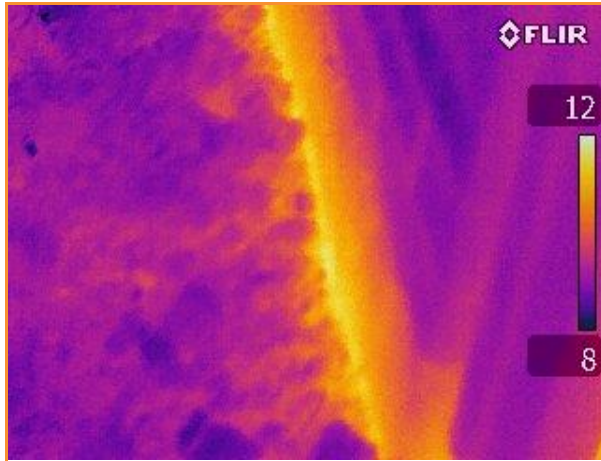
6.36: Thermographic image from above of leakage along base outside of kitchen wall

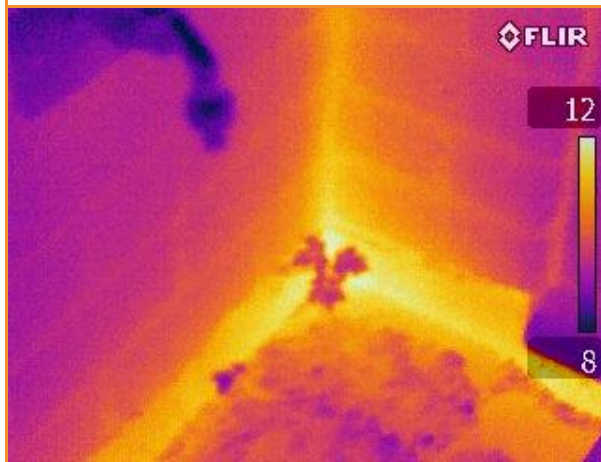
6.37: Thermographic image of leakage where extension meets main house at front

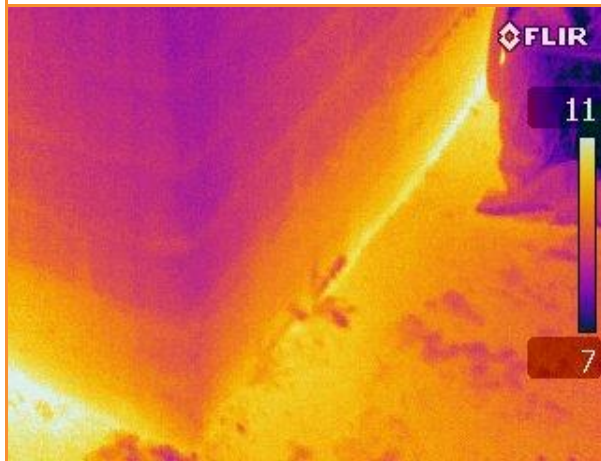
6.38: Thermographic image from above of leakage along base of wall at rear

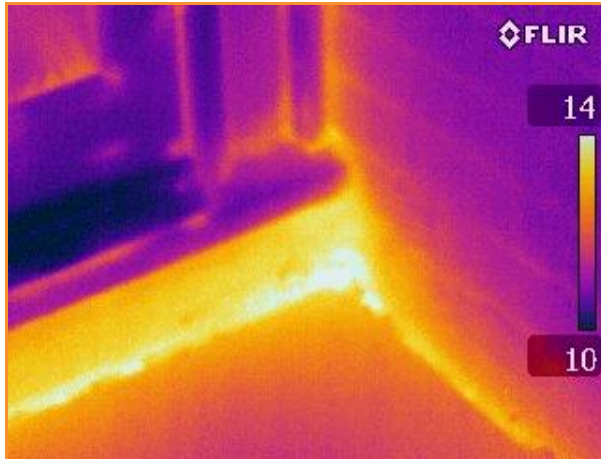
6.39: Thermographic image of leakage where extension meets main house at rear

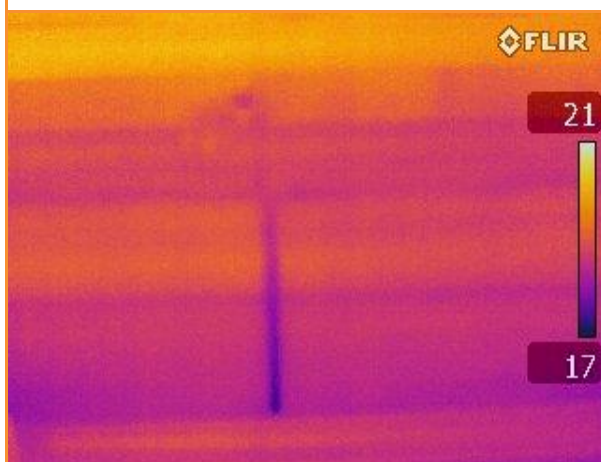
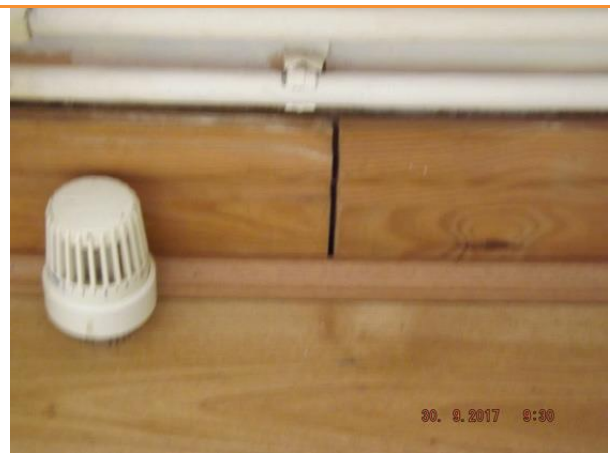
6.40: Thermographic image showing leakage found through joints and along bottom edge of skirting boards in living room

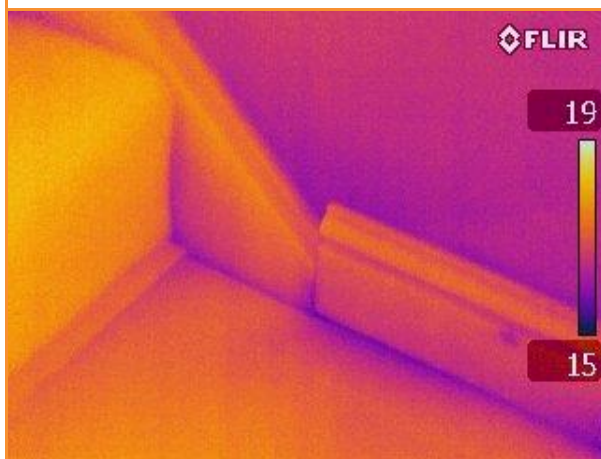
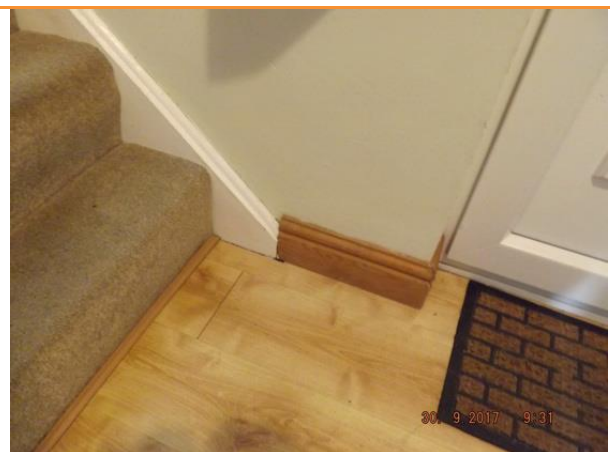
6.41: Thermographic image showing leakage along edges of skirting at base of stairs

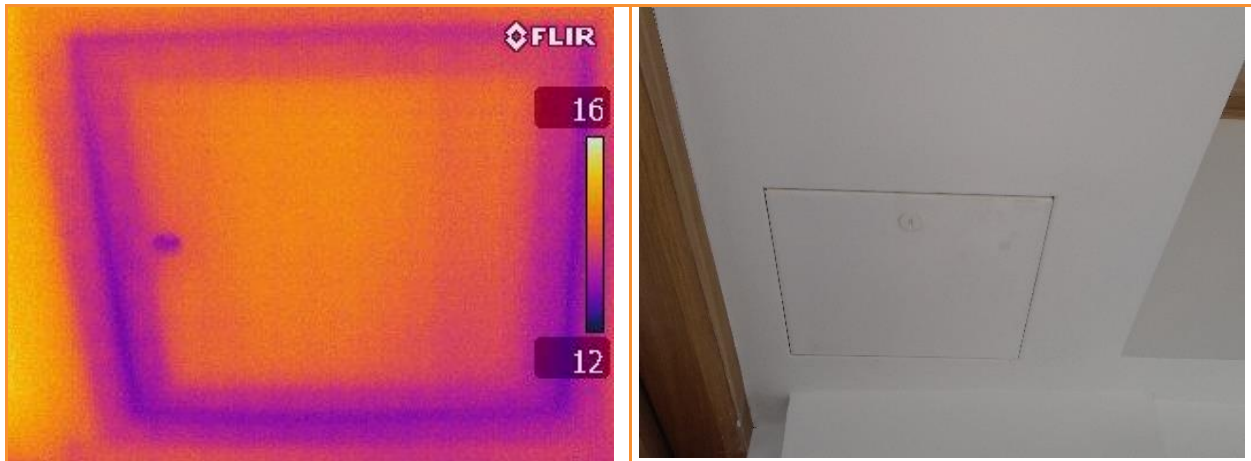
6.42: Substantial leakage around access hatch into boxing above and just inside main entrance door
