Common Leakage Sites no.6

Along the top and bottom edges of skirting boards.

Building Fabric Leakage 6: Along the top and bottom edges of skirting boards

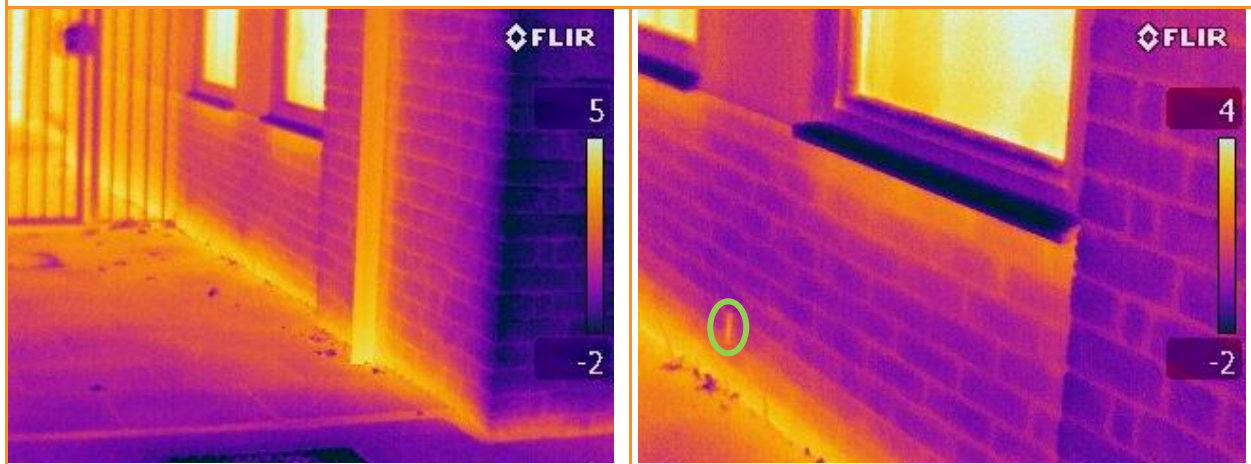
6.43: Heat loss along the bottom of the wall at the western end of the building before pressure applied, then after pressure applied, showing apparently similar heat loss along base of wall suggesting missing insulation rather than air leakage. The exception is the cavity vent (circled) which is clearly connected to the internal environment

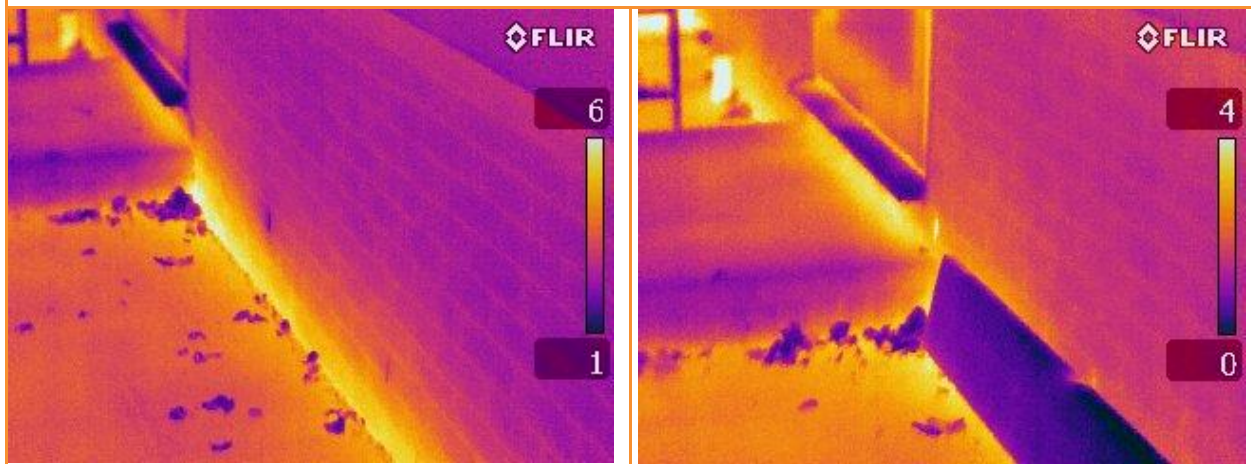
6.44: Some heat loss visible under threshold of side door before pressure applied to building, then after pressure applied, thermographic image shows much more heat loss under the threshold of the side door, indicating considerable leakage

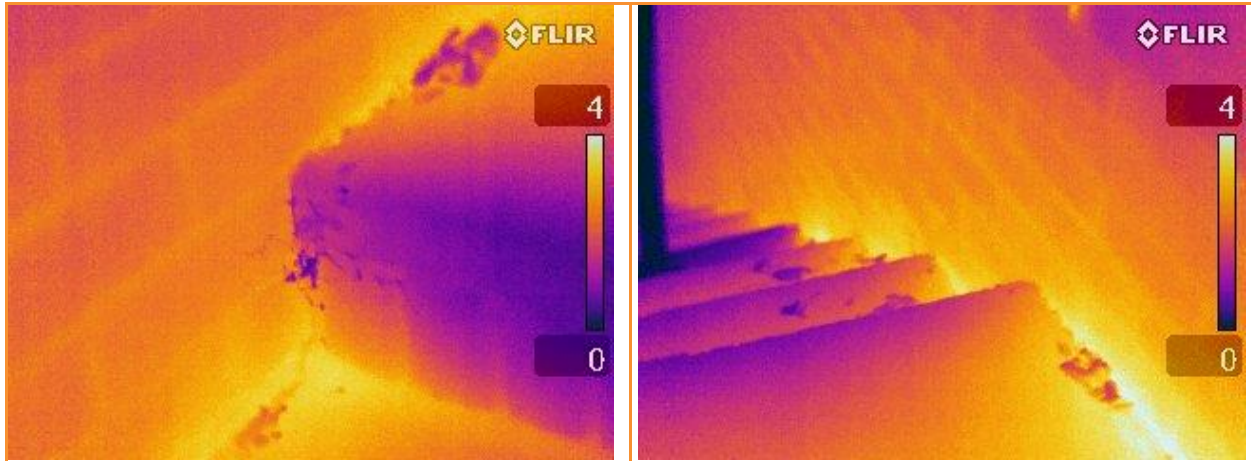
6.45: Thermographic image showing heat loss on edge of steps at rear of building, before pressure applied, then after pressure applied, showing heat loss on edge of steps at rear of building but not conclusively worse

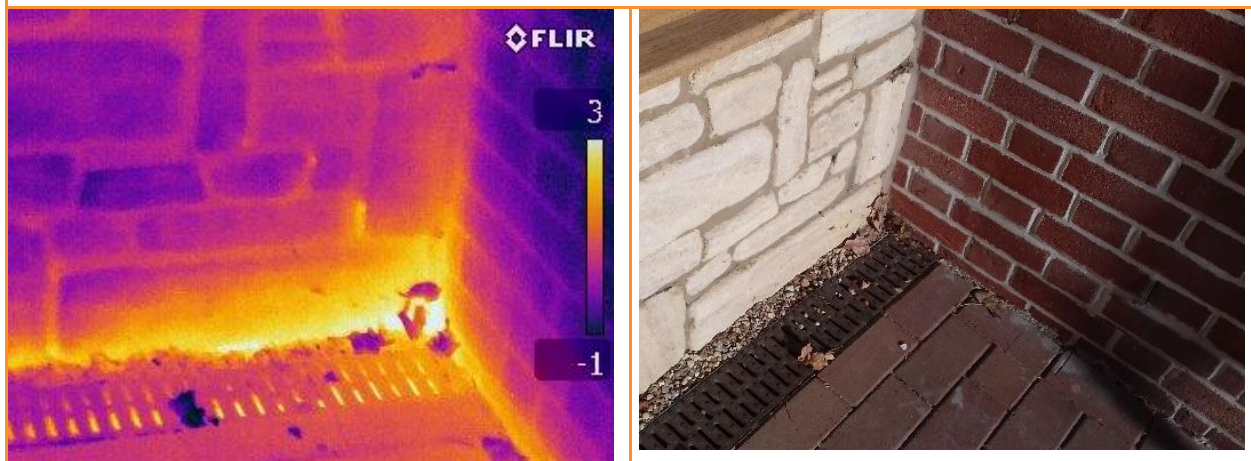
6.46: Thermographic image when building pressurised, showing substantial heat loss at end of ground floor wall, adjacent to pillar

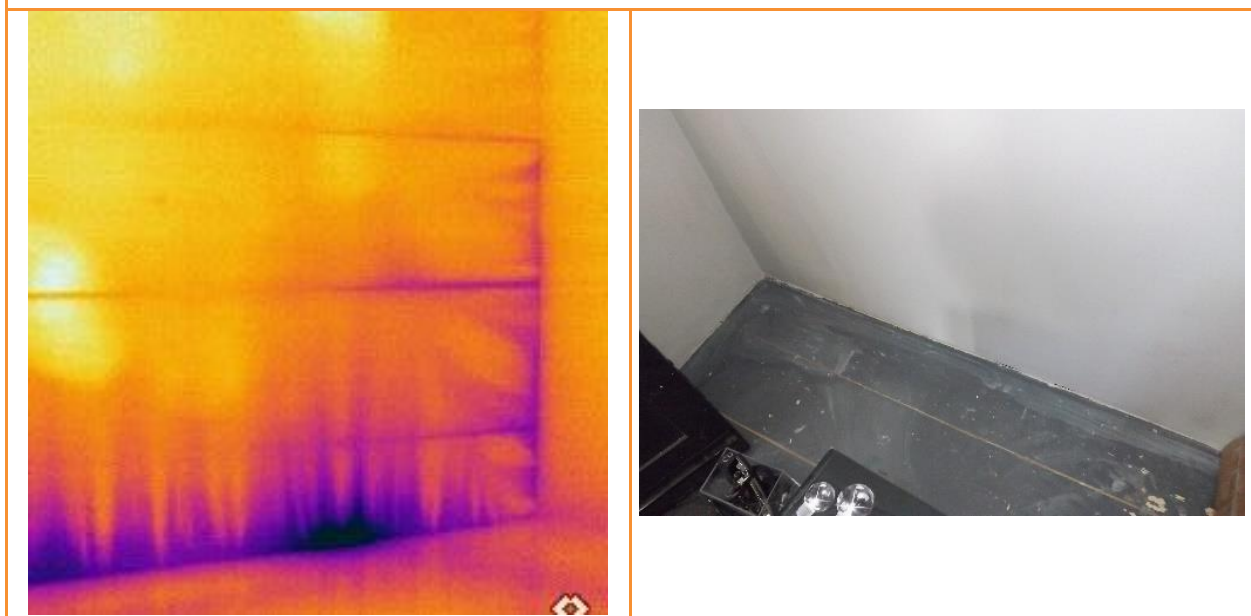
6.47: Thermographic image showing leakage along base and sides of partition upper wall

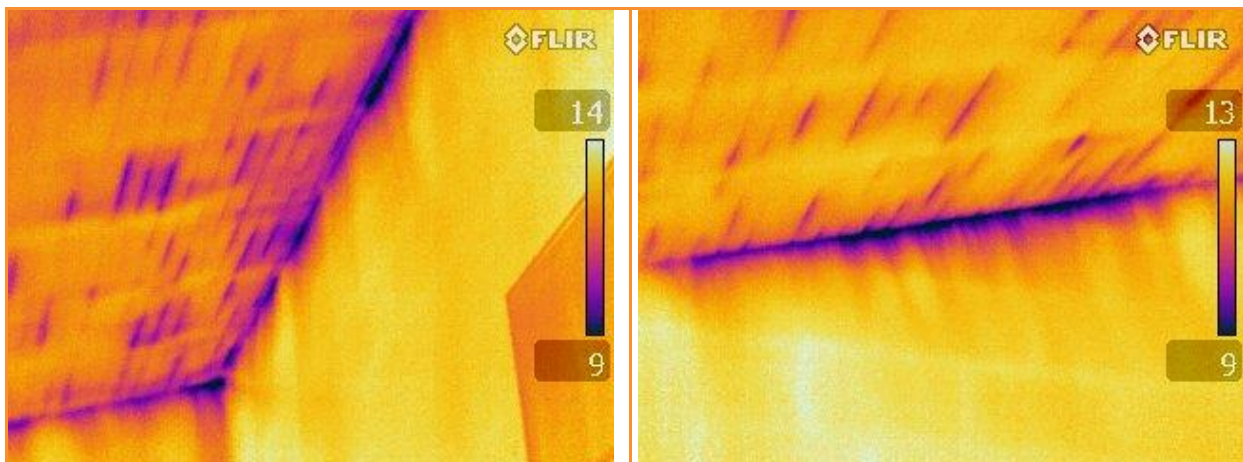
6.48: Thermographic image showing substantial leakage along internal (left) and external (right) edges of ceiling in lounge
