Common Leakage Sites no.8

Building Fabric Leakage 8: Around loft hatches and access hatches

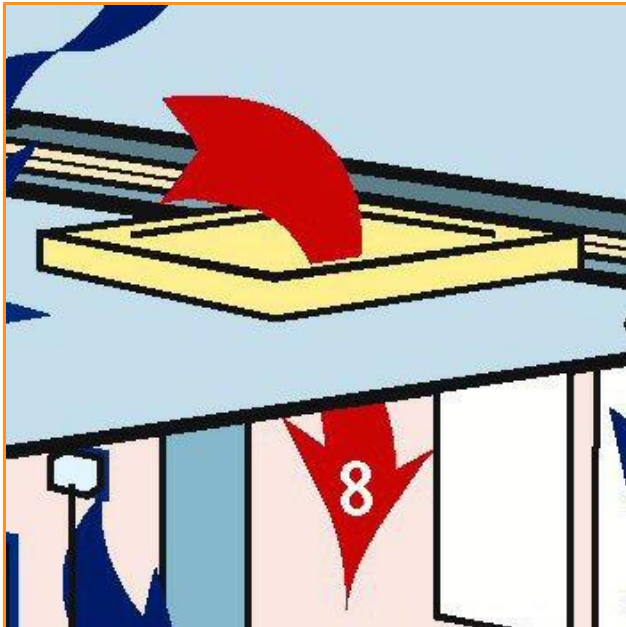
Around loft hatches, including between framing and adjacent plasterboard ceiling. Can occur with prefabricated high-performance loft hatches.

In this instance air is leaking from the unheated roof space into the house around the loft hatch or its frame due to a poor fit or inadequate sealing. This is an extremely common problem, even with modern prefabricated loft hatches.

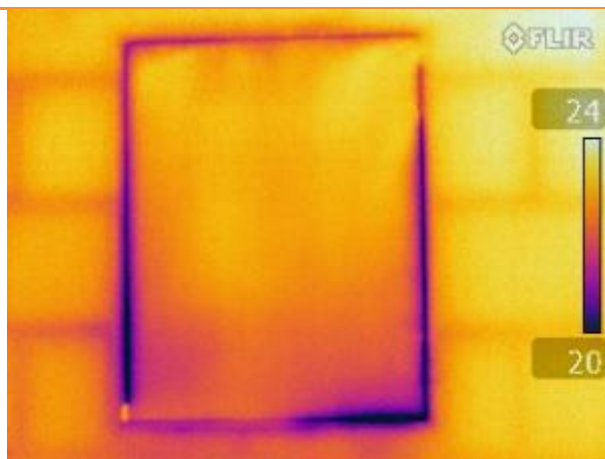
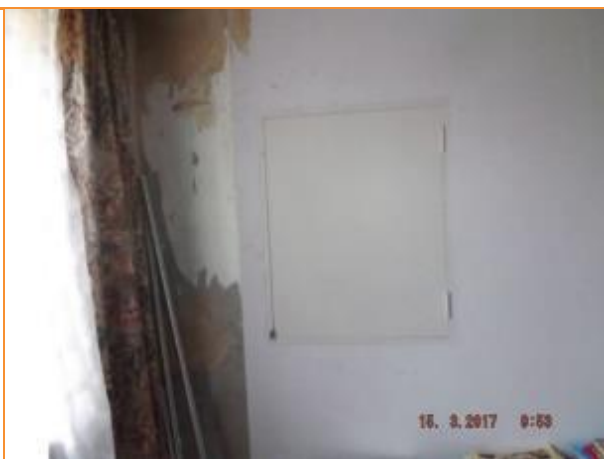
8.01: Internal thermographic image whilst house is depressurised showing leakage around access hatch. Blockwork pattern behind plasterboard also visible.

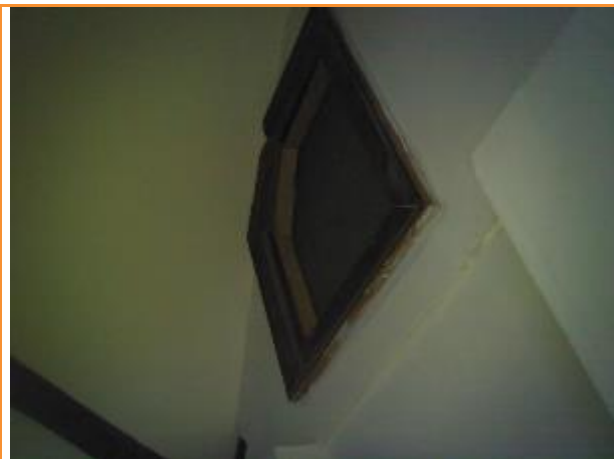
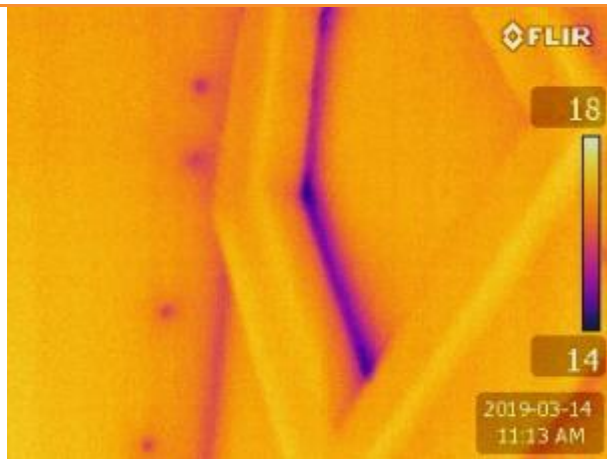
8.02: Internal thermographic image whilst house is depressurised showing leakage on access hatch into loft.

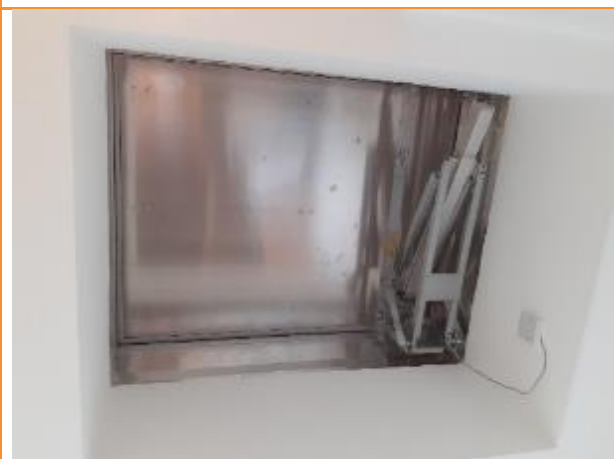
8.03: Leakage between top of roof upstand and bottom edge of smoke vent (AOV)

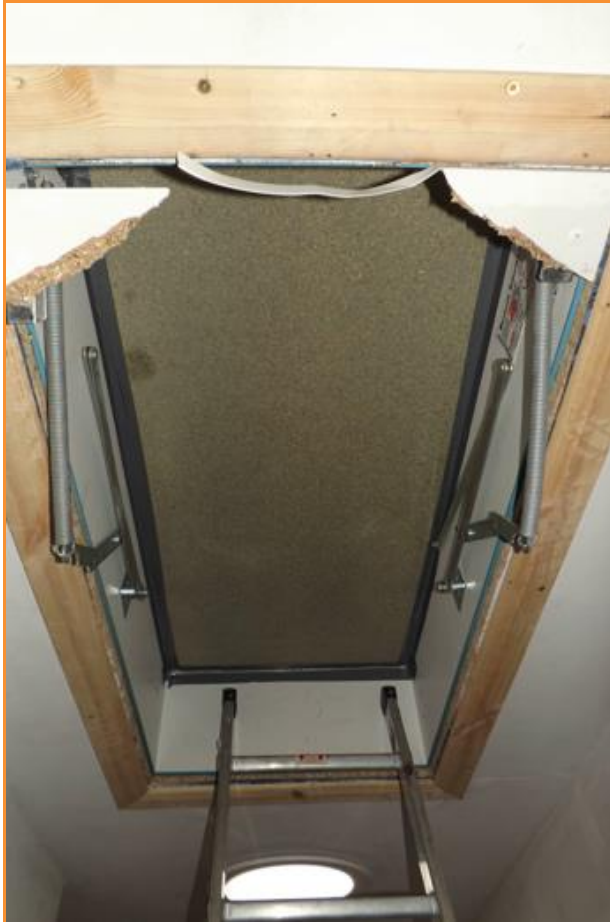
8.04: Leakage around the edges of large loft hatch – temporarily sealed to quantify by subtraction the significance of the problem.

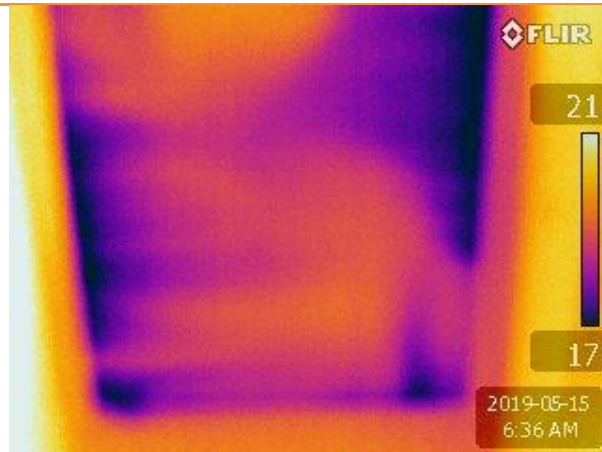
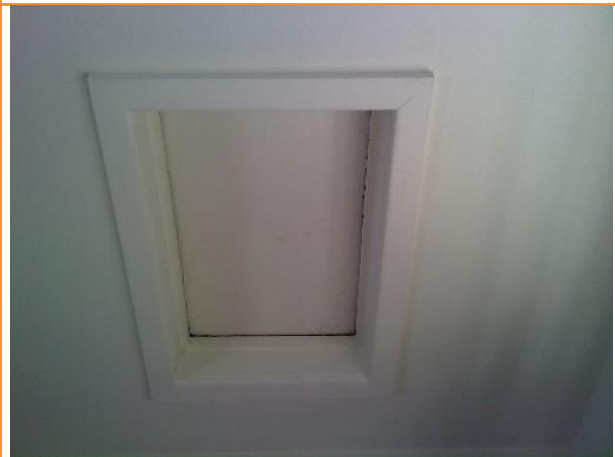
8.05: Internal thermographic image whilst house depressurised, showing substantial leakage on small bedroom loft hatch, first floor

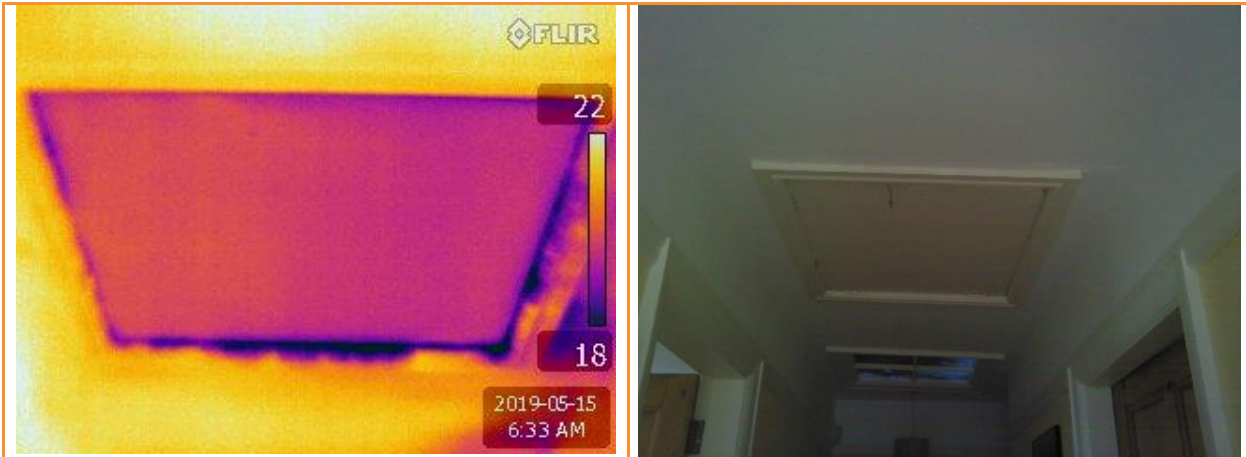
8.06: Internal thermographic image whilst house depressurised, showing substantial leakage on central loft hatch, first floor

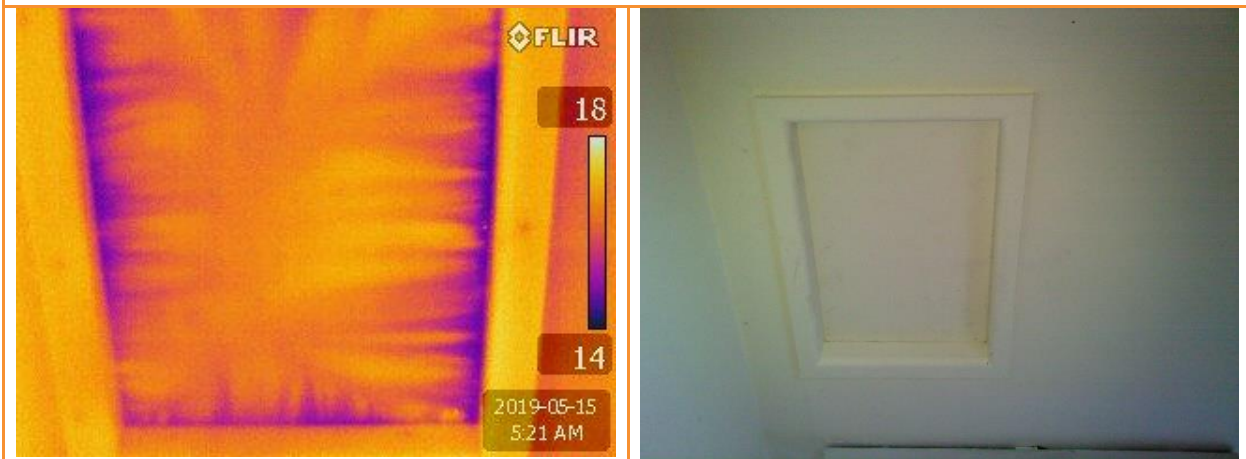
8.07: Internal thermographic image whilst house depressurised showing substantial leakage around edges of boot room loft hatch, ground floor

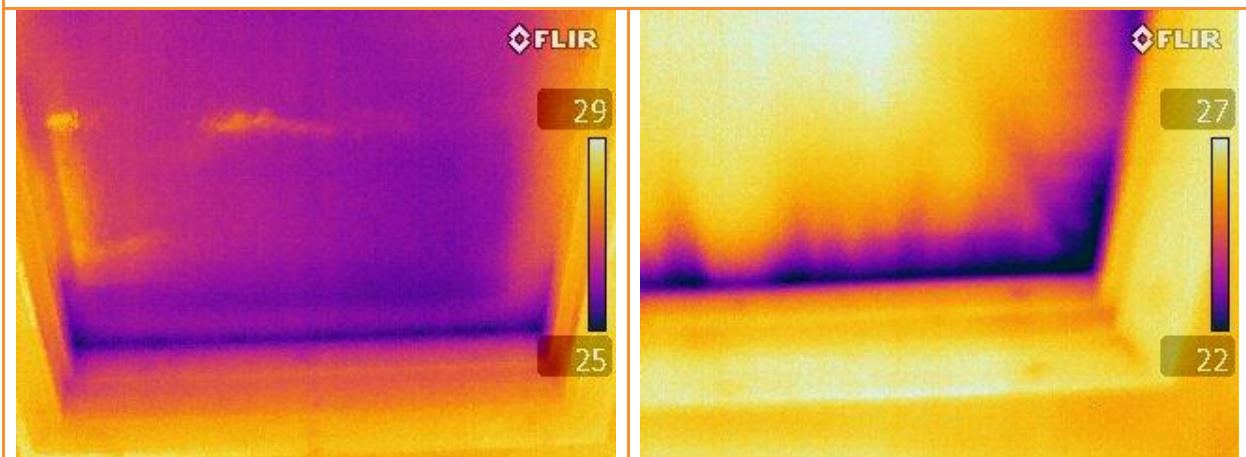
8.08: Cold spots and leakage on loft hatch before door fan operating (left), and then extensive leakage around loft hatch after door fan running (right)

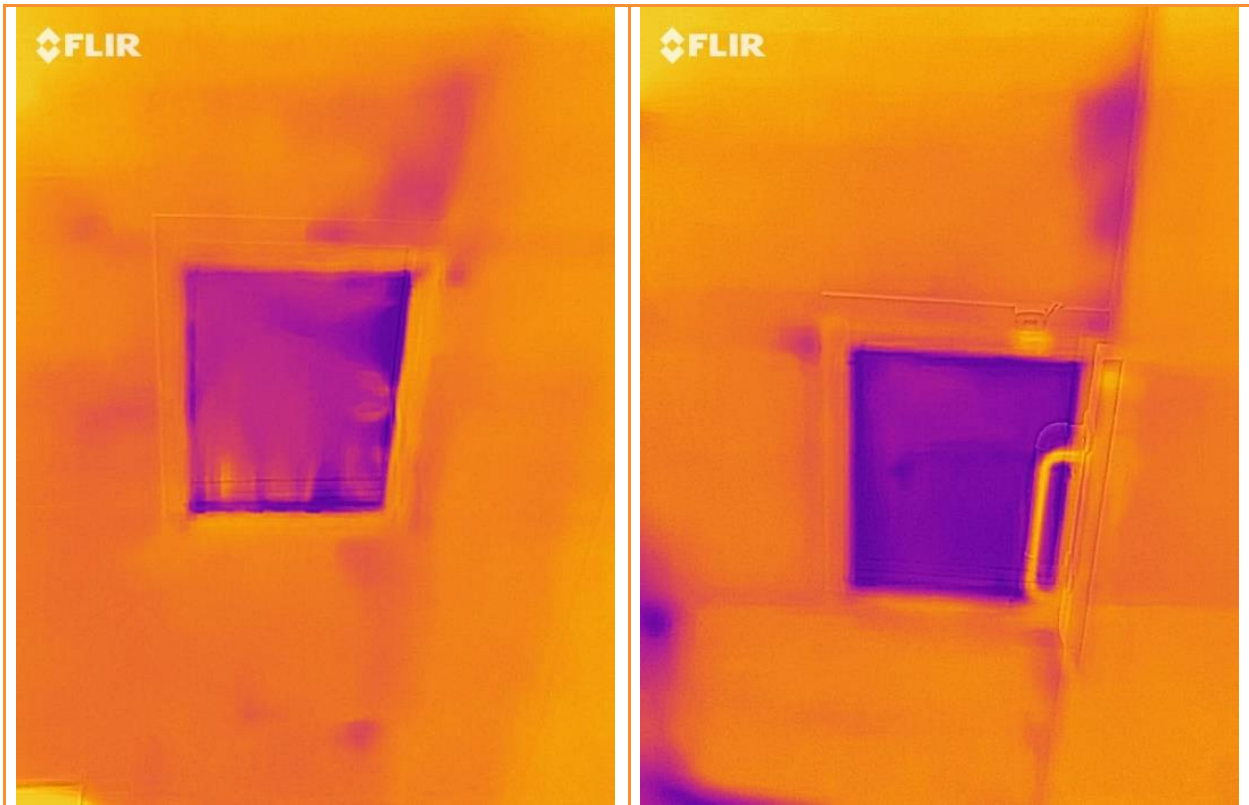
8.09: Internal thermographic images whilst building depressurised, showing substantial leakage on two loft hatches – amongst the worst leaks because warm air rises and then escapes around the hatches, sucking cold air into the church hall at low level

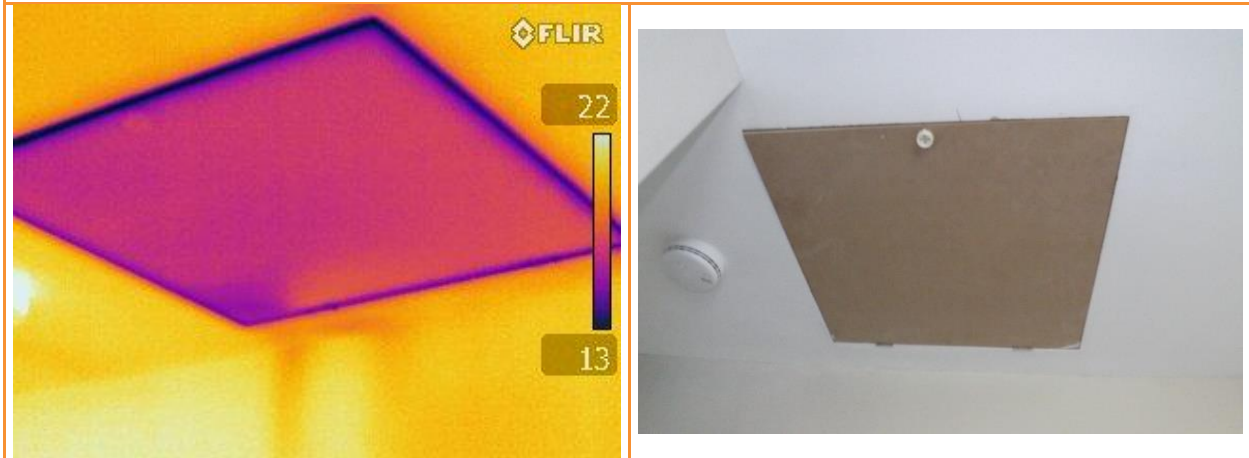
8.10: Thermographic image showing substantial leakage around the loft hatch
