Common Leakage Sites no.9

Through the eaves.

Building Fabric Leakage 9: Through the eaves

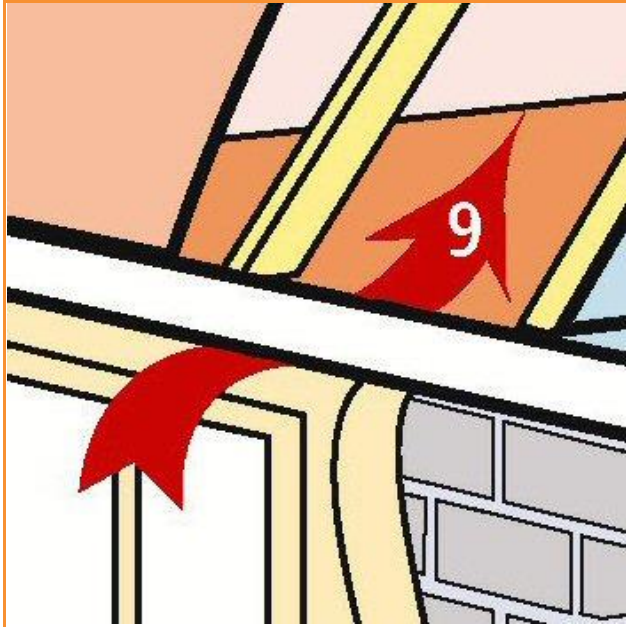
In this instance air is leaking through the eaves of the building into the roof space.

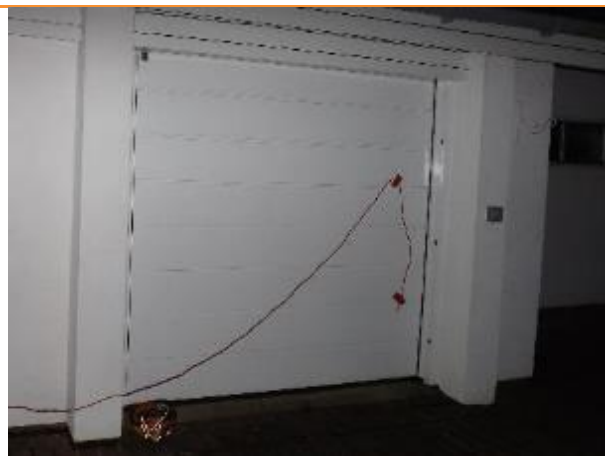
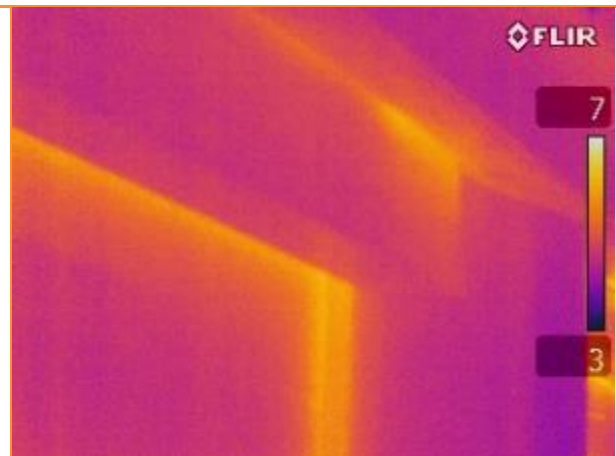
9.01: External thermographic image whilst house is pressurised showing leakage along section of eaves junction to top of wall above garage doorway.

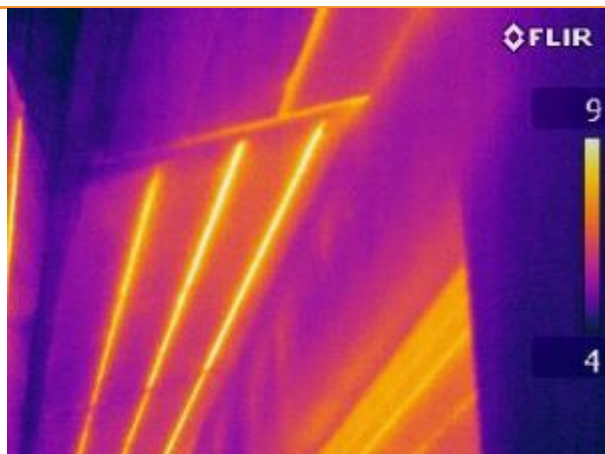
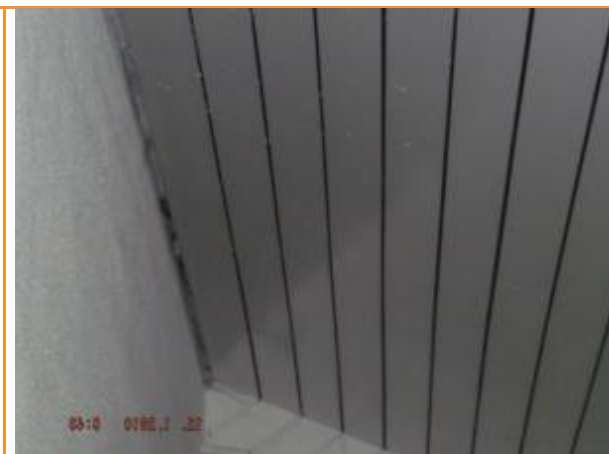
9.02: External thermographic image showing leakage along the eaves of a house when pressurised, clearly demonstrating substantial air leakage into the ventilated roof space.

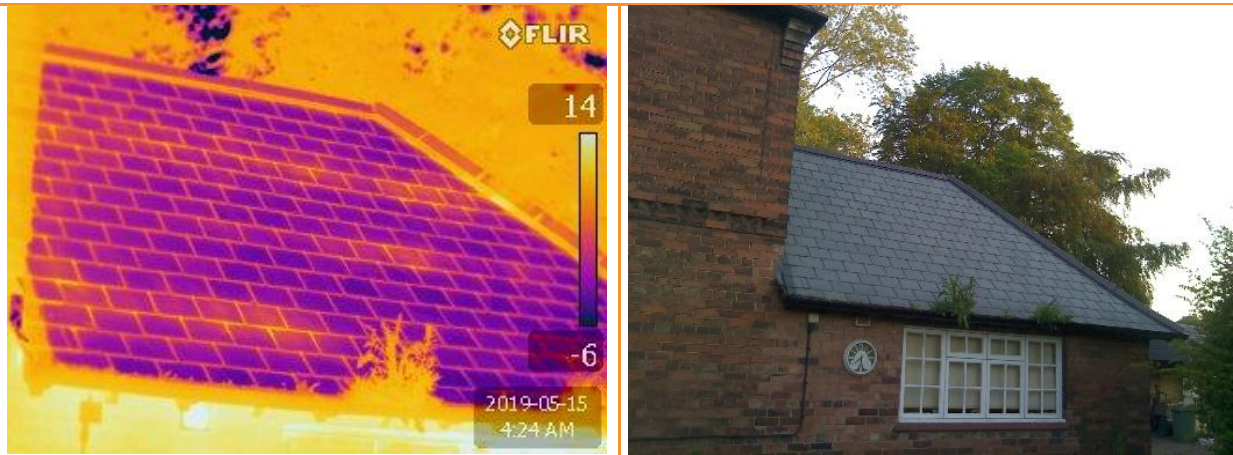
9.03: External thermographic image after house pressurised, showing major leakage along eaves, also along edges of ridge and hip tiles

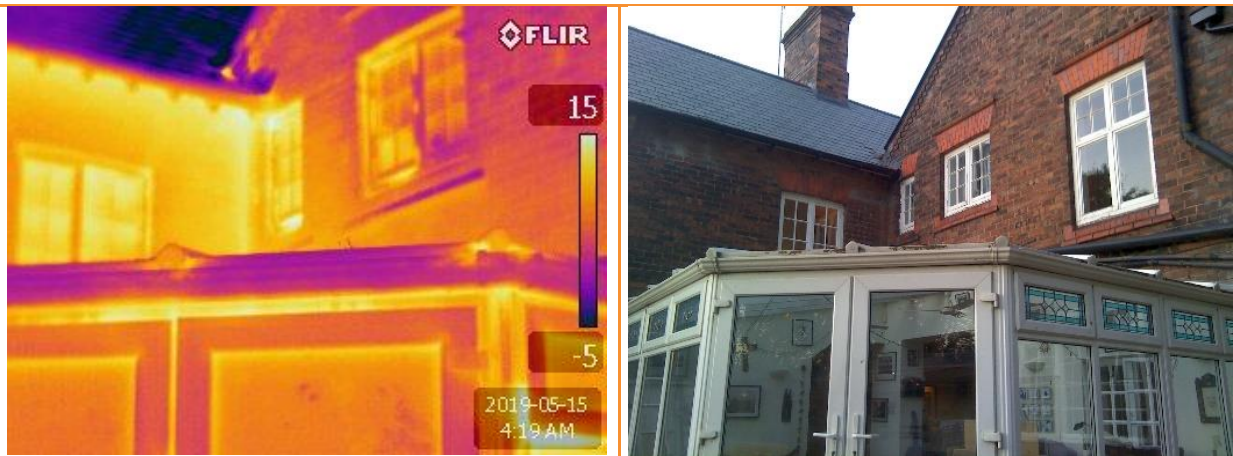
9.04: External thermographic image after house pressurised, showing increased heat loss along eaves, also around top of conservatory and at ends of conservatory roof structure

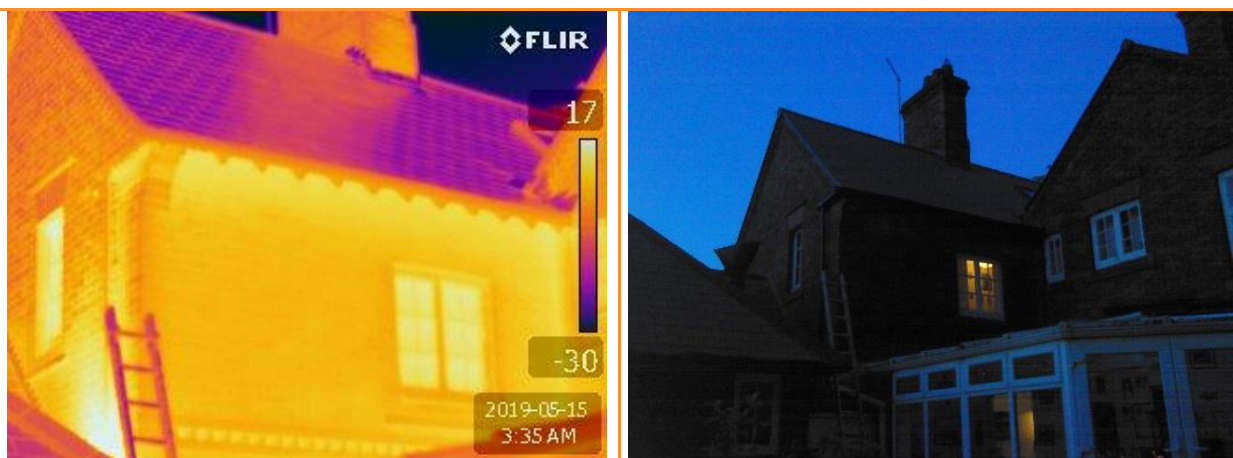
9.05: External thermographic image before house pressurised, showing heat loss along eaves driven by stack effect

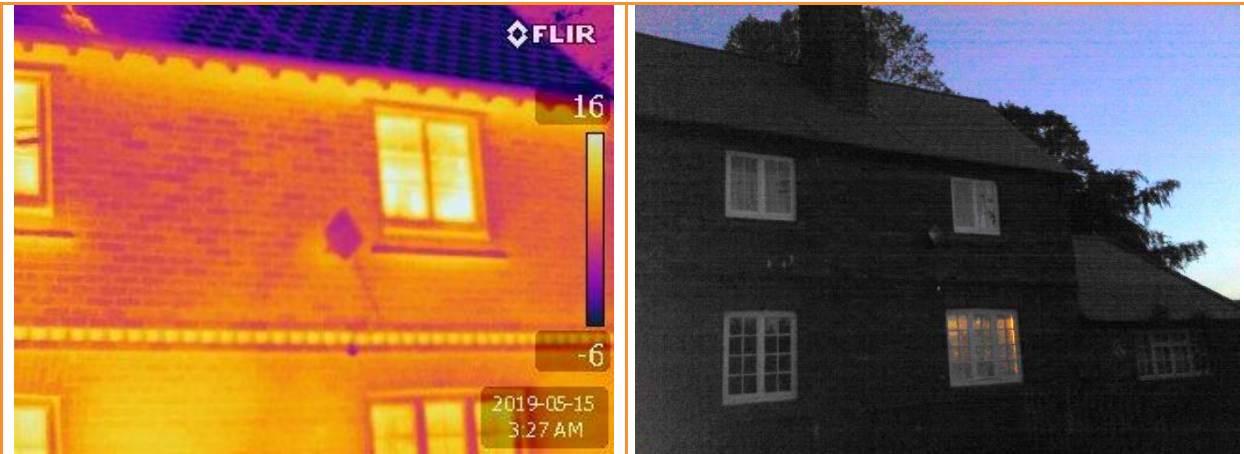
9.06: External thermographic image after house pressurised, showing heat loss along eaves, also along external edge of intermediate floor

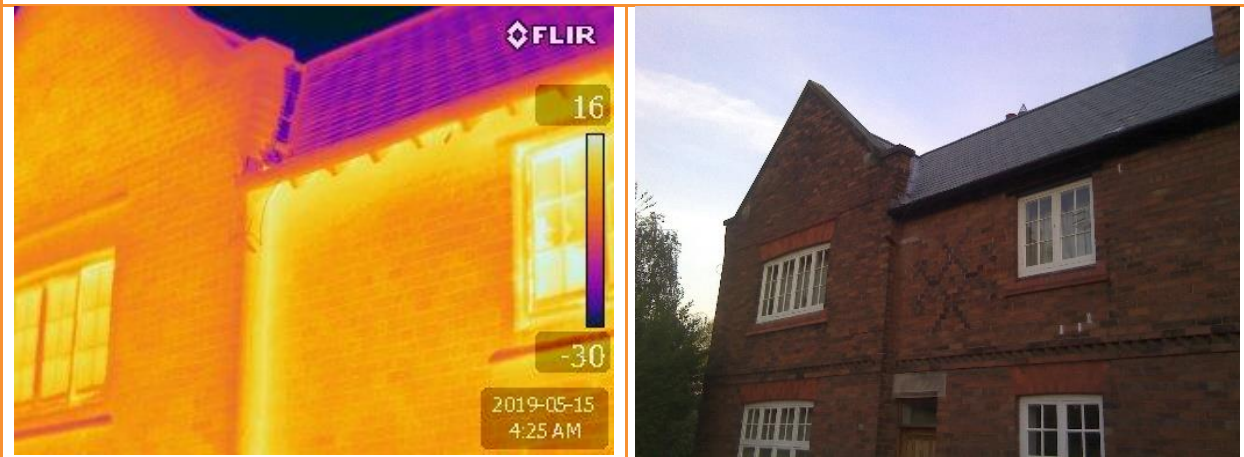
9.07: External thermographic image after house pressurised, showing significant leakage along eaves. Also apparent leakage along vertical interface between two sections of house

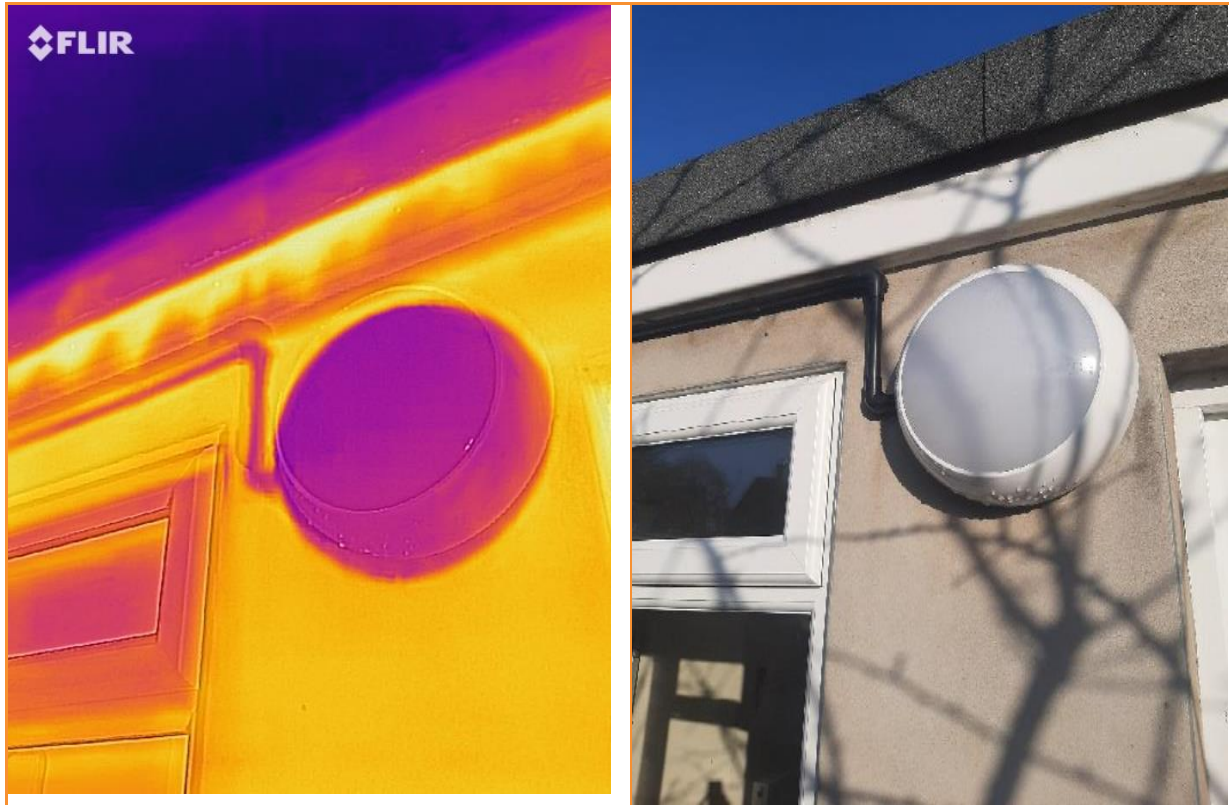
9.08: External thermographic image whilst building pressurised, showing considerable warm air (white/yellow) escaping along the bottom edge of eaves to the rear flat roof extension

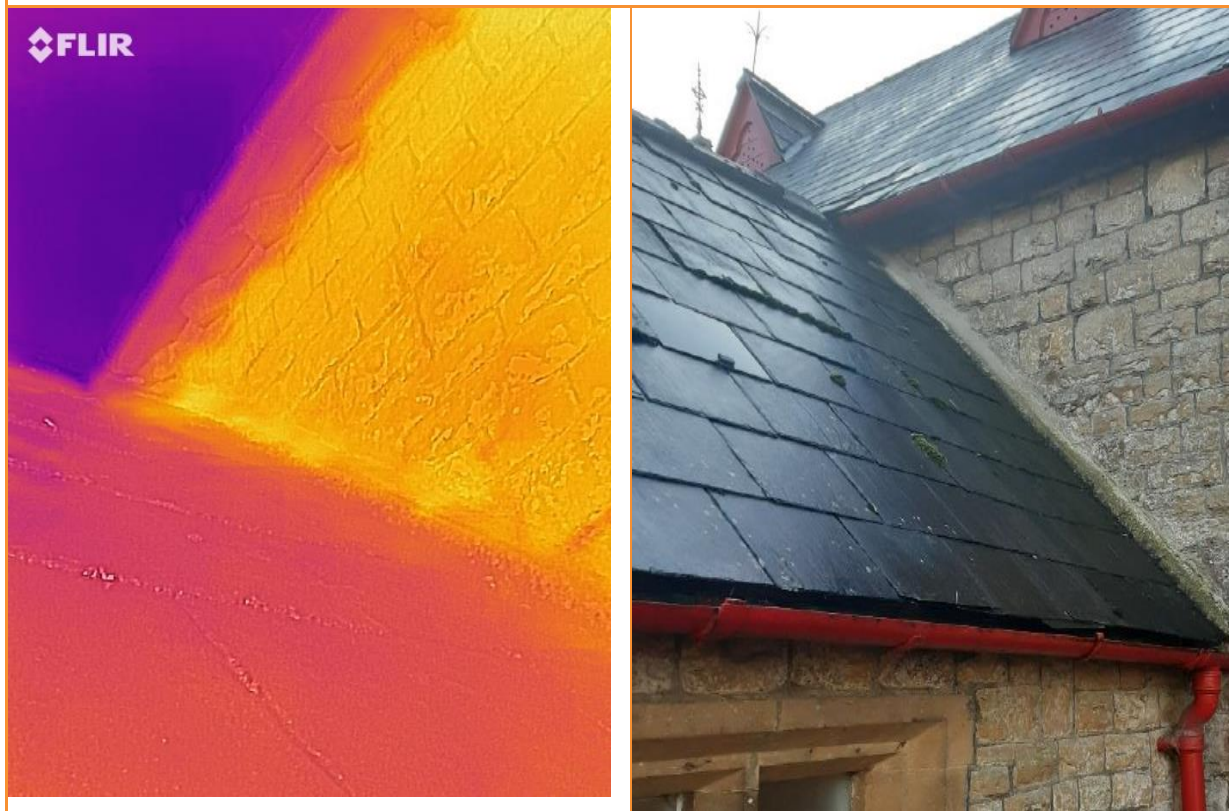
9.09: External thermographic image whilst building pressurised, showing warm air (white/yellow) escaping along (1) the sloping verge at the end of the entrance section and (2) the bottom edge of the main hall eaves

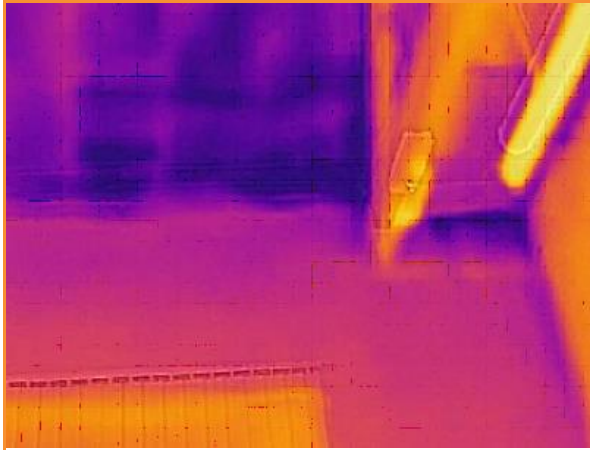
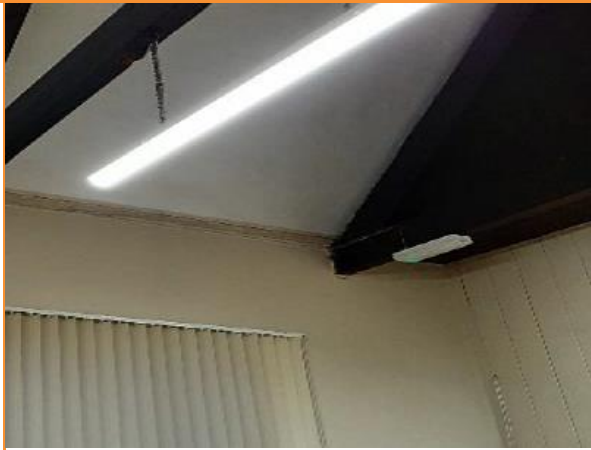
9.10: Internal thermographic image whilst building is depressurised showing substantial cold spots in the sloping ceiling above hall with considerable air leakage along eaves section at centre-right of image

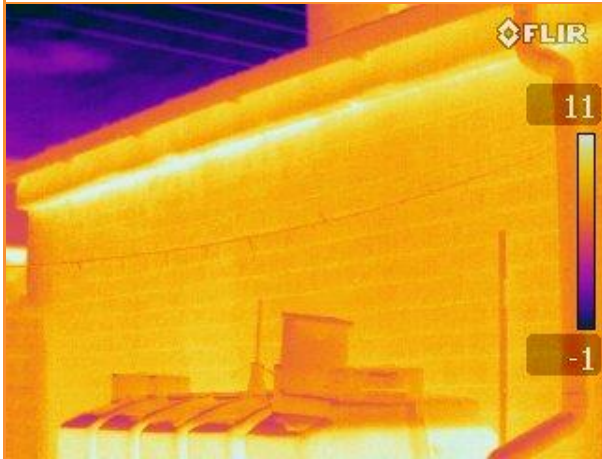
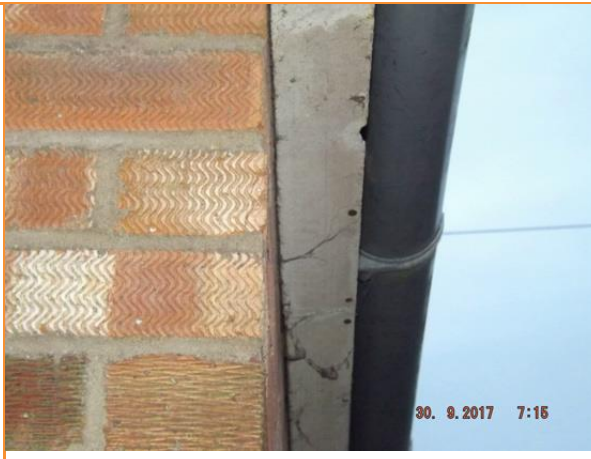
9.11: Thermographic image showing leakage along eaves of extension

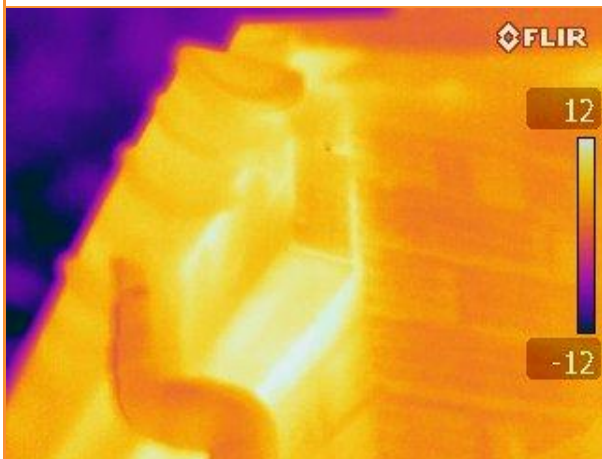
9.12: Thermographic image showing substantial leakage at rear end of extension eaves

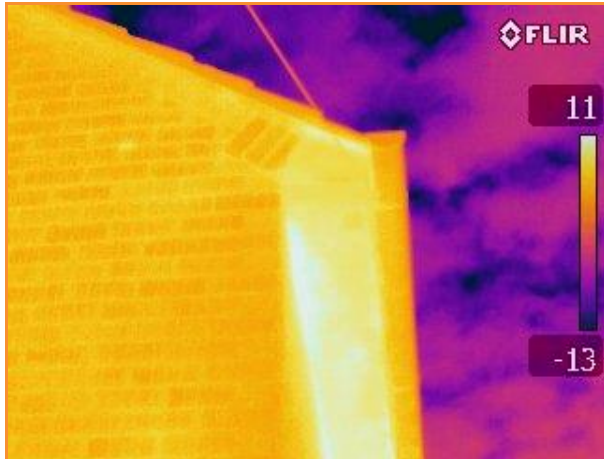
9.13: Thermographic image showing leakage associated with the eaves at the rear of the house

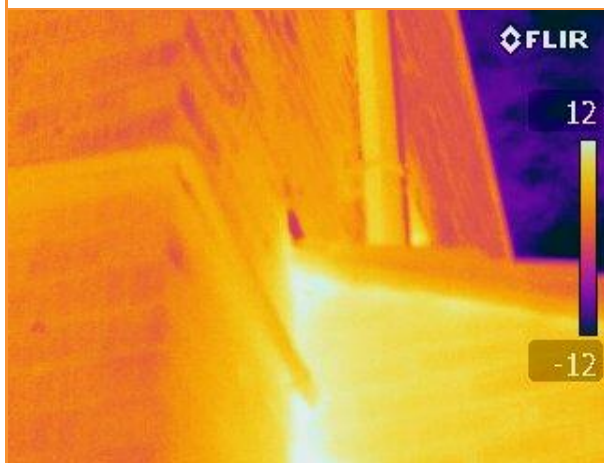
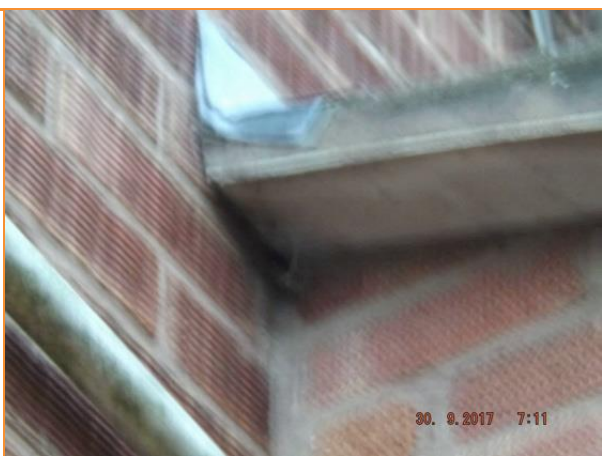
9.14: Leakage along interface between top of wall and underside of roof to lean-to extension

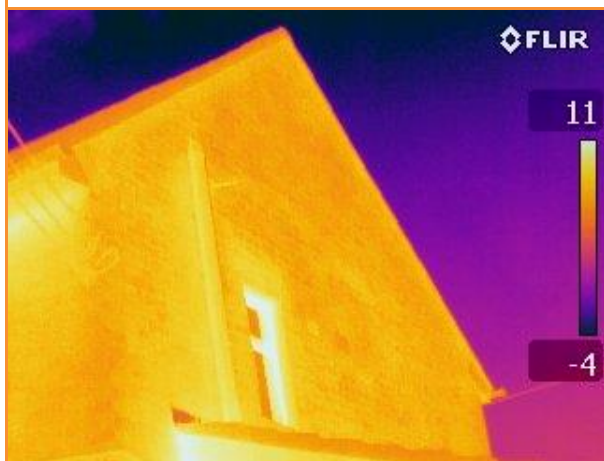
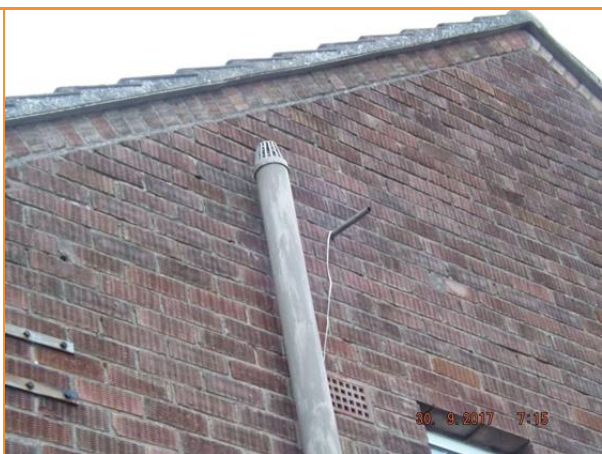
9.15: Thermographic image showing some leakage along the edge of the gable end

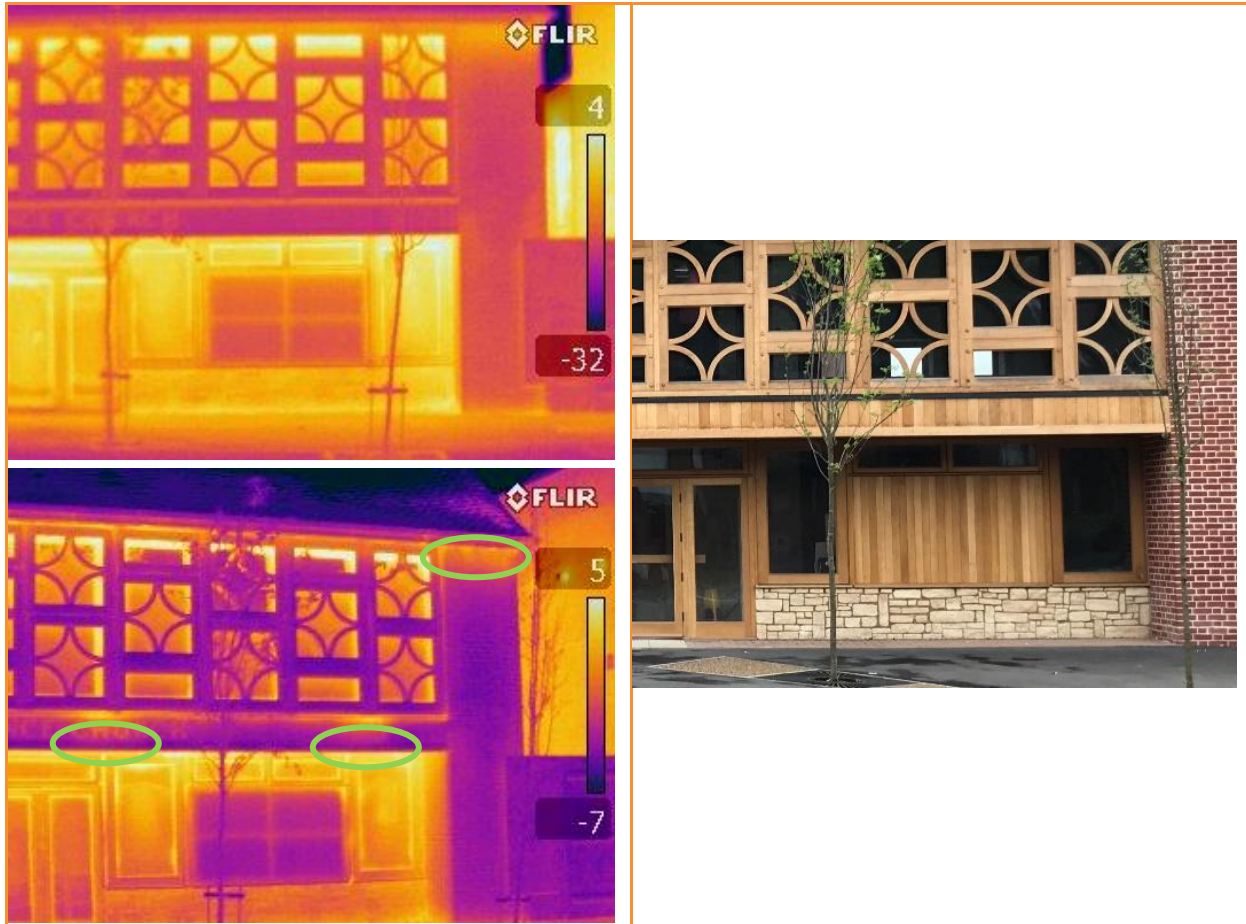
9.16: Leakage along underside of balcony and along eaves visible behind upper window frames, before building pressurised (top), then after building pressurised, showing more leakage along underside of balcony, and at top of brick column at right hand side (bottom)

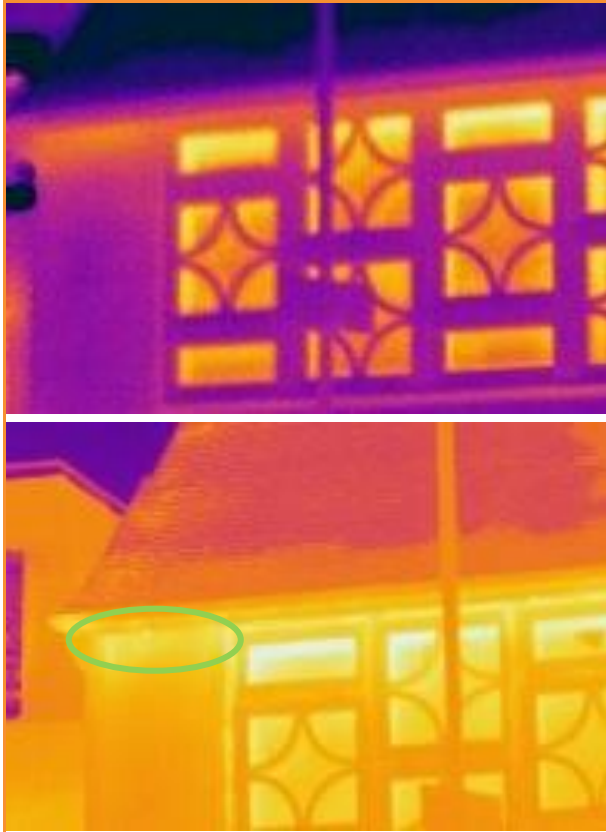
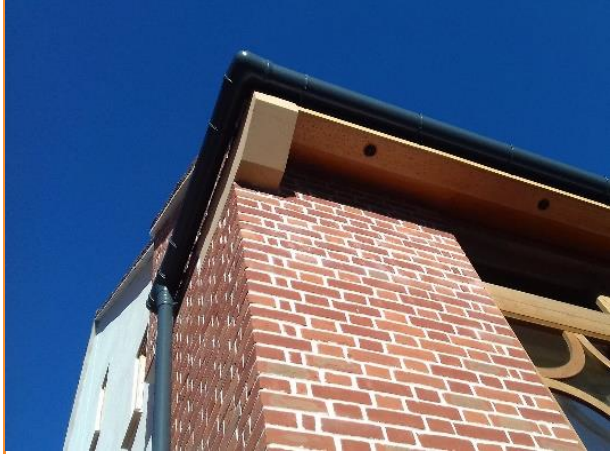
9.17: Thermal image of top of left-hand column, some heat loss before pressure applied to building (top), then after pressure applied to building, showing significantly more heat loss

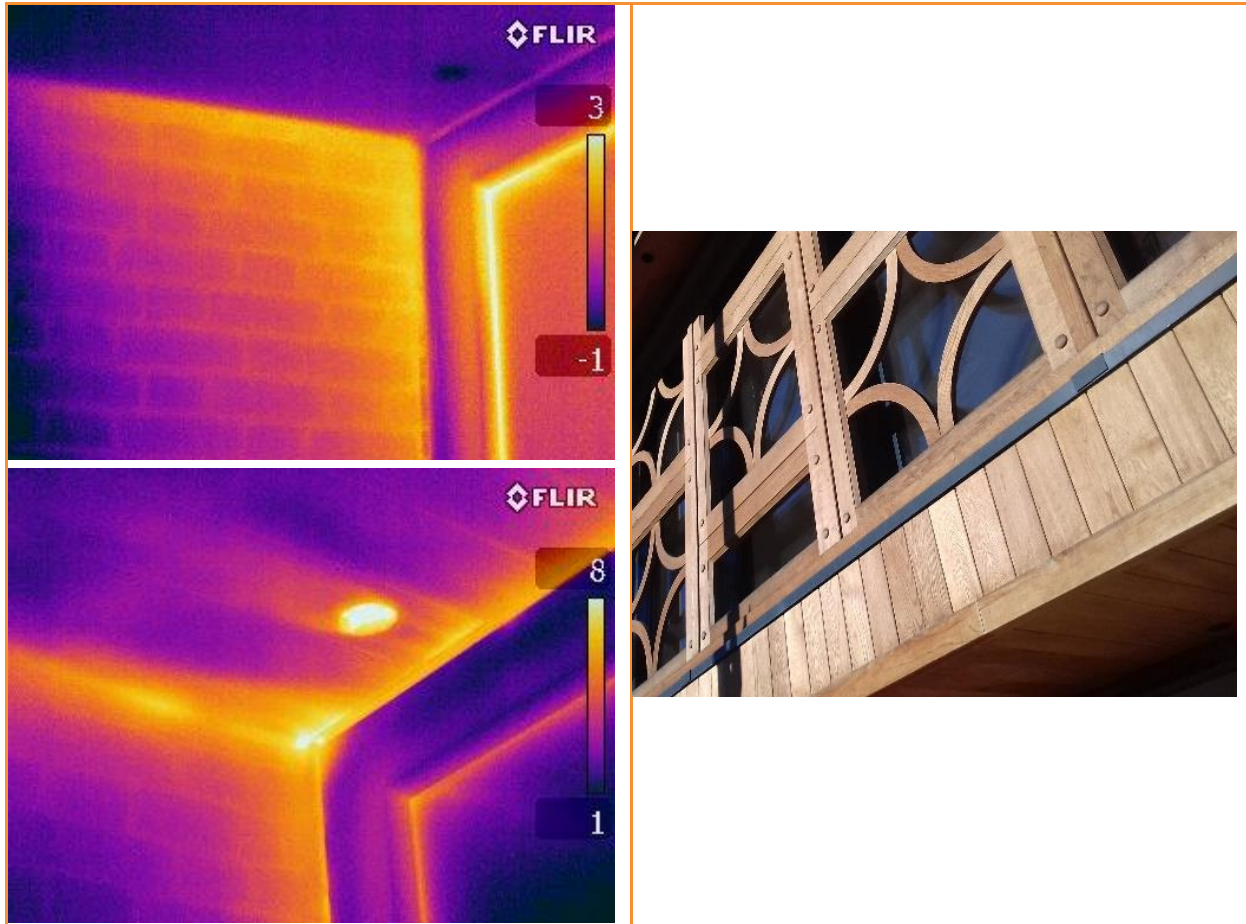
9.18: Thermographic image before pressure applied, underside of balcony left hand end (top), then after pressure applied, much more heat loss visible along top of window frame, also through vent in underside of overhang (bottom). Green arrow on right hand photo shows approximate location of these leaks

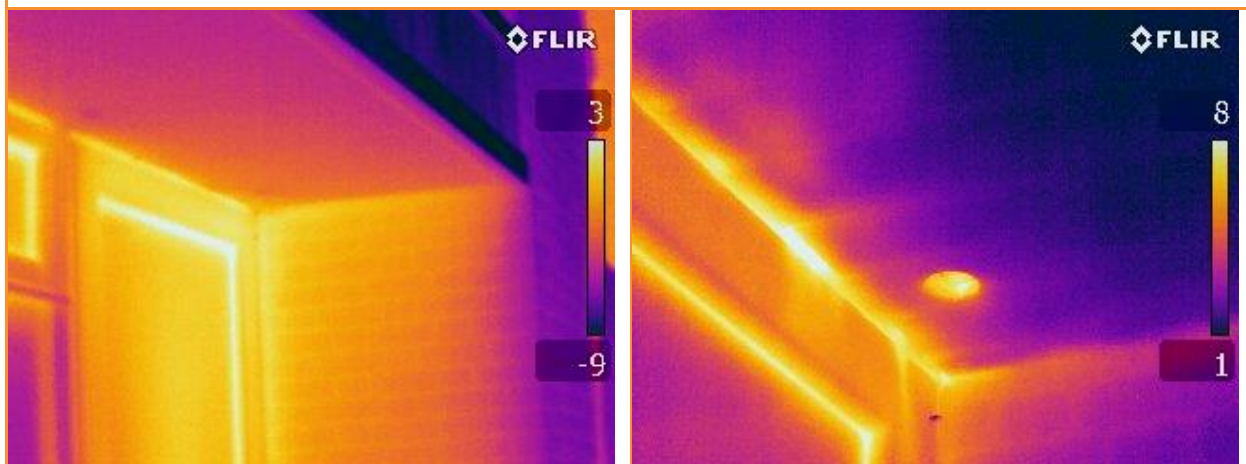
9.19: Thermographic image before pressure applied, underside of balcony right hand end, then after pressure applied, much more heat loss visible, including through vent in underside of overhang

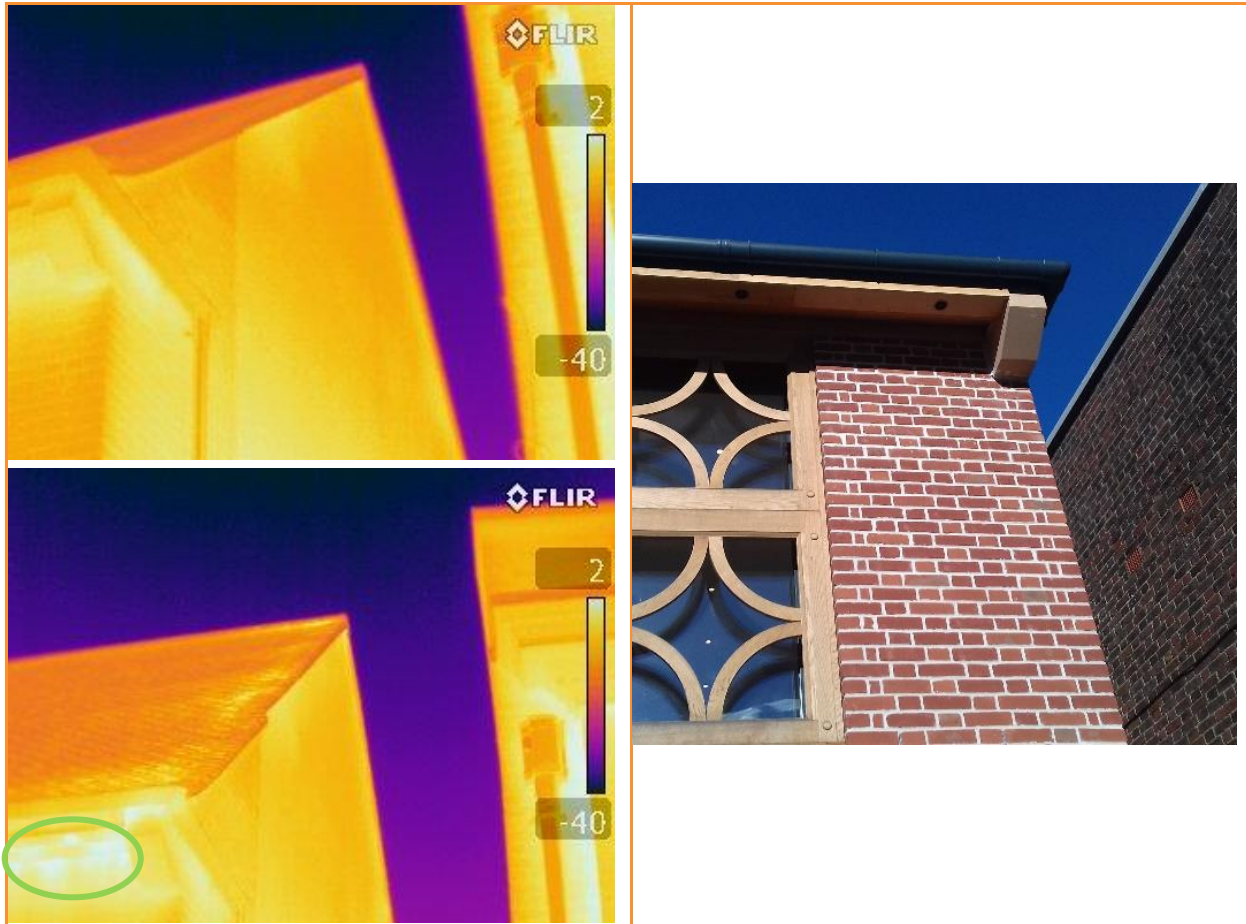
9.20: Thermographic image of eaves at eastern end, before pressure applied (top), then after pressure applied showing visible additional leakage at ridge, through roof, along eaves and particularly at top of front corner column (bottom)

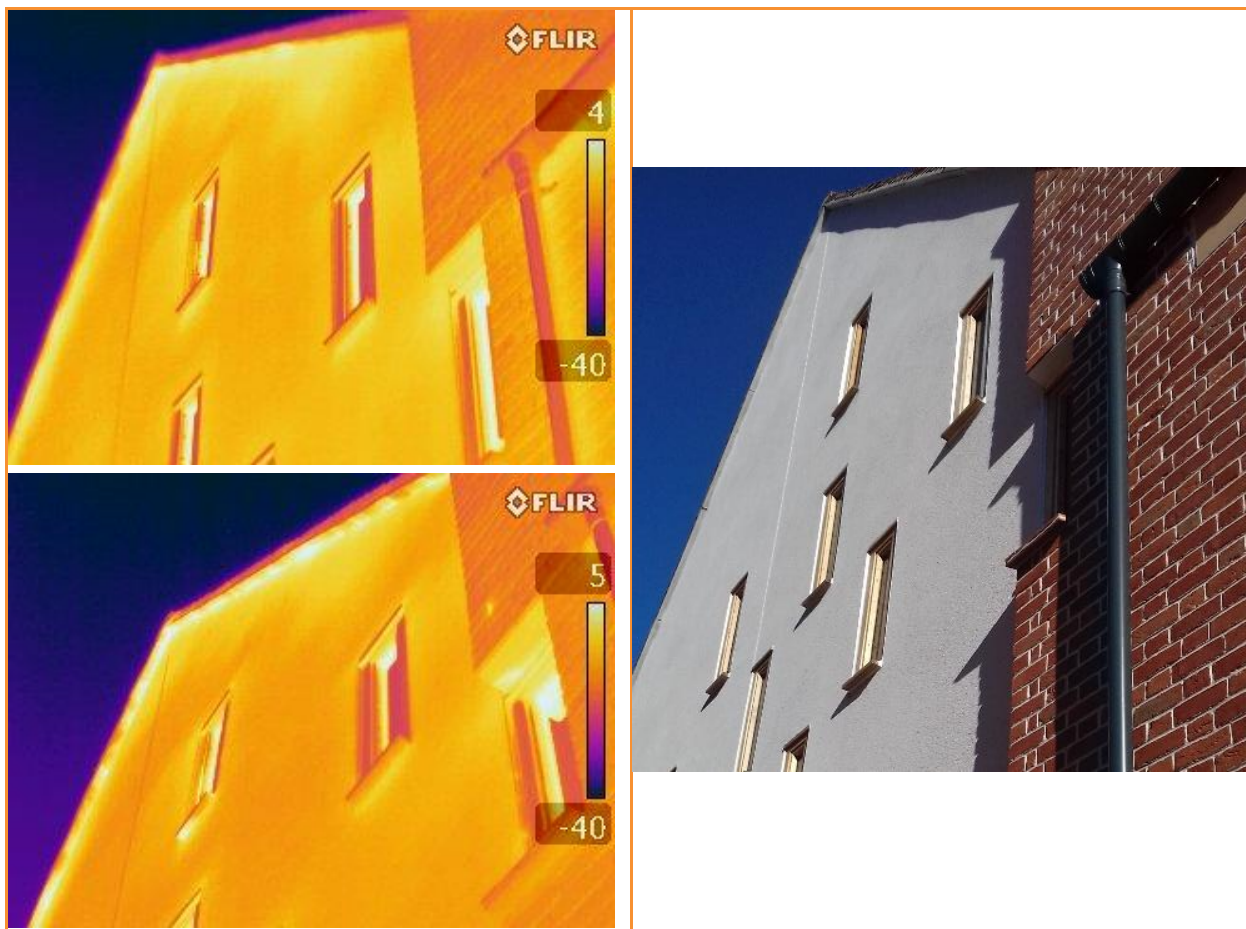
9.21: Thermographic image of eaves at western end, before pressure applied (top), then after pressure applied showing visible additional leakage at ridge and along eaves (bottom)

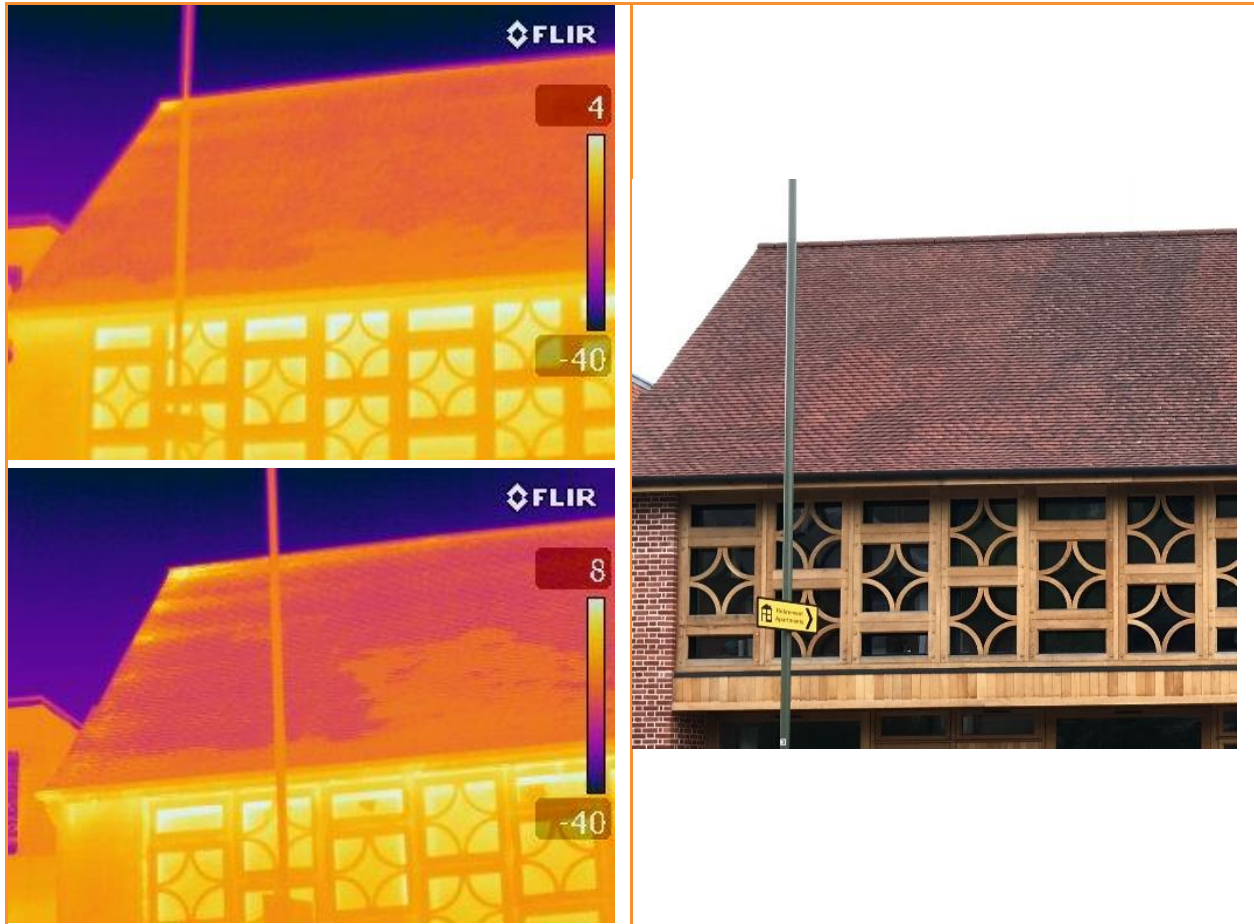
9.22: Thermographic image of western end of roof viewed from the south side, no pressure applied (top), then after pressure applied showing substantially more leakage at ridge and top of eaves (bottom)

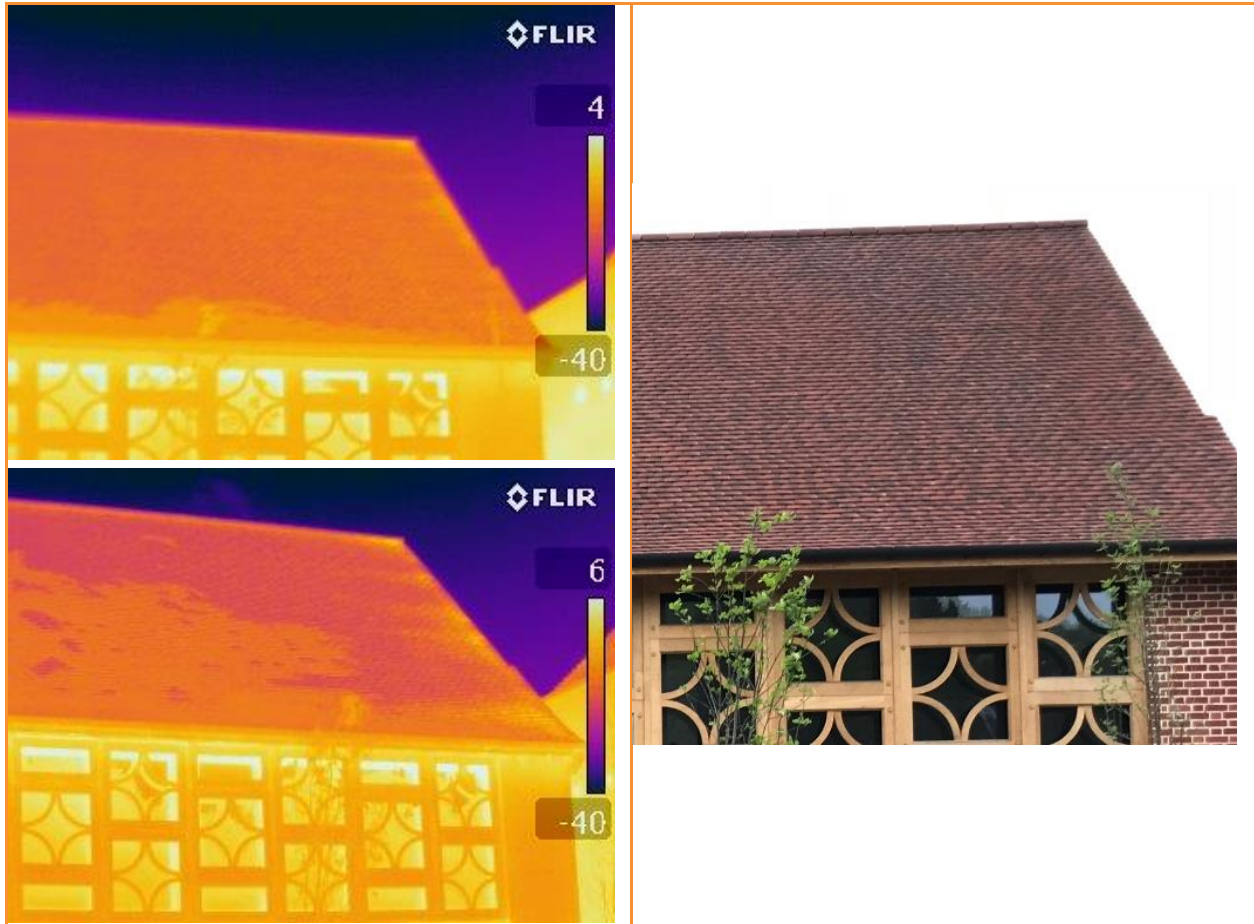
9.23: Thermographic image of eastern end of roof viewed from the south side, no pressure applied (top), then after pressure applied showing substantially more leakage at ridge and along the top of the eaves in several places (bottom)

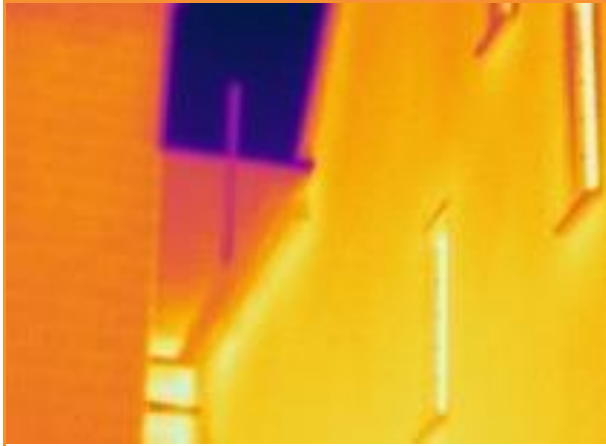
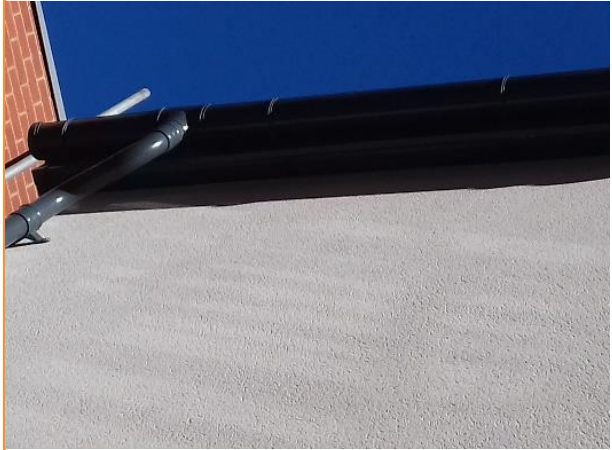
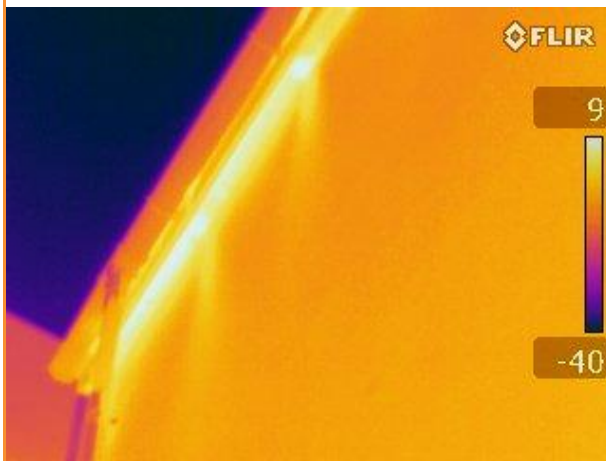
9.24: Thermographic image of section of rear eaves, western end of building, before pressure applied (top), then when pressurised showing substantially more heat loss (bottom)

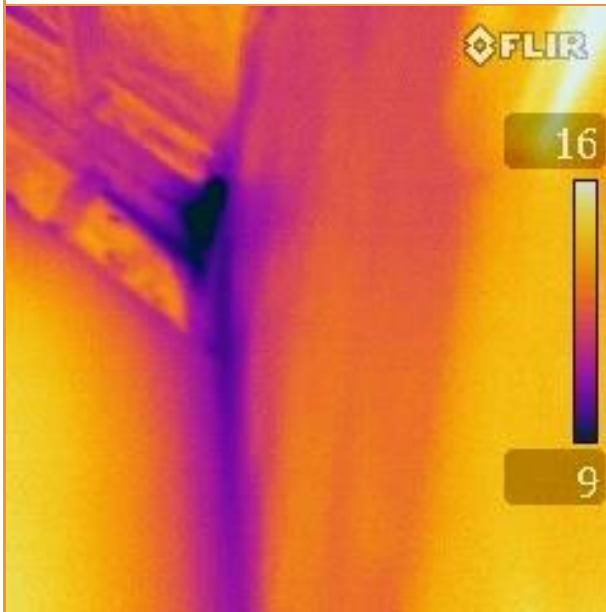
9.25: Thermographic image after depressurised, substantial cold entering building behind steel

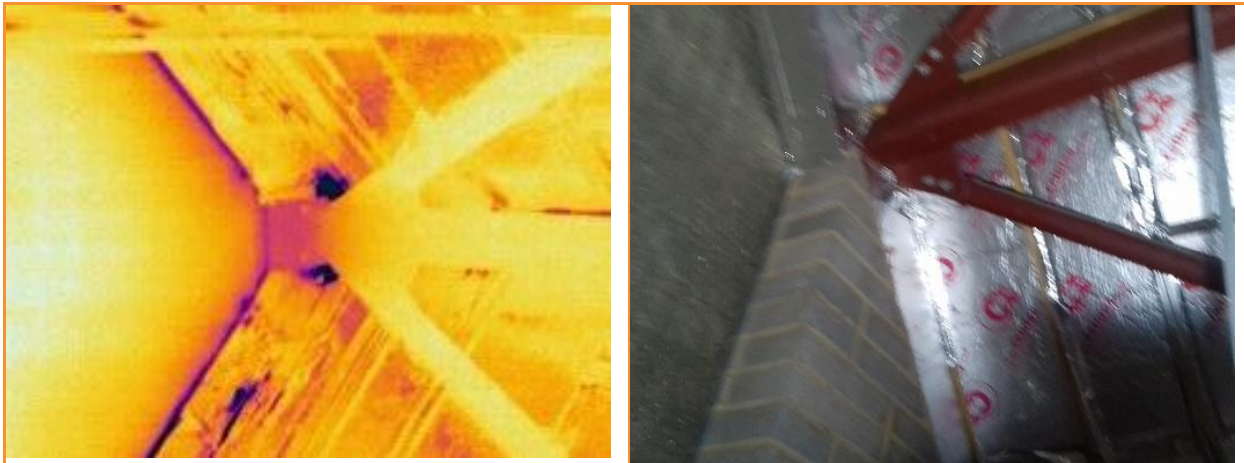
9.26: Thermographic image after pressure applied, of roof space above Sunday School room, cold incoming air clearly visible along top of gable (left side), also above joints in steel frame

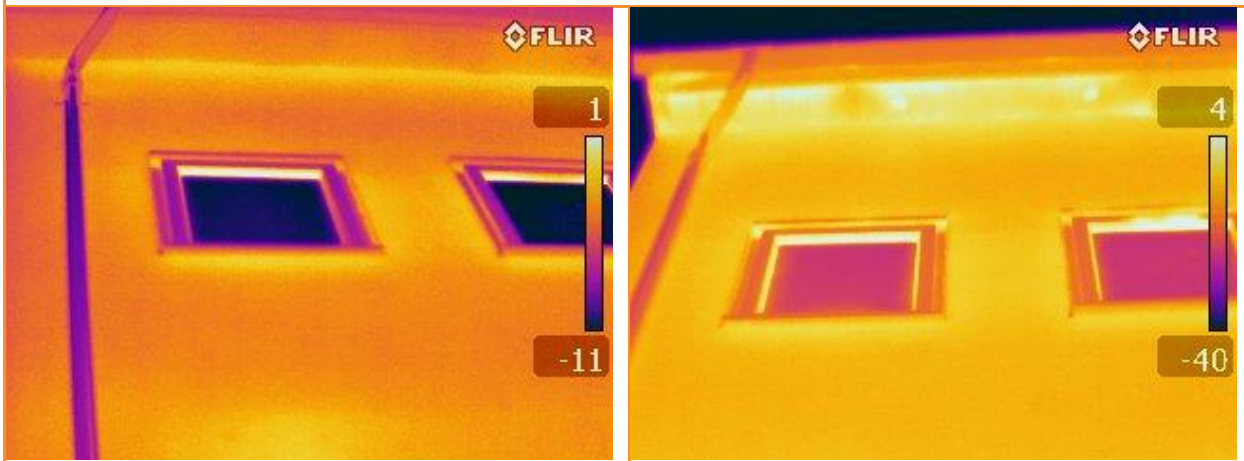
9.27: Thermographic image of eaves, rear eastern corner, before pressure applied, then after pressure applied showing visibly greater heat loss – also at head of RH window

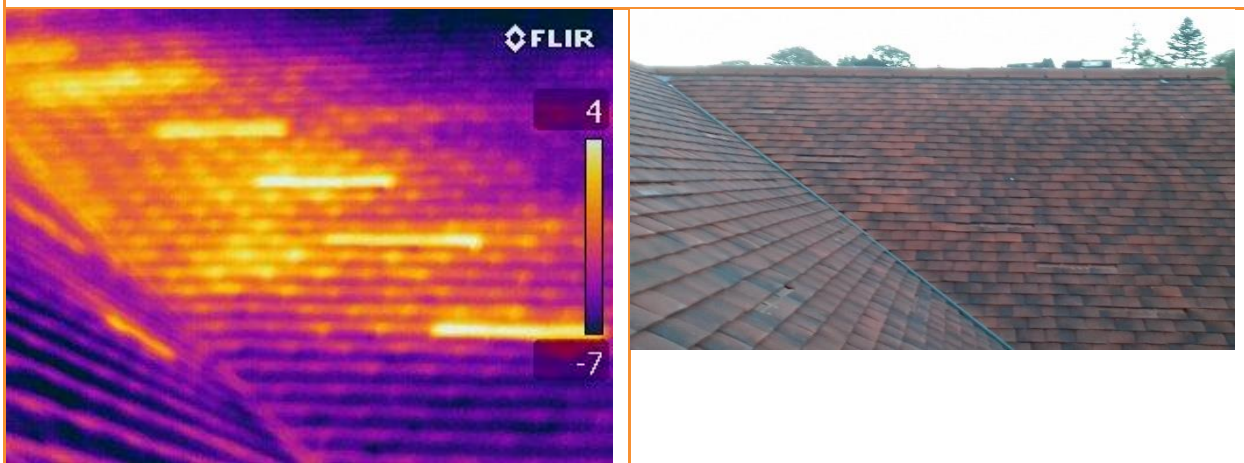
9.28: Thermographic image of rear roof, western end, before pressure applied – significant heat loss visible

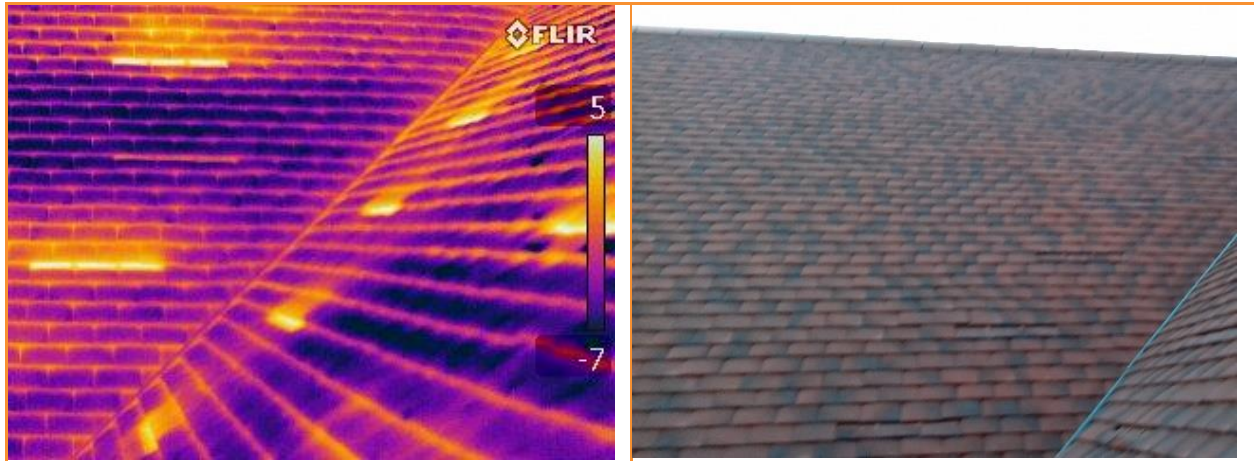
9.29: Thermographic image of rear roof, central section, before pressure applied – significant heat loss visible

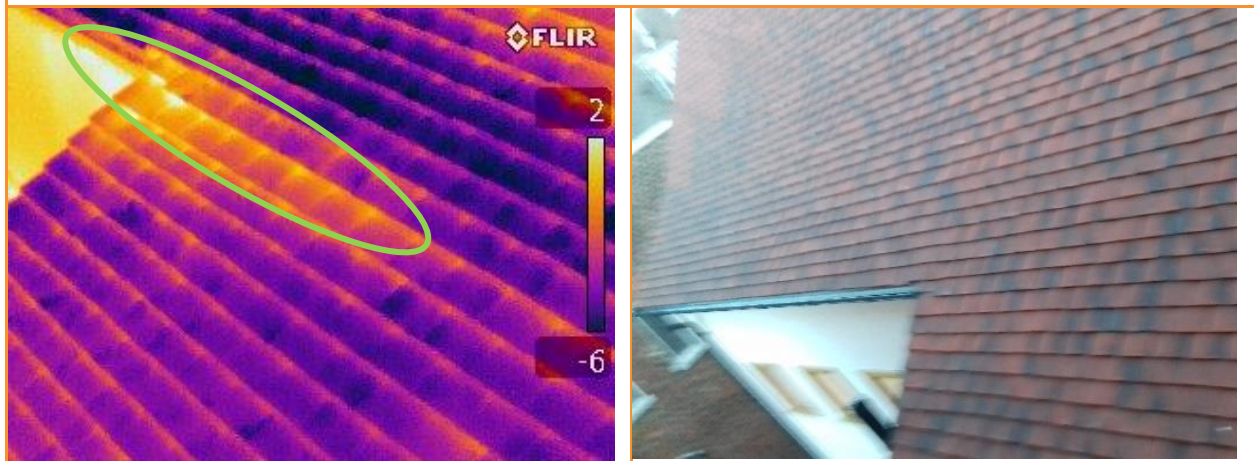
9.30: Thermographic image of rear roof, eastern end above kitchen, after pressure applied. Appears to be a leakage issue adjacent to the internal corner, extending across
