Common Leakage Sites no.9

Through the eaves.

Building Fabric Leakage 9: Through the eaves

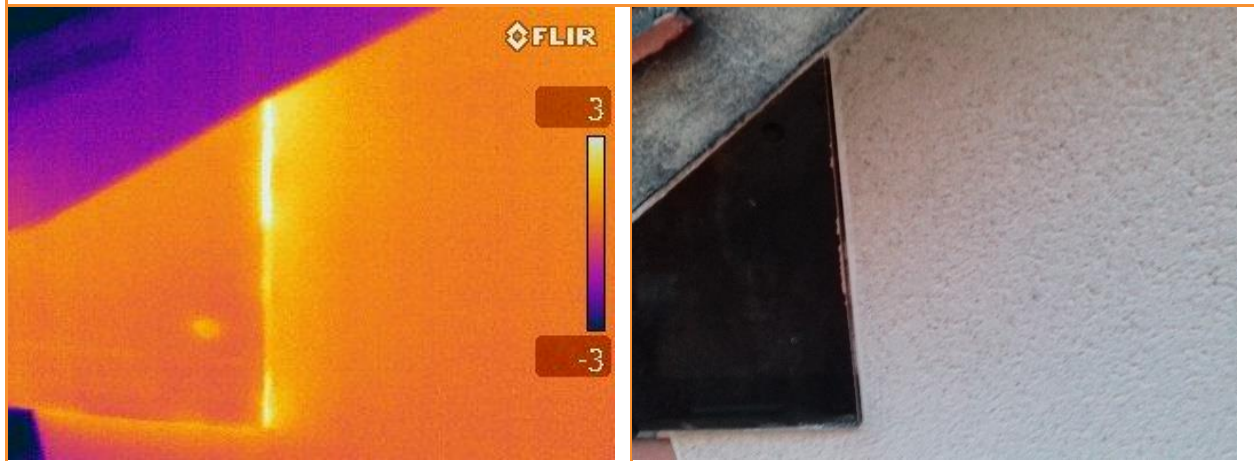
9.31: Thermographic image showing substantial leakage at edge of panel beneath eaves, whilst building pressurised

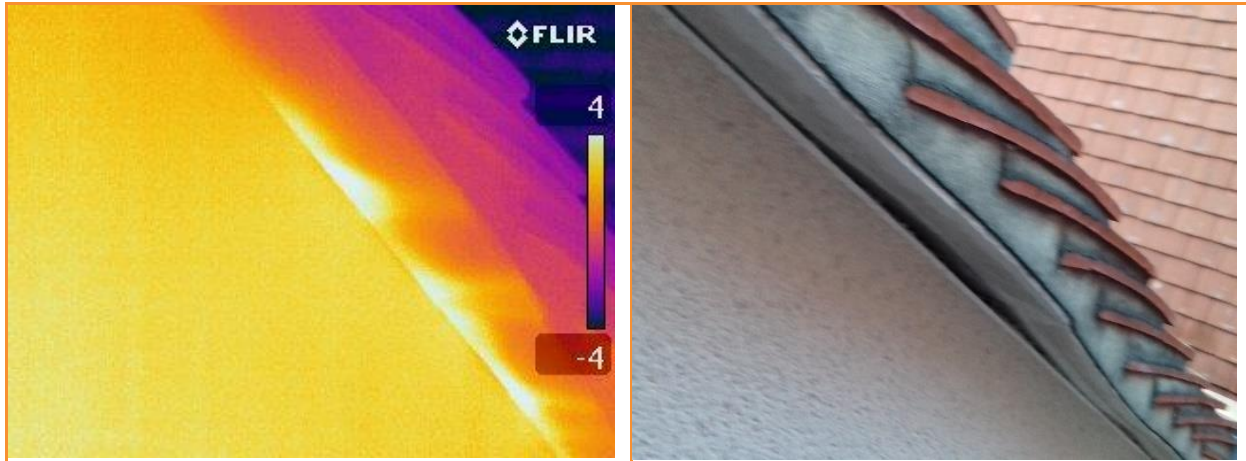
9.32: Thermographic image showing substantial leakage along eaves, whilst building pressurised

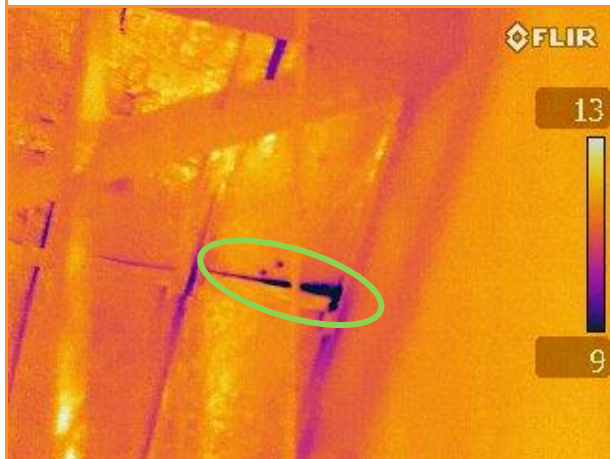
9.33: Thermographic image showing leakage where foil tape between pieces of insulation has come off, building depressurised

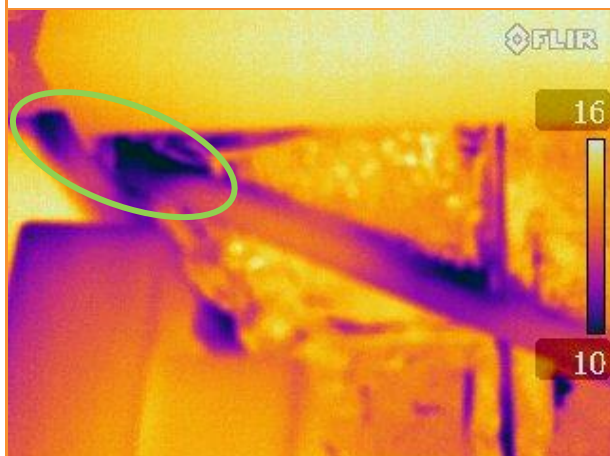
9.34: Thermographic image whilst building depressurised, showing major leak behind joint in steel frame

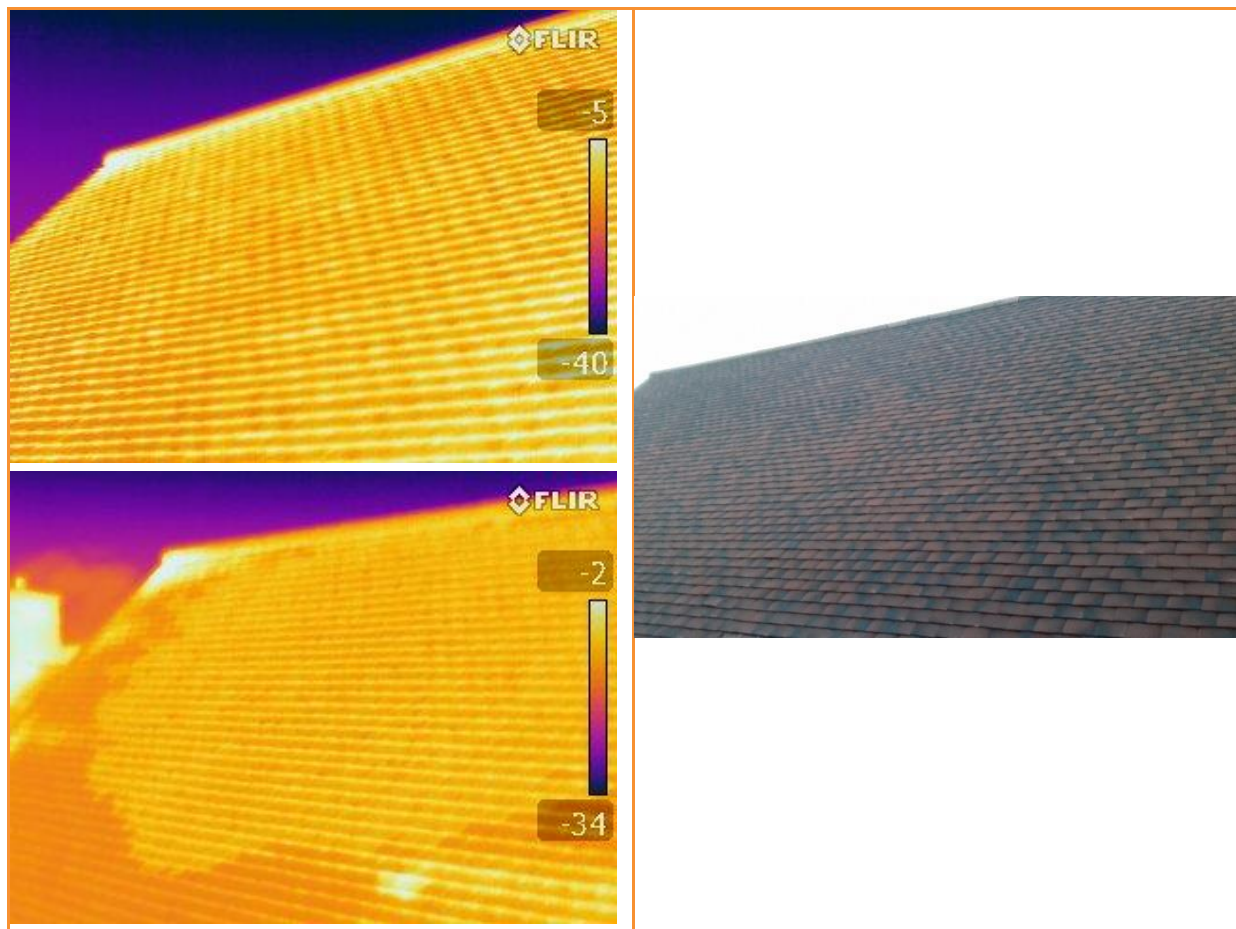
9.35: Thermographic image of rear roof, eastern end, before pressure applied (top), then after pressure applied, substantial extra heat loss

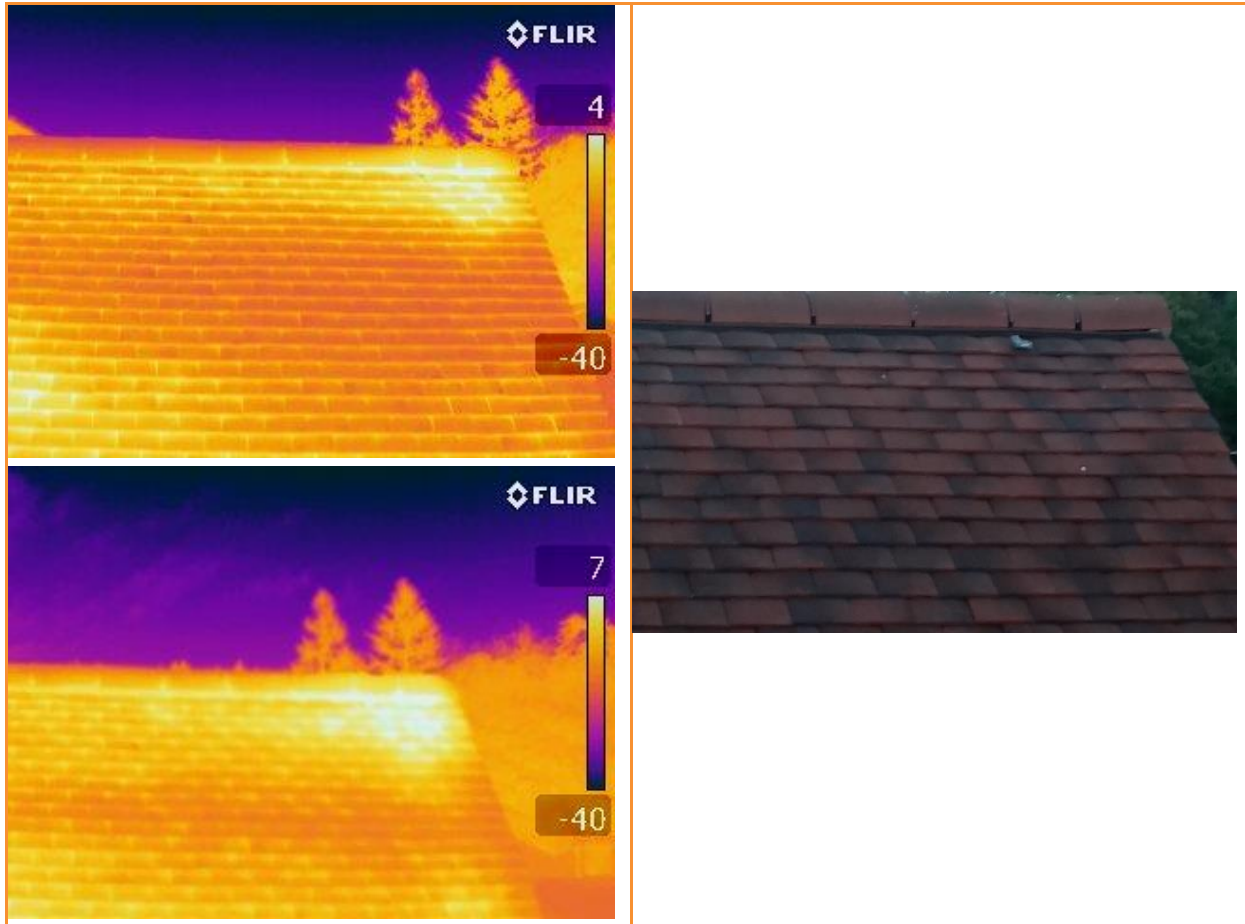
9.36: Thermographic image of rear roof, western end, before pressure applied, considerable heat loss (top), then after pressure applied, substantial extra heat loss

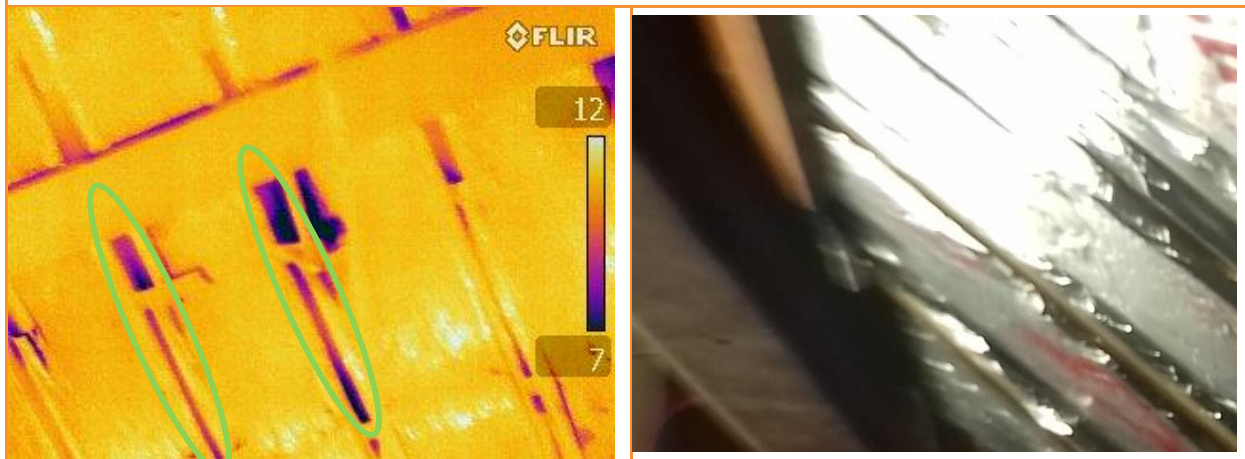
9.37: Thermographic image showing lines of leakage along roof joists where taping has failed, building depressurised

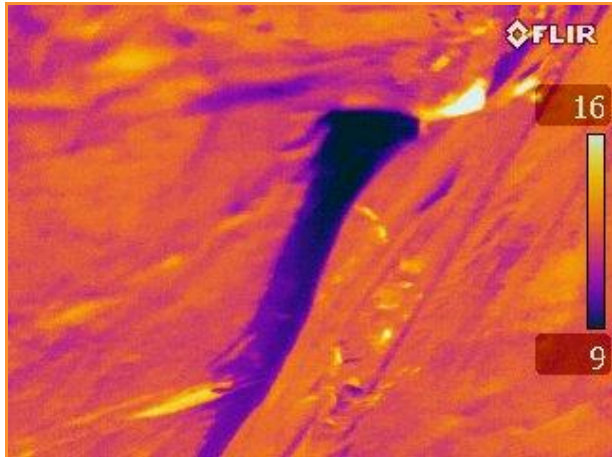
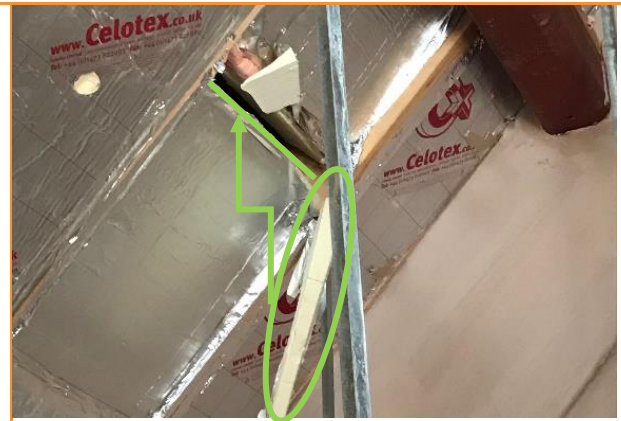
9.38: Thermographic image showing leakage past section of foil tape that has peeled off, building depressurised

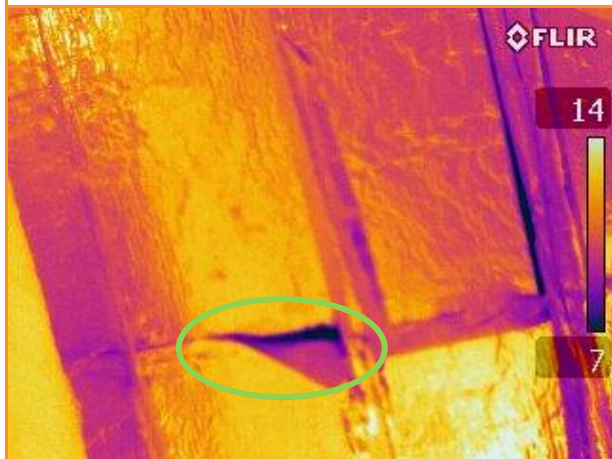
9.39: Thermographic image of leakage where foil tape has peeled off, building depressurised

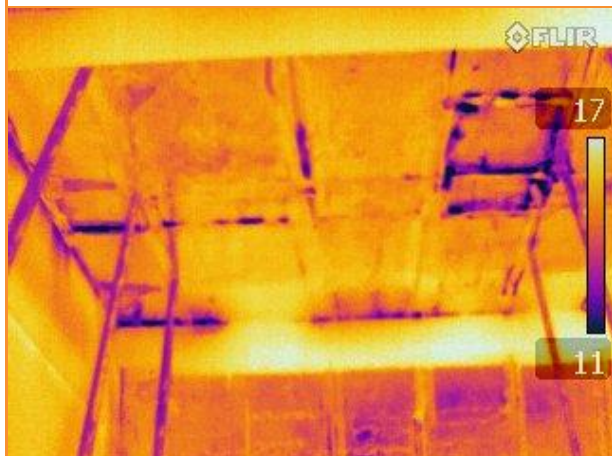
9.40: Thermographic image whilst building depressurised, leakage on many edges of roof insulation pieces where foil taping has failed

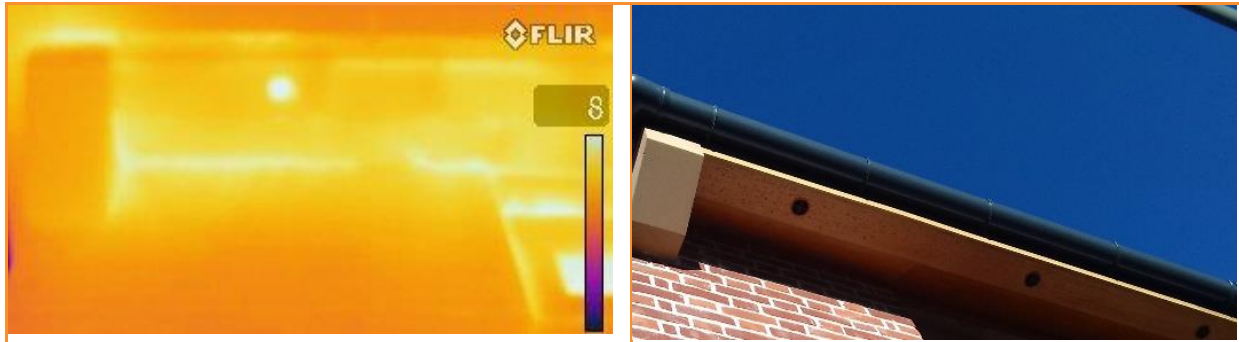
9.41: Thermographic image while building pressurised, through eaves vent & top of column

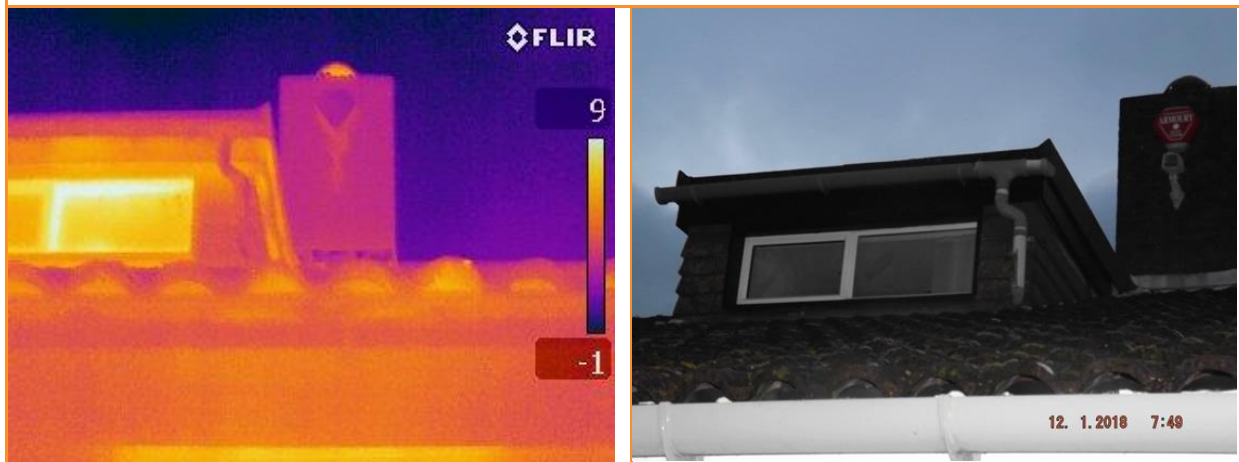
9.42: Thermographic image showing leakage beneath the curved ends of the roof tiles along the eaves, indicating significant leakage into the roof space

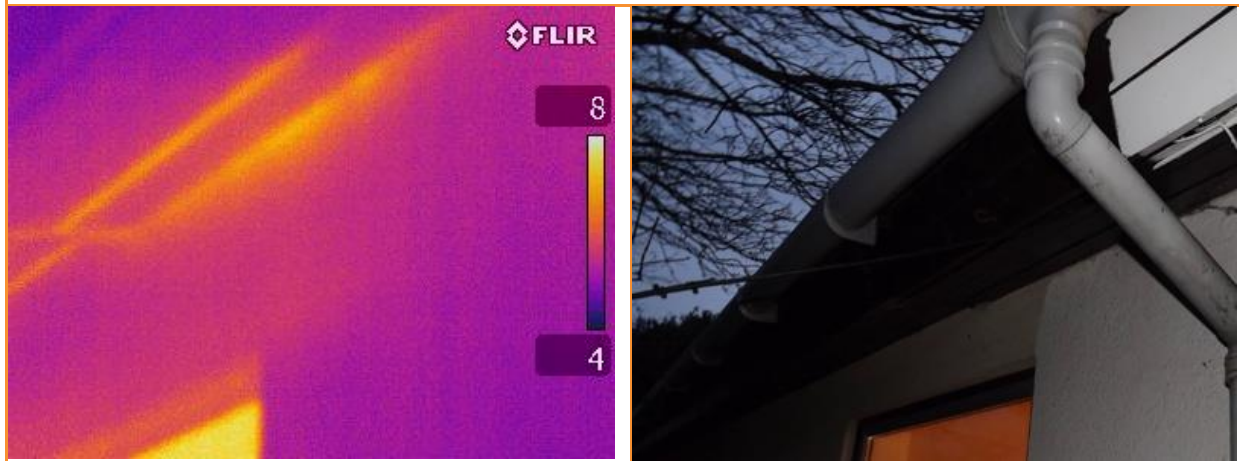
9.43: Thermographic image showing leakage through gaps in the boarding beneath the roof

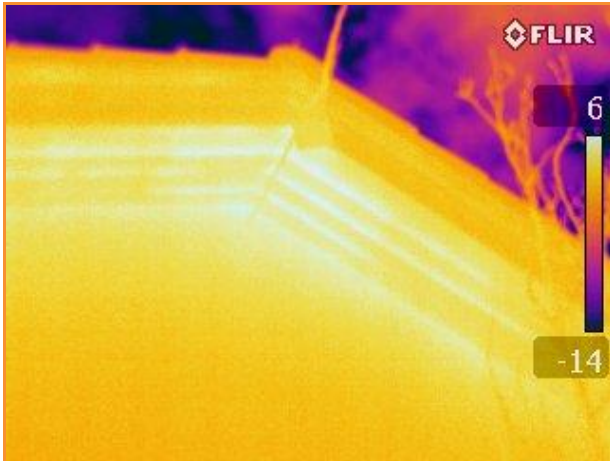
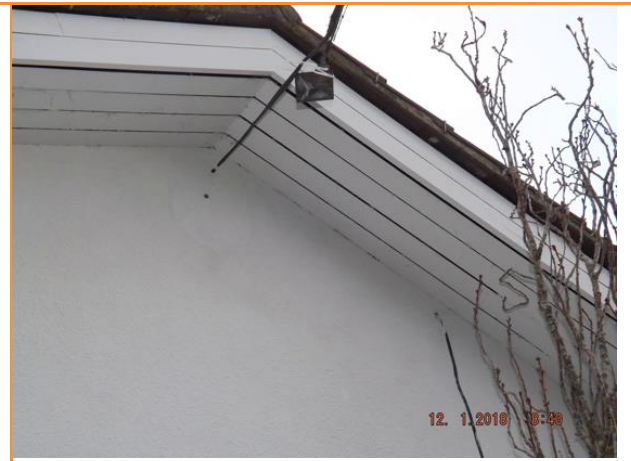
9.44: Thermographic image showing considerable leakage at wall to roof interface and also through gaps between boarding to the underside of the roof

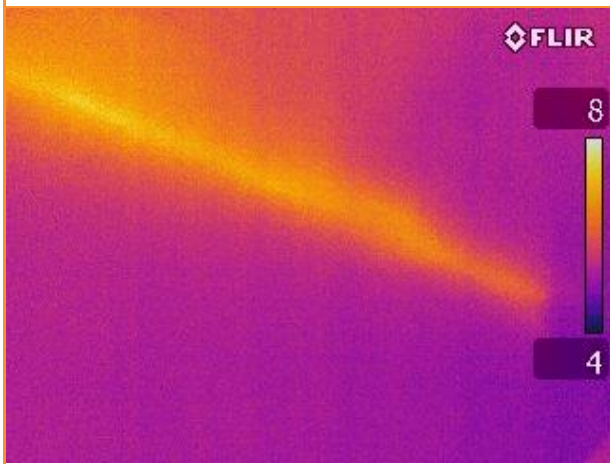
9.45: Thermographic image showing leakage along the interface between the eaves and the top of the wall, during pressurisation
