**Retrofit: Moving
in and Moving on**

Earby EcoHaus Refurbishment by Peter Wilkinson of EcoDesign

Earby EcoHaus - refurbishment

- **Site address;** 2 Kenilworth Drive, Earby, Lancashire.
- **Client;** Peter & Linda Wilkinson.
- **Design team;** EcoDesign, Earby, Lancashire.
- **Contractor;** Dales Contracts Ltd. Earby, Lancashire.
- **Local Authority;** Borough of Pendle, Nelson.
- **Property;** 67m² 3 bedroom end terrace. Spooner system timber framed, brick clad Local Authority built in the 1950s.

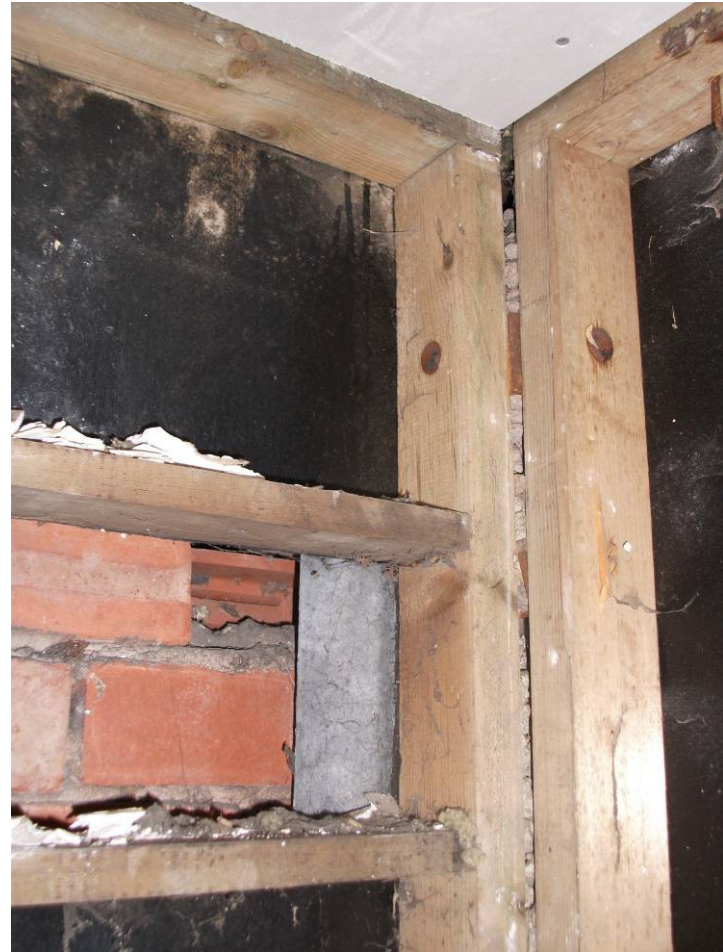
Existing external wall:

- Render & dash finish on 40mm EPS insulation on brick outer leaf.
- 50mm partially ventilated clear cavity.
- Bituminous sarking felt to cavity face of 70mm timber stud.
- Plasterb'd & skim finish.

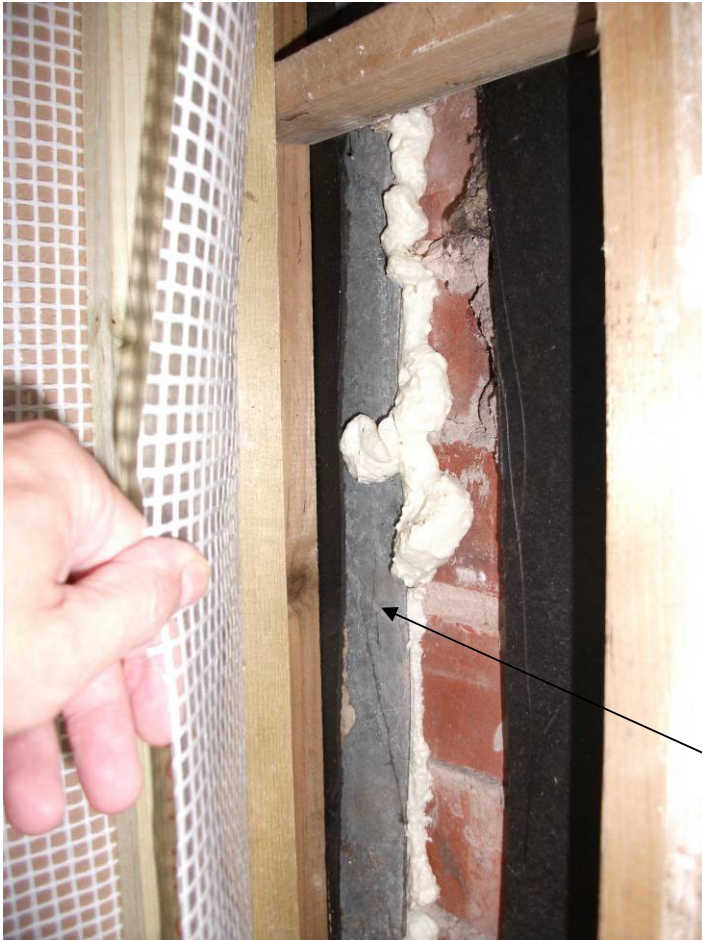
Original metal cavity closer sealed with expanding foam to make air tight.

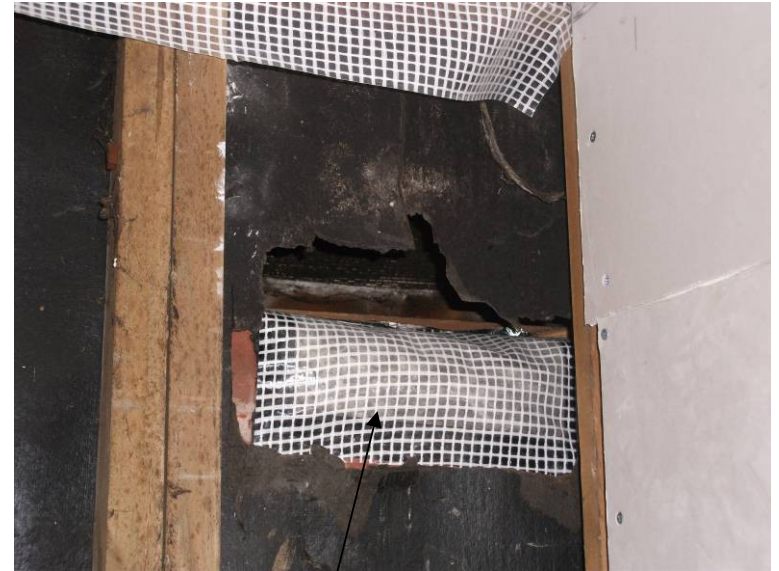
Original air grate filled with insulation & sealed with VCL & made air tight.
