a building process story

typical 80's block of flats to Enerphit

ANNE THORNE ARCHITECTS LLP

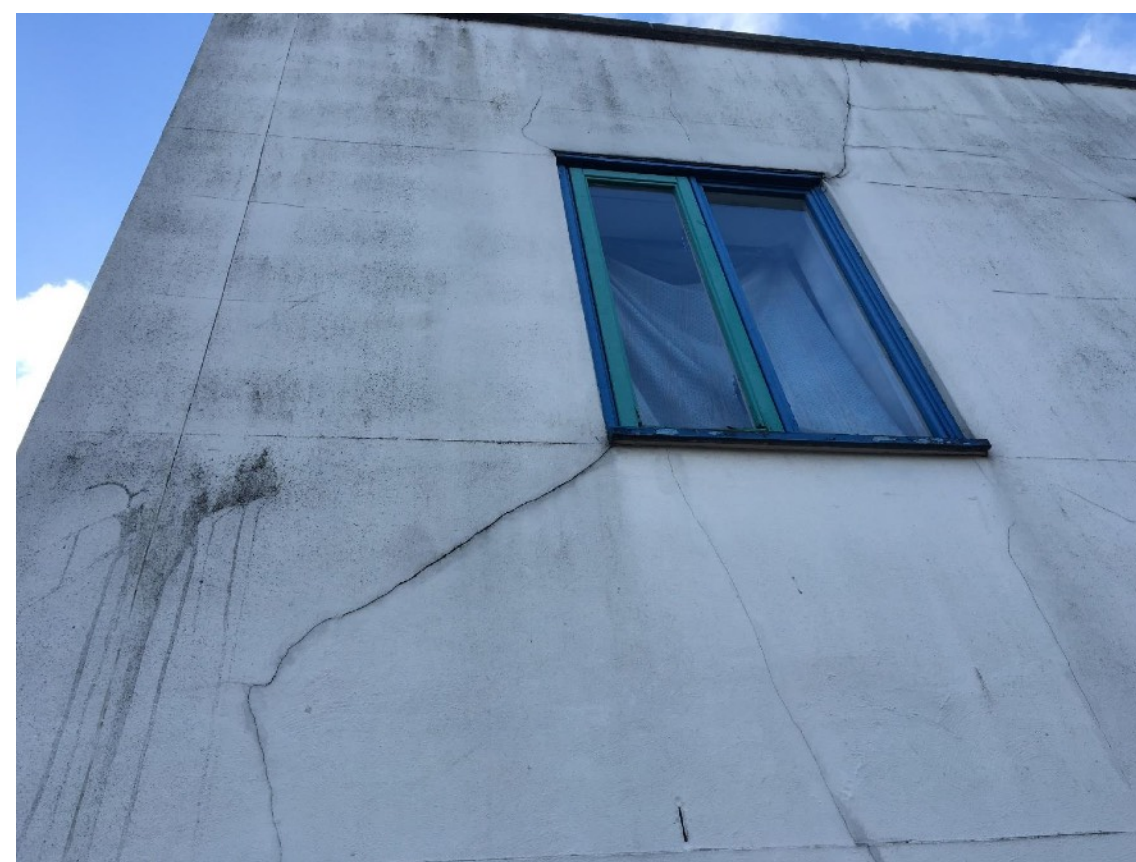
fragile fabric - stitch it together  
new cavity ties, stitch masonry cracks with helifix ties  
airtightness barrier - inside or out?  
crossing over from inside to out at party wall  
single people housing - electric only?

Corbett and Tasker structural engineers

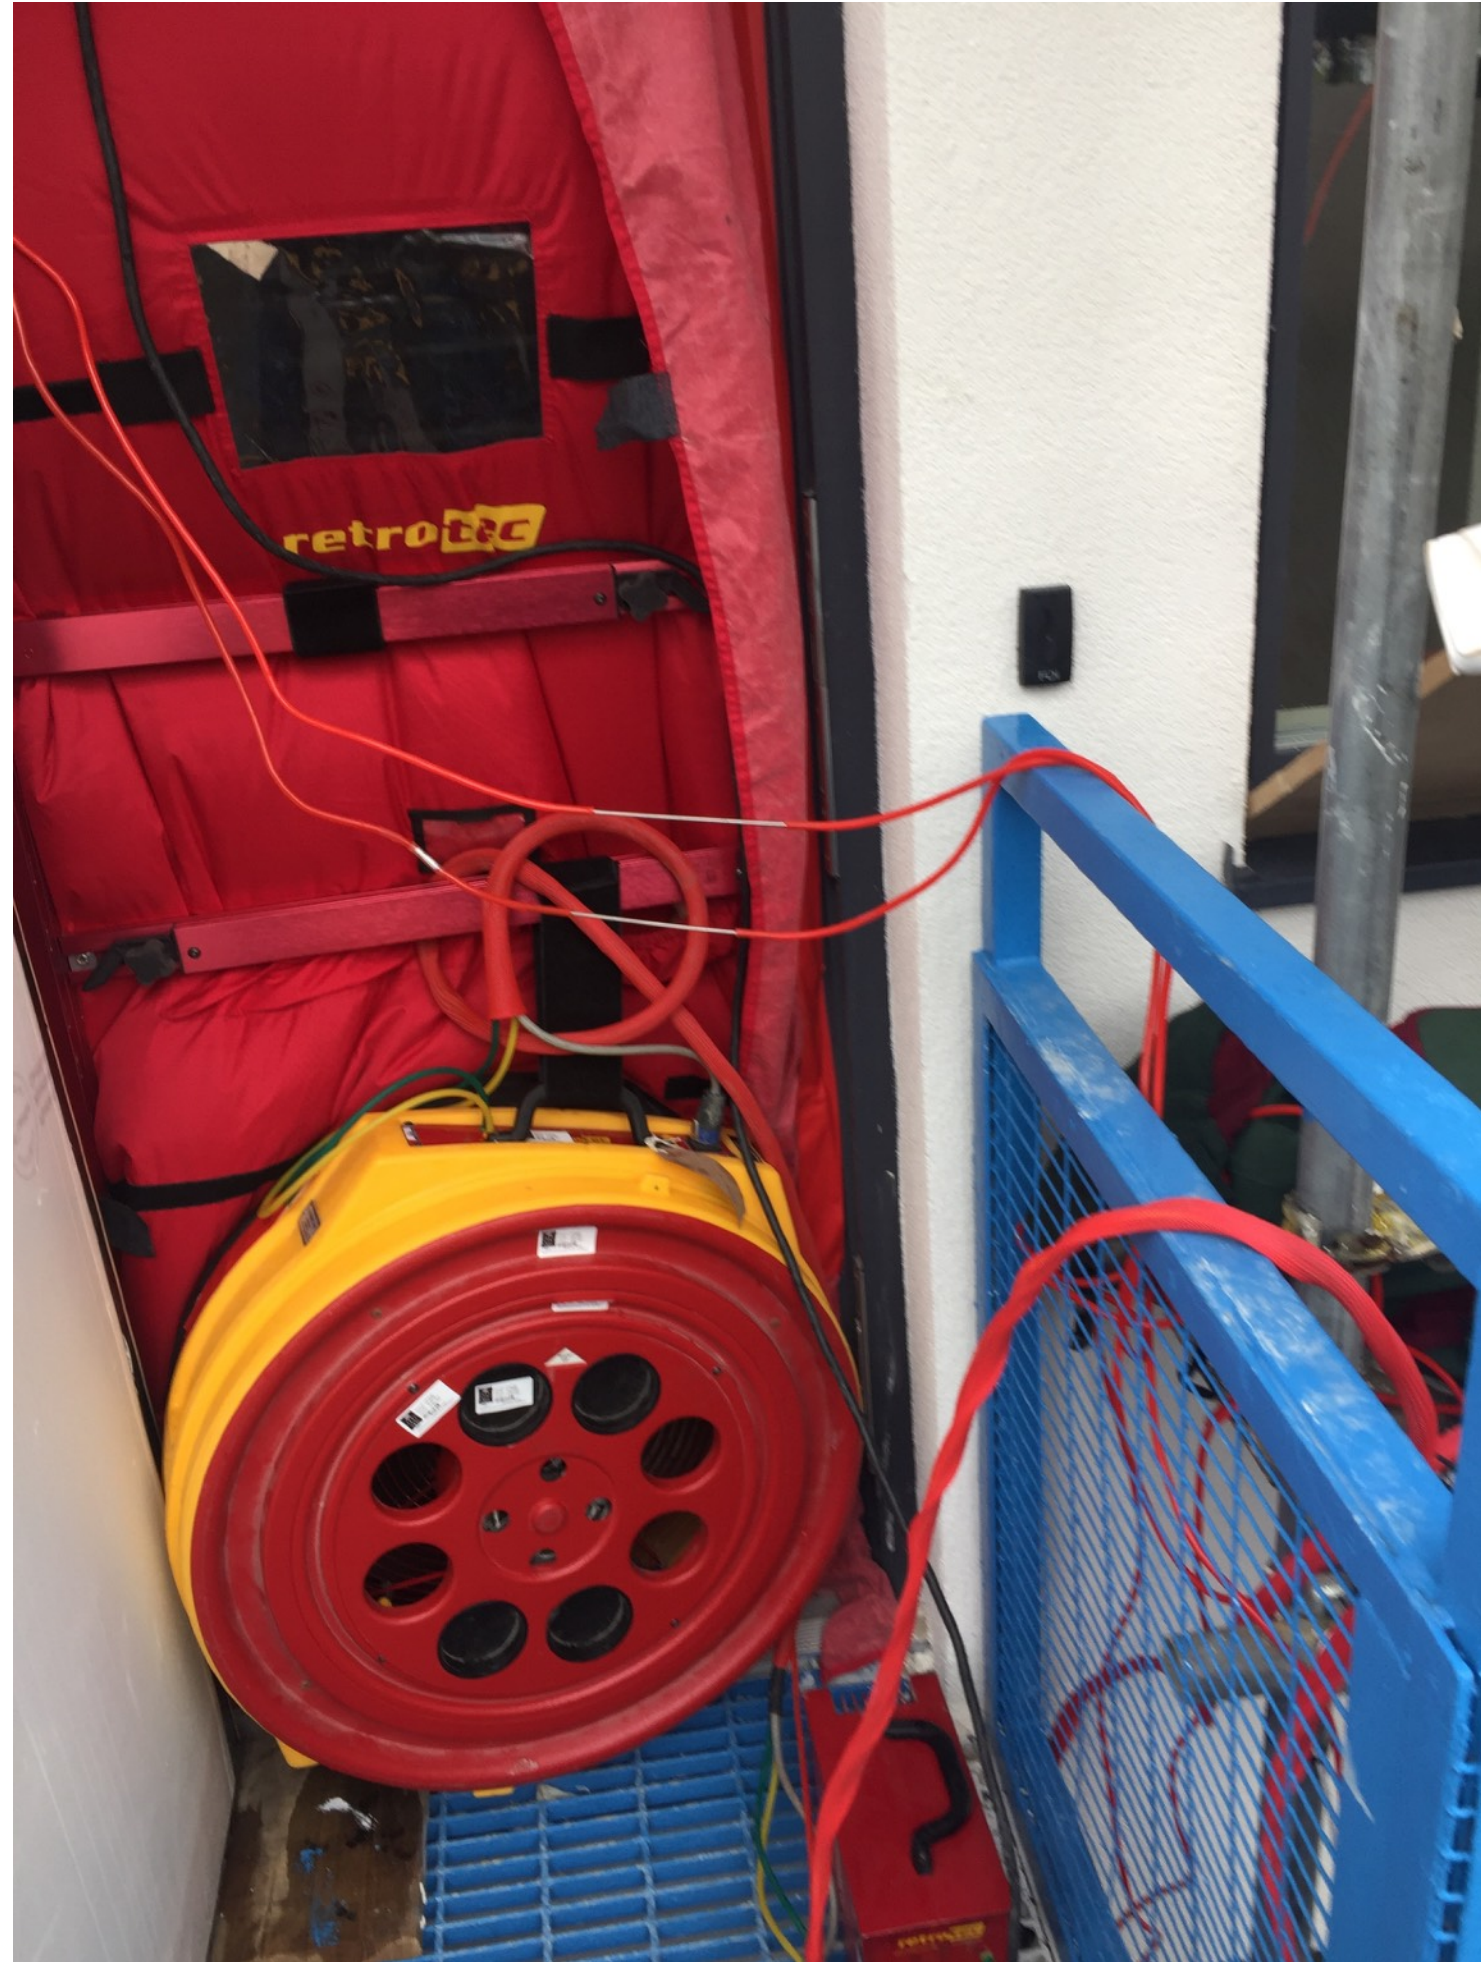
-testing all floors together  
with ground floor flats  
through old service ducts, and  
checked with a separate line  
to one of the ground floor  
flats

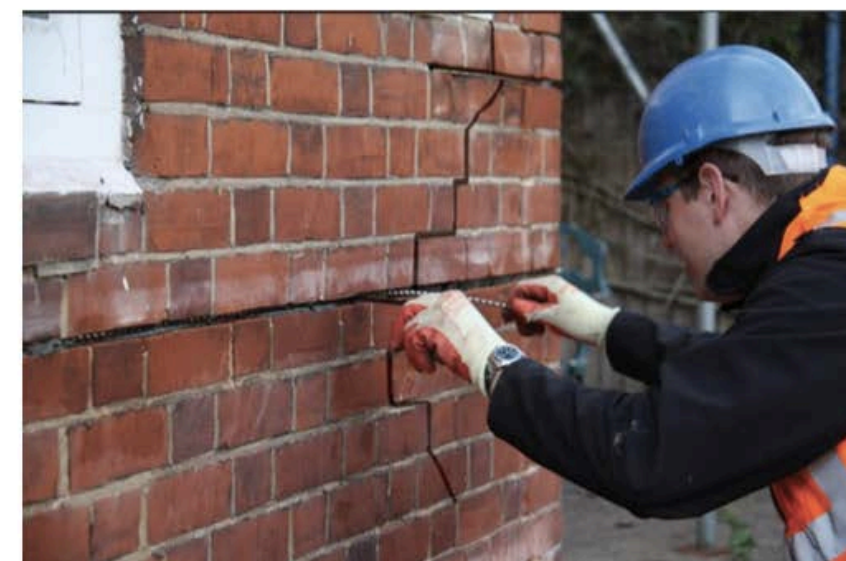
Figure 4 - Typical image of Helifix crack stitch method where mortar joints are raked out, helical bars inserted and grouted/resin injected in order to reinforce the wall panel

An example of a specialist supplier of crack stitching and bed-joint reinforcement is Helifix, who may be prepared to visit the site and make recommendations with regards detailed remedial works, once the cracks have been determined to be 'live' or 'dead'. Refer to Figure 4 for an indication of the method proposed.

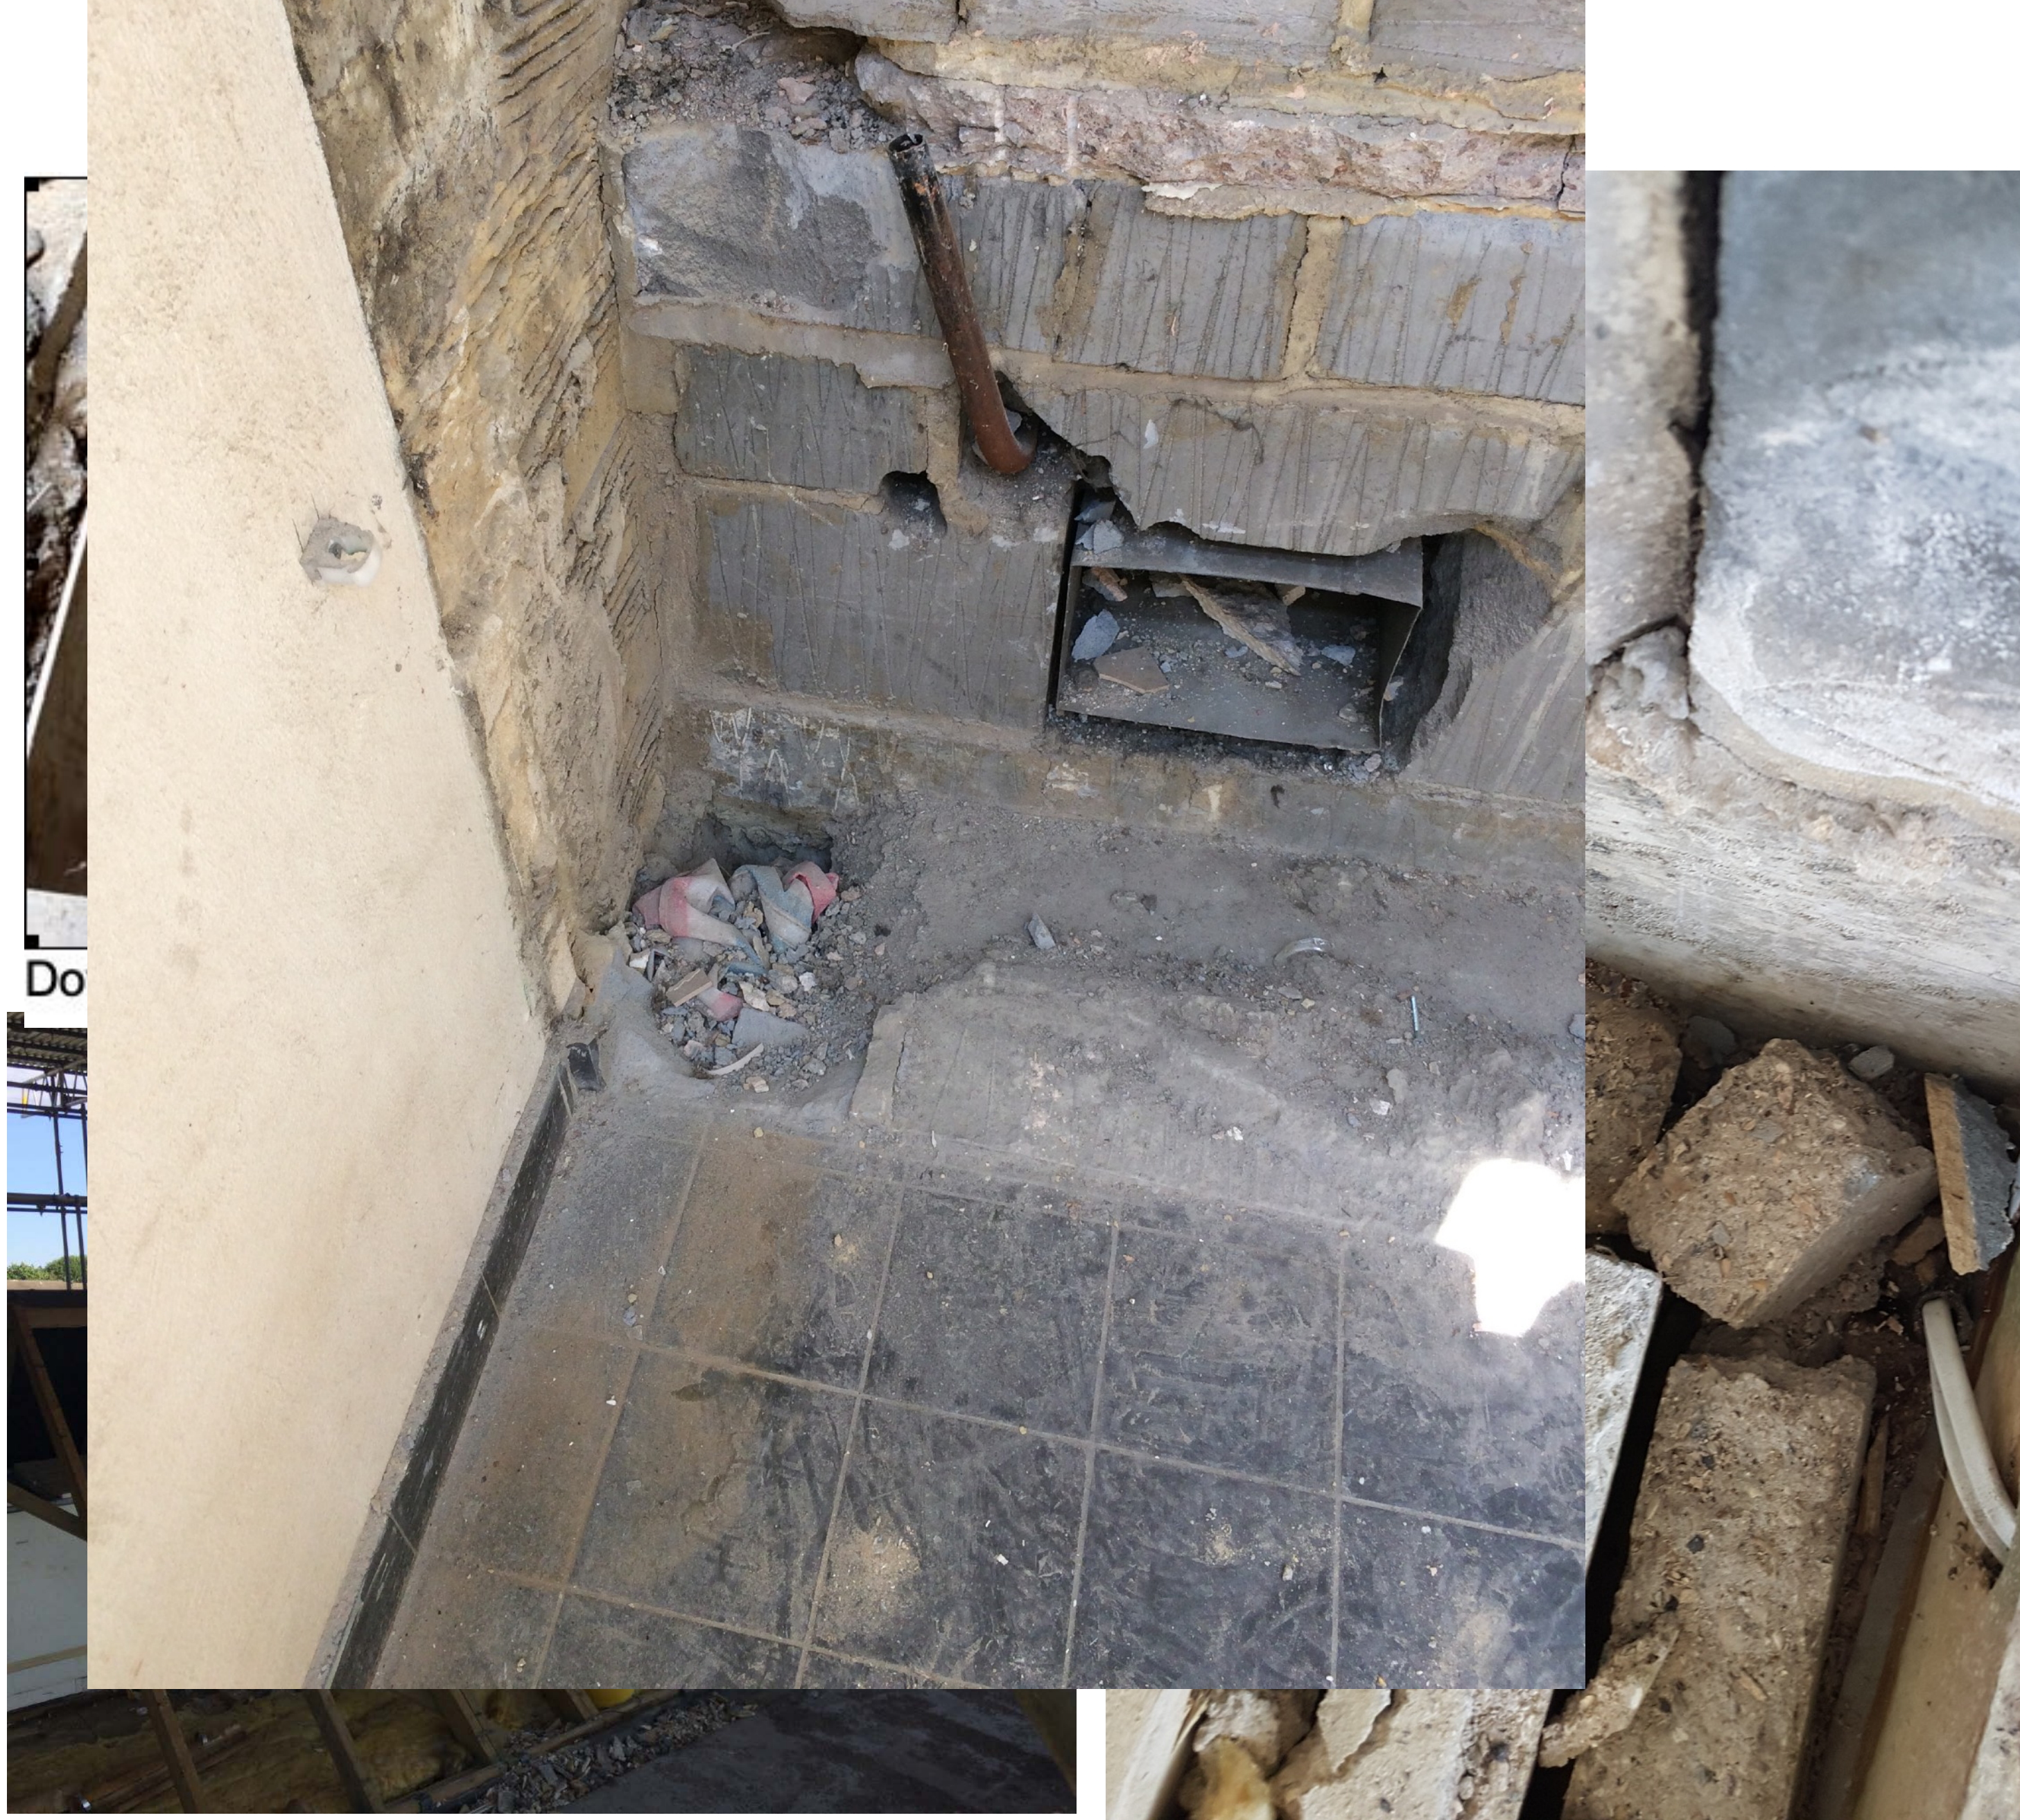
further damage revealed  
new structure on old fittings  
helix stitching  
replacement joist hangers  
etc

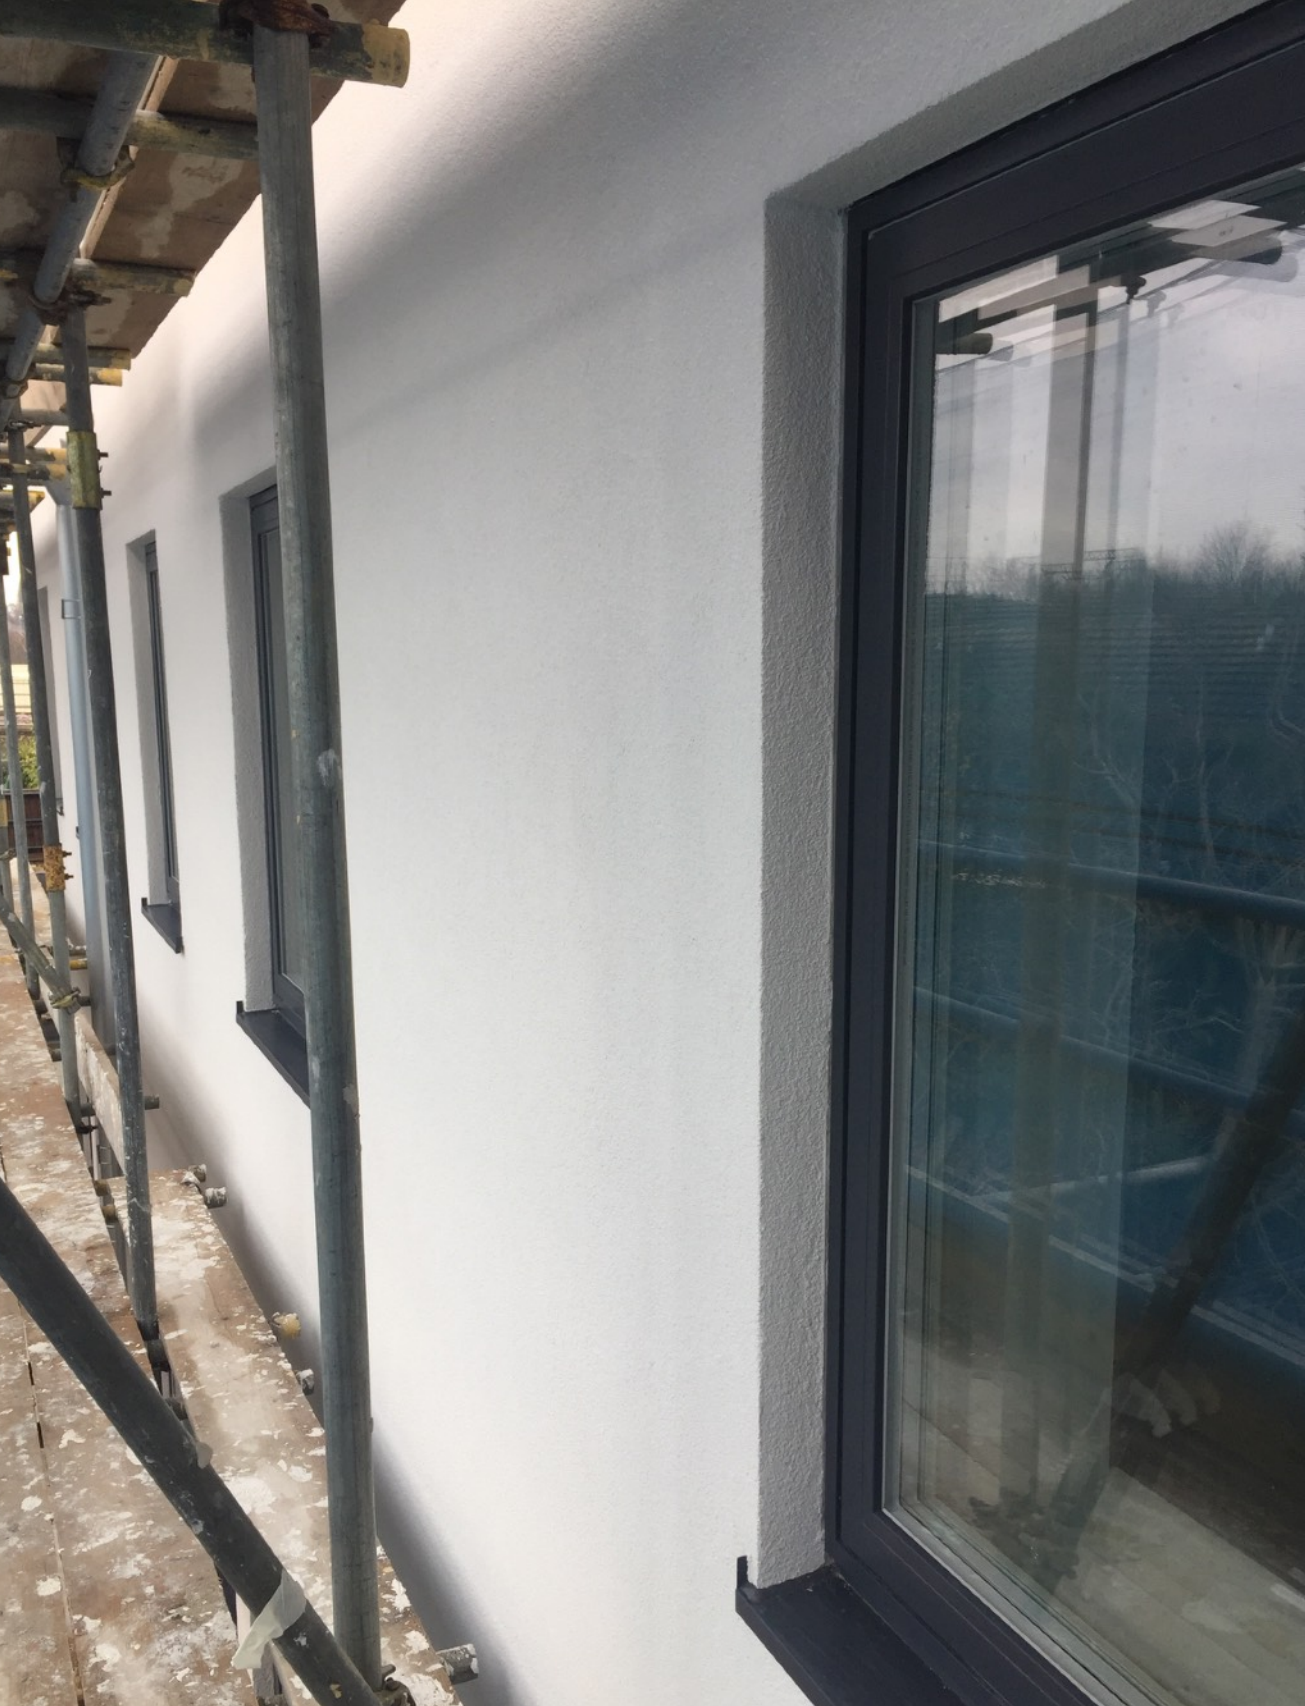
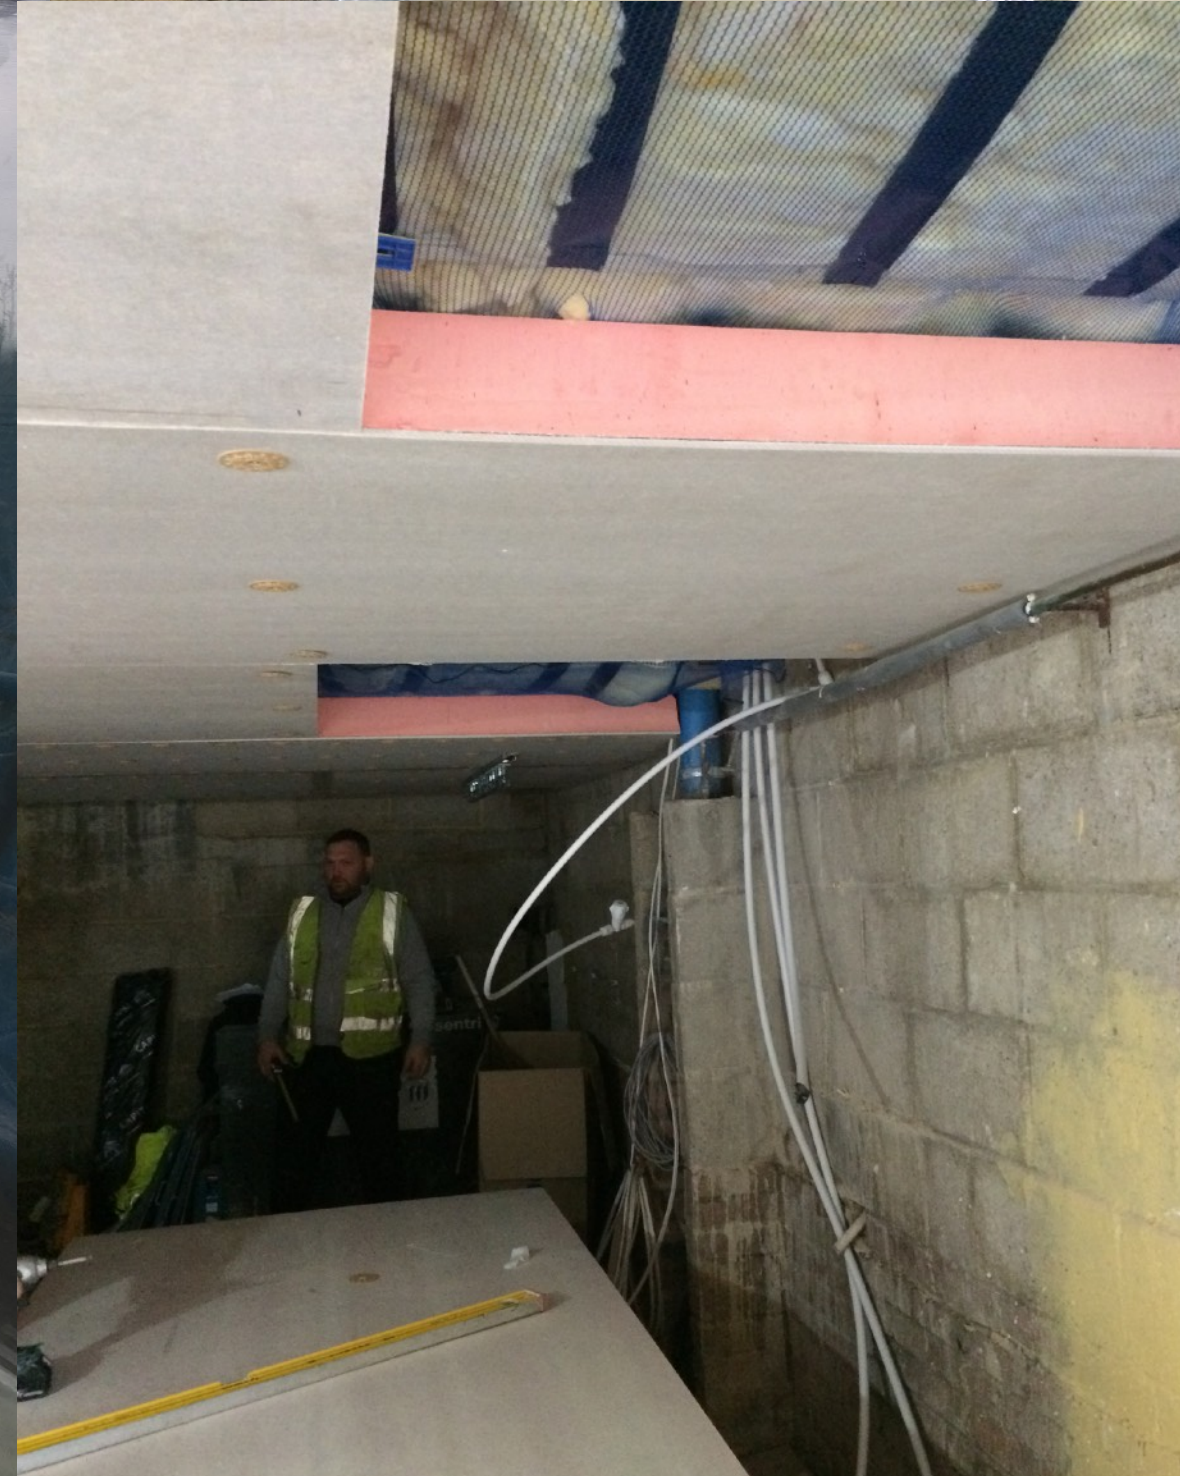
tight MVHR routes  
pv to roof  
air tightness layer to undercroft,  
insulation taken down piers

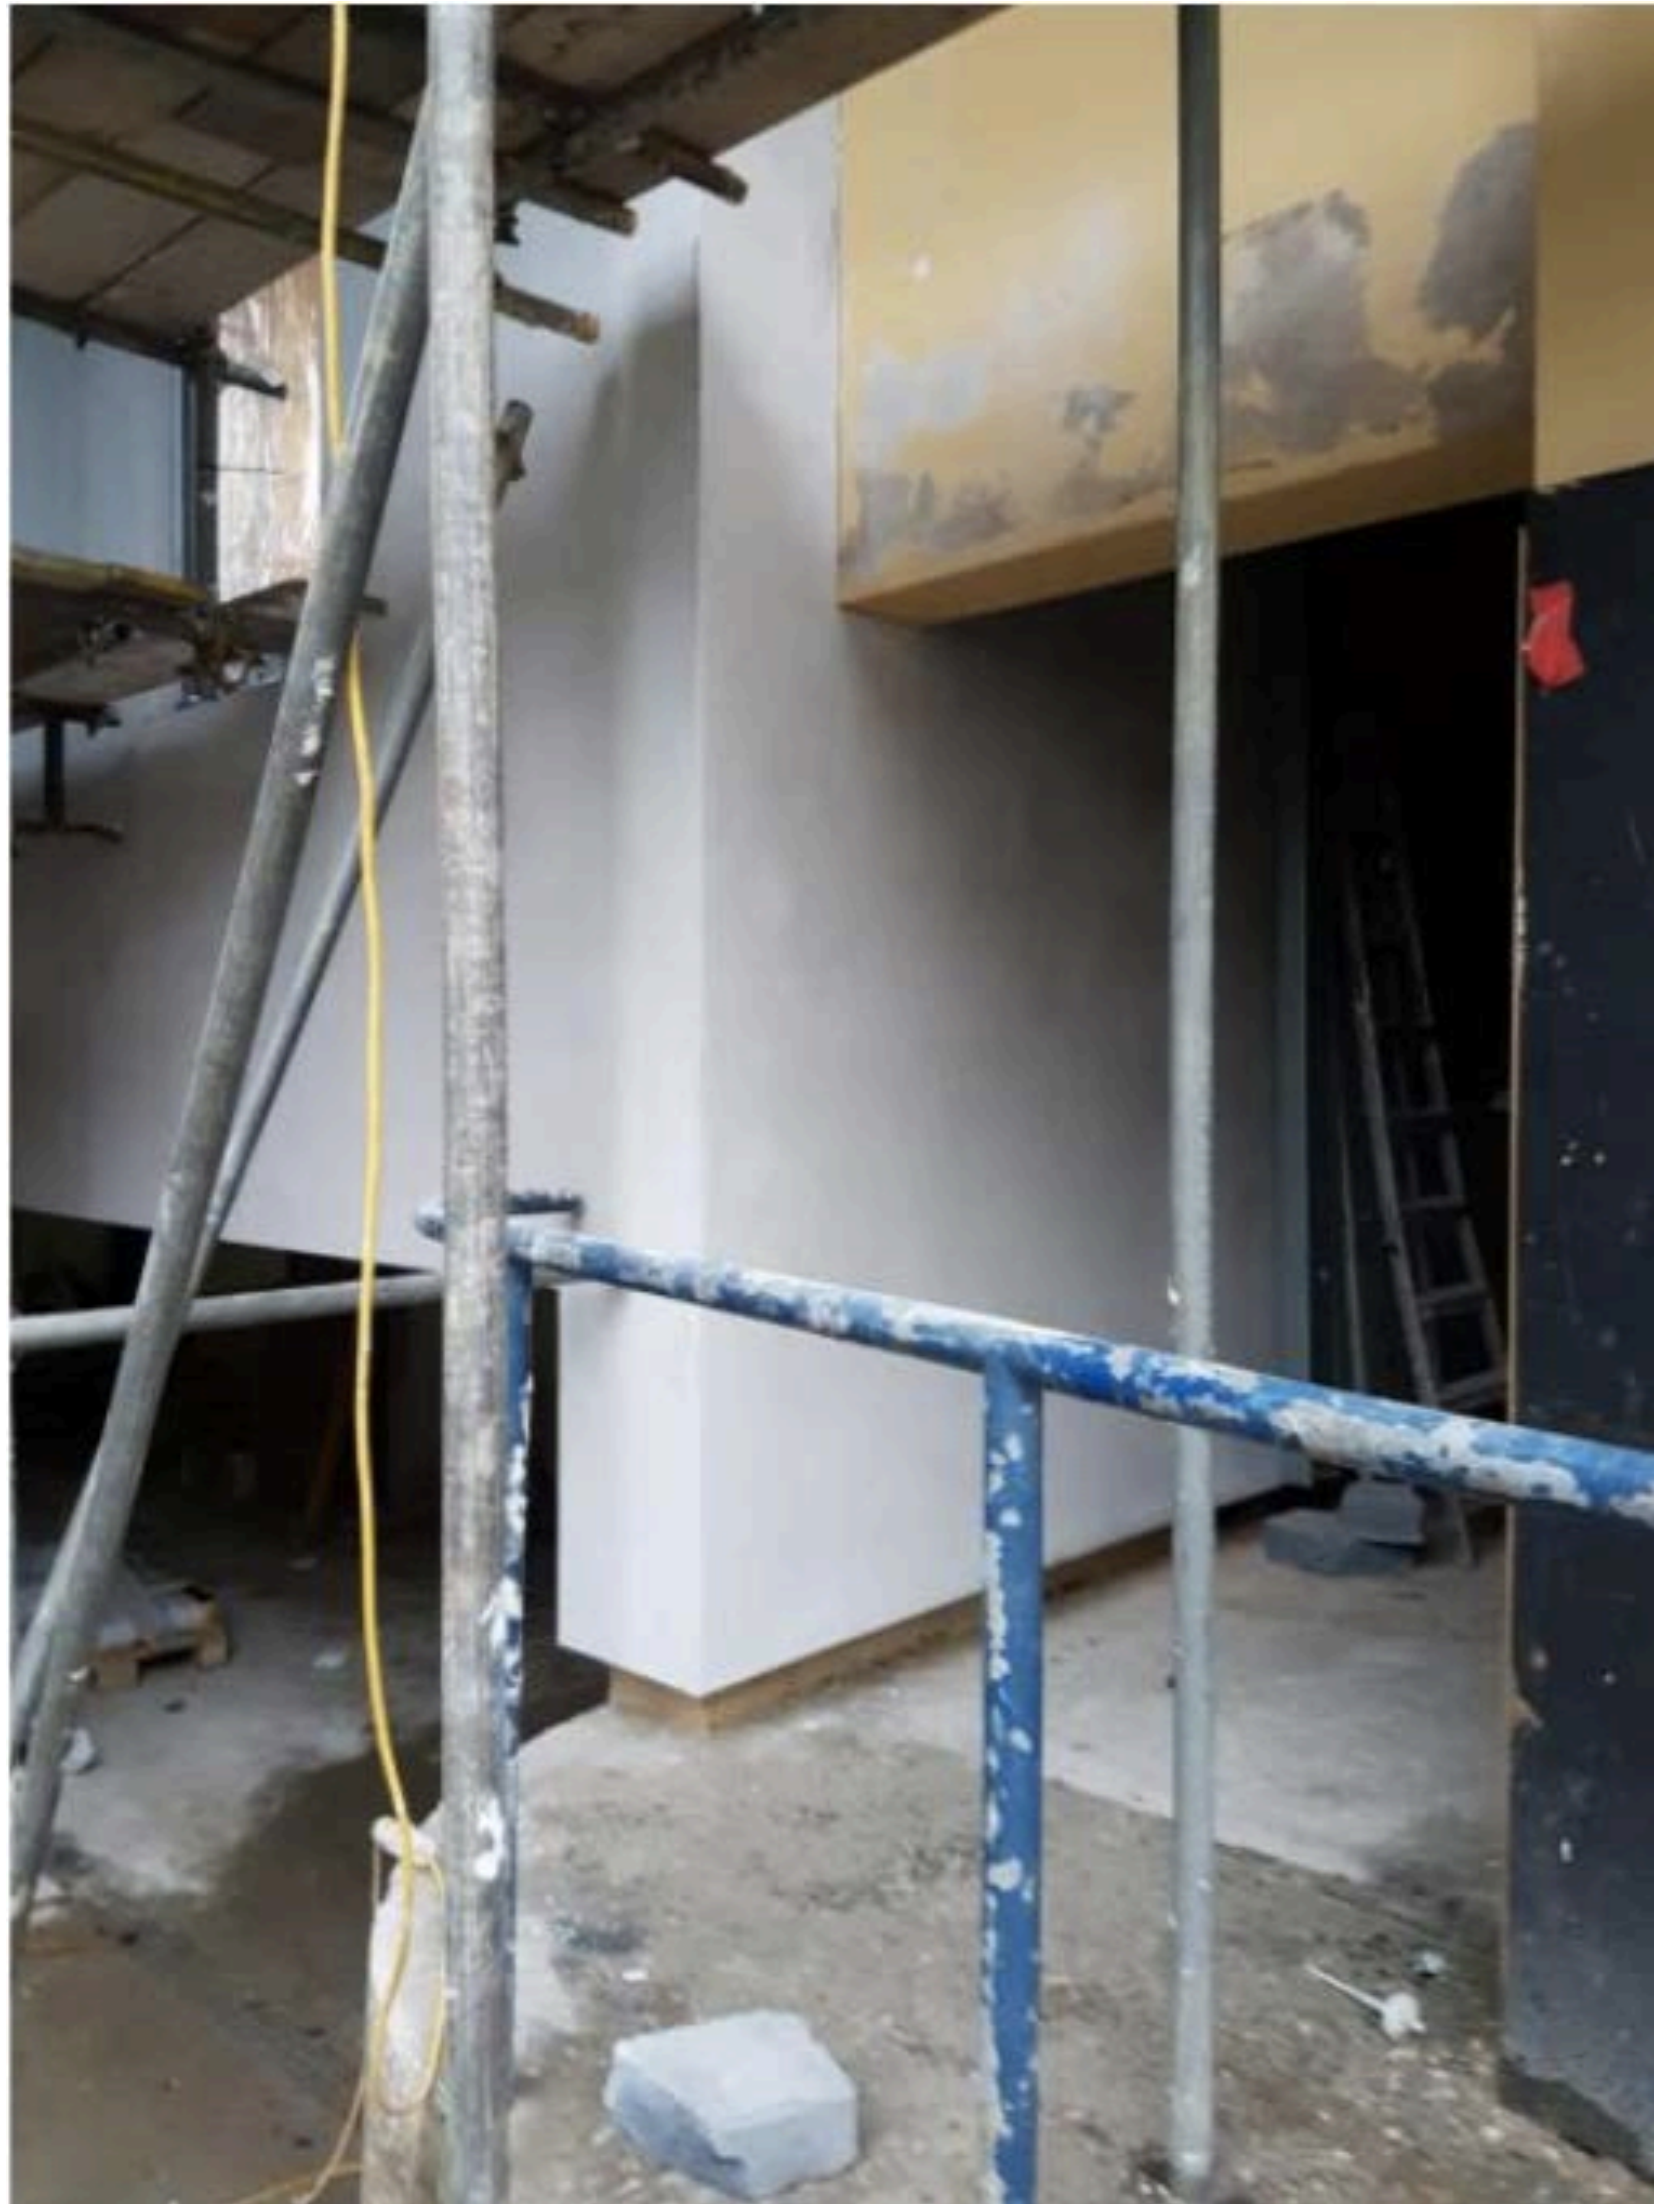
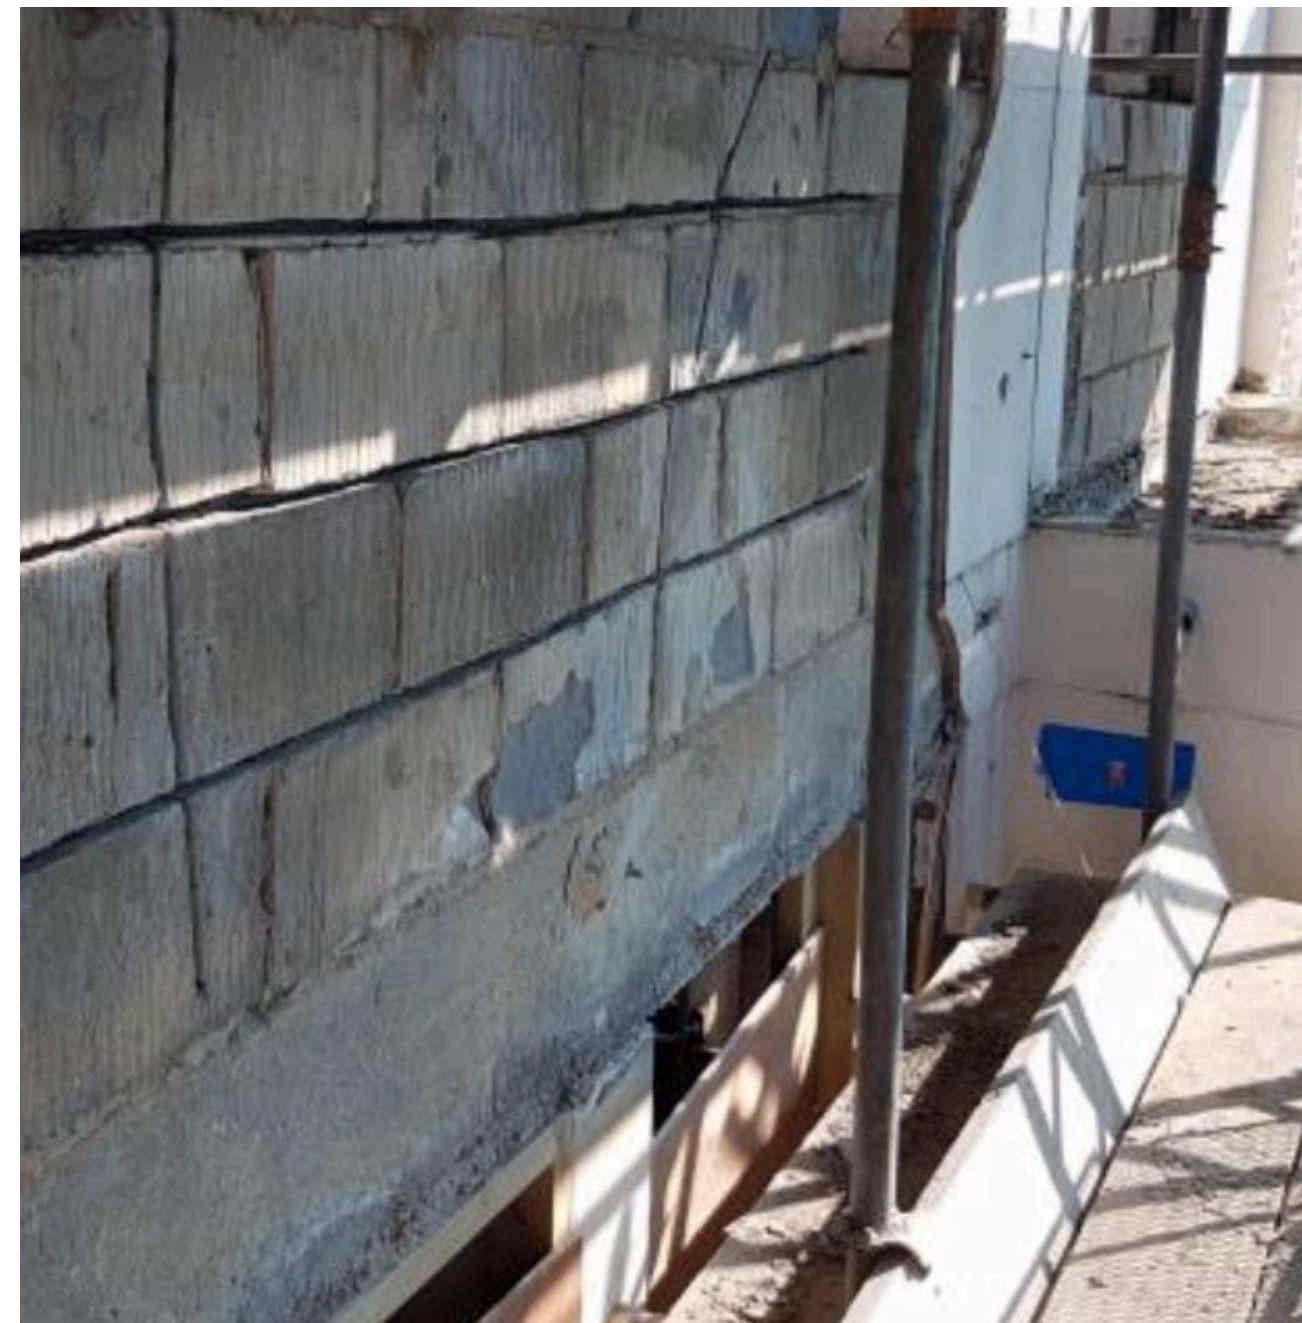
cavities refilled  
Sto mineral wool insulation on  
stitched blockwork  
with mesh and base coat to  
insulated boards
