a building process story

typical 80's block of flats to Enerphit

ANNE THORNE ARCHITECTS LLP

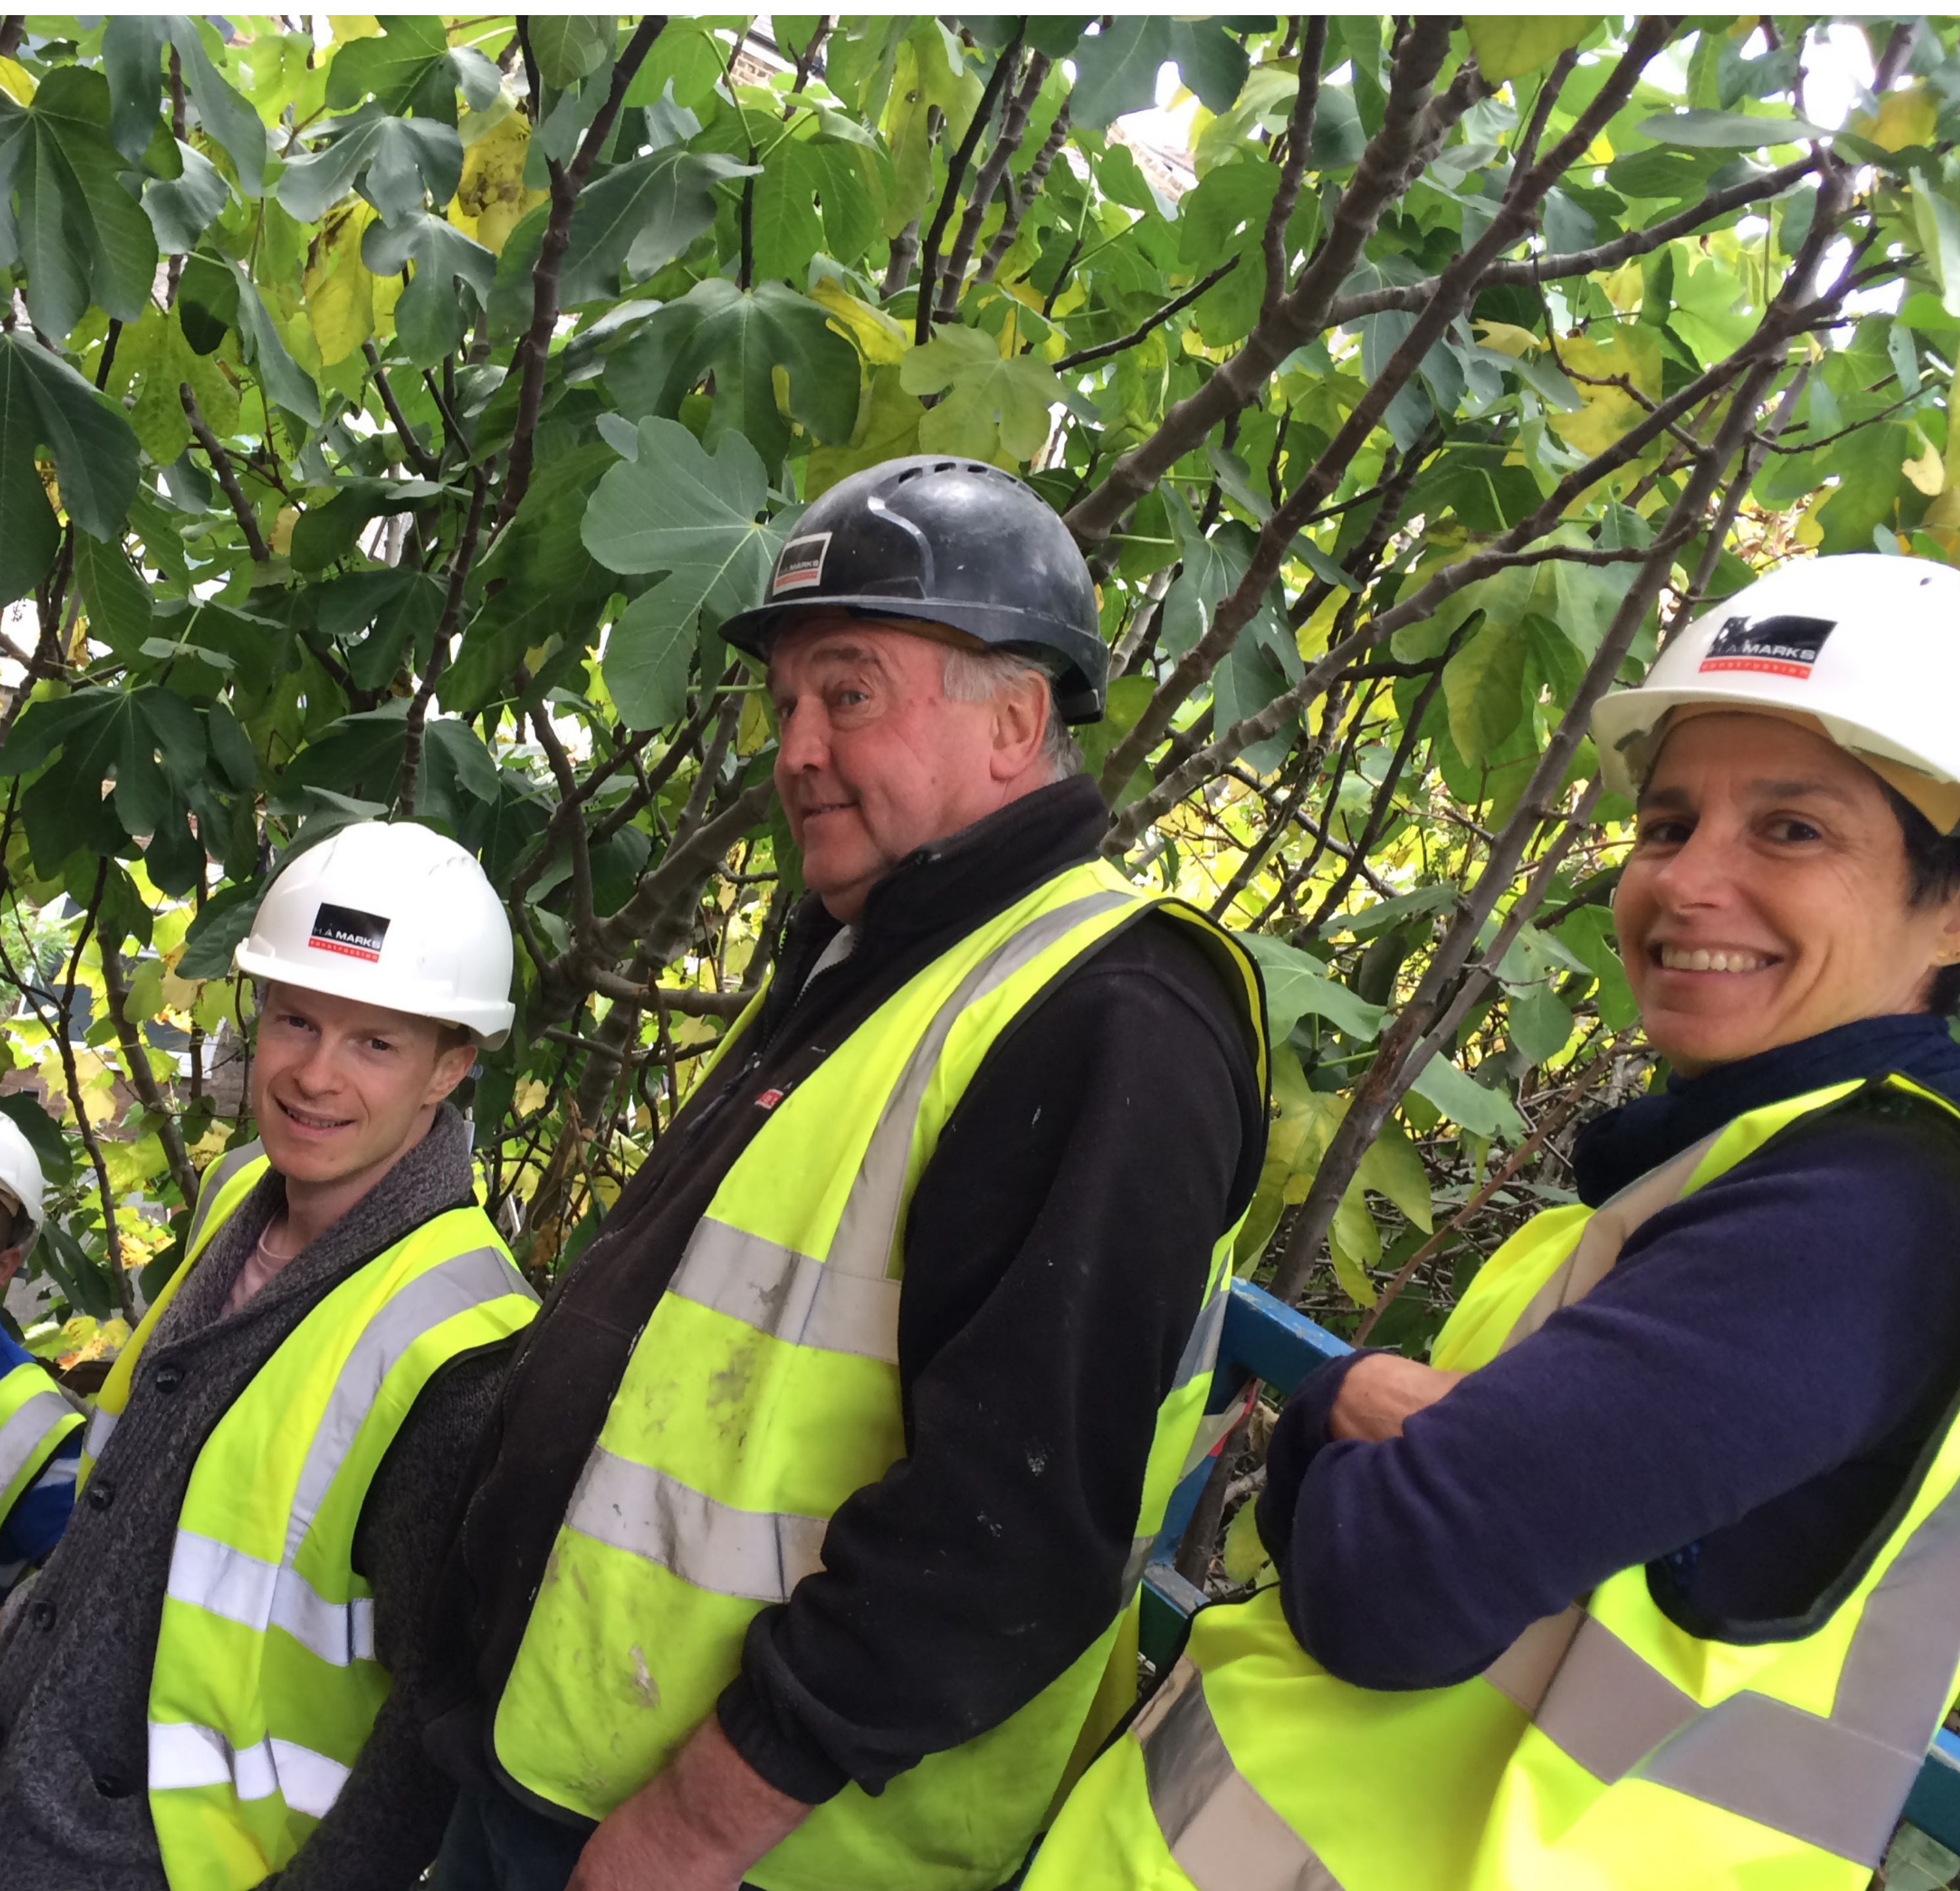
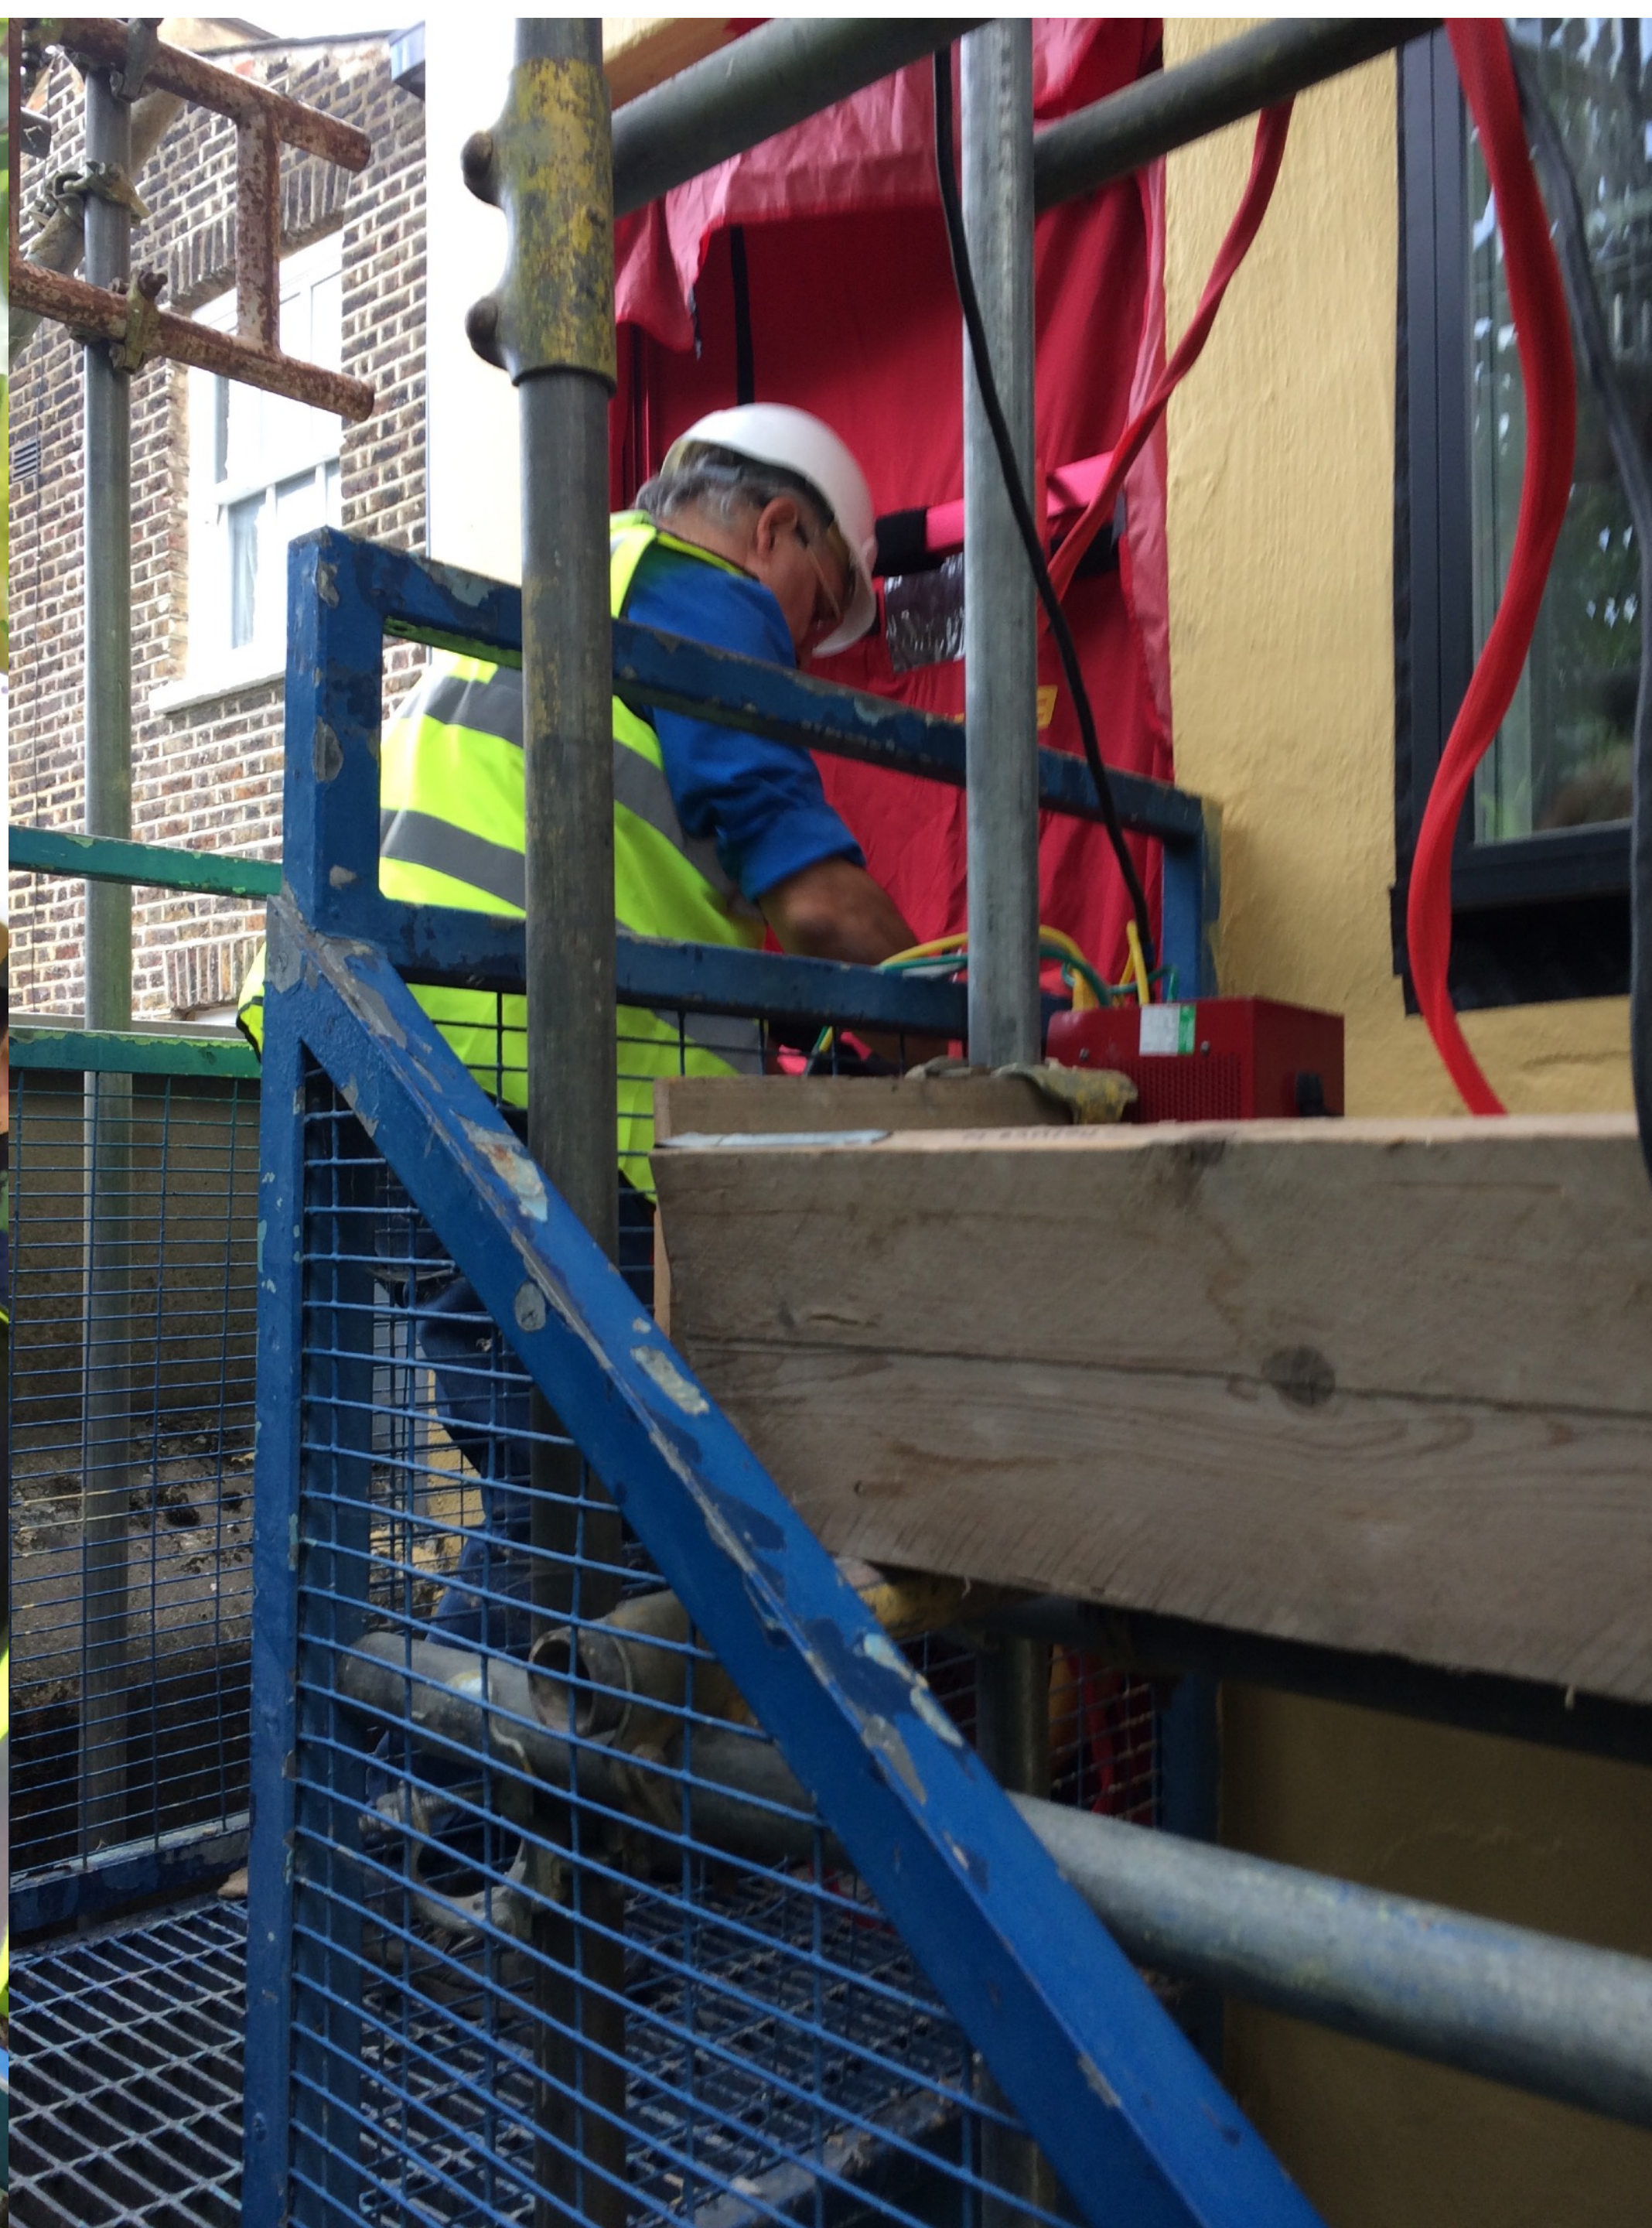
cavities refilled  
Sto mineral wool insulation on  
stitched blockwork  
with mesh and base coat to  
insulated boards

preliminary airtightness testing  
achieved 0.36 AC/hr  
final test result 0.66AC/hr
