MONITORING MOISTURE IN HISTORIC BUILDING: A RETROFIT TO THE AECB SILVER STANDARD

Harry Paticas BA BSc AAdipl

Arboreal Architecture Ltd

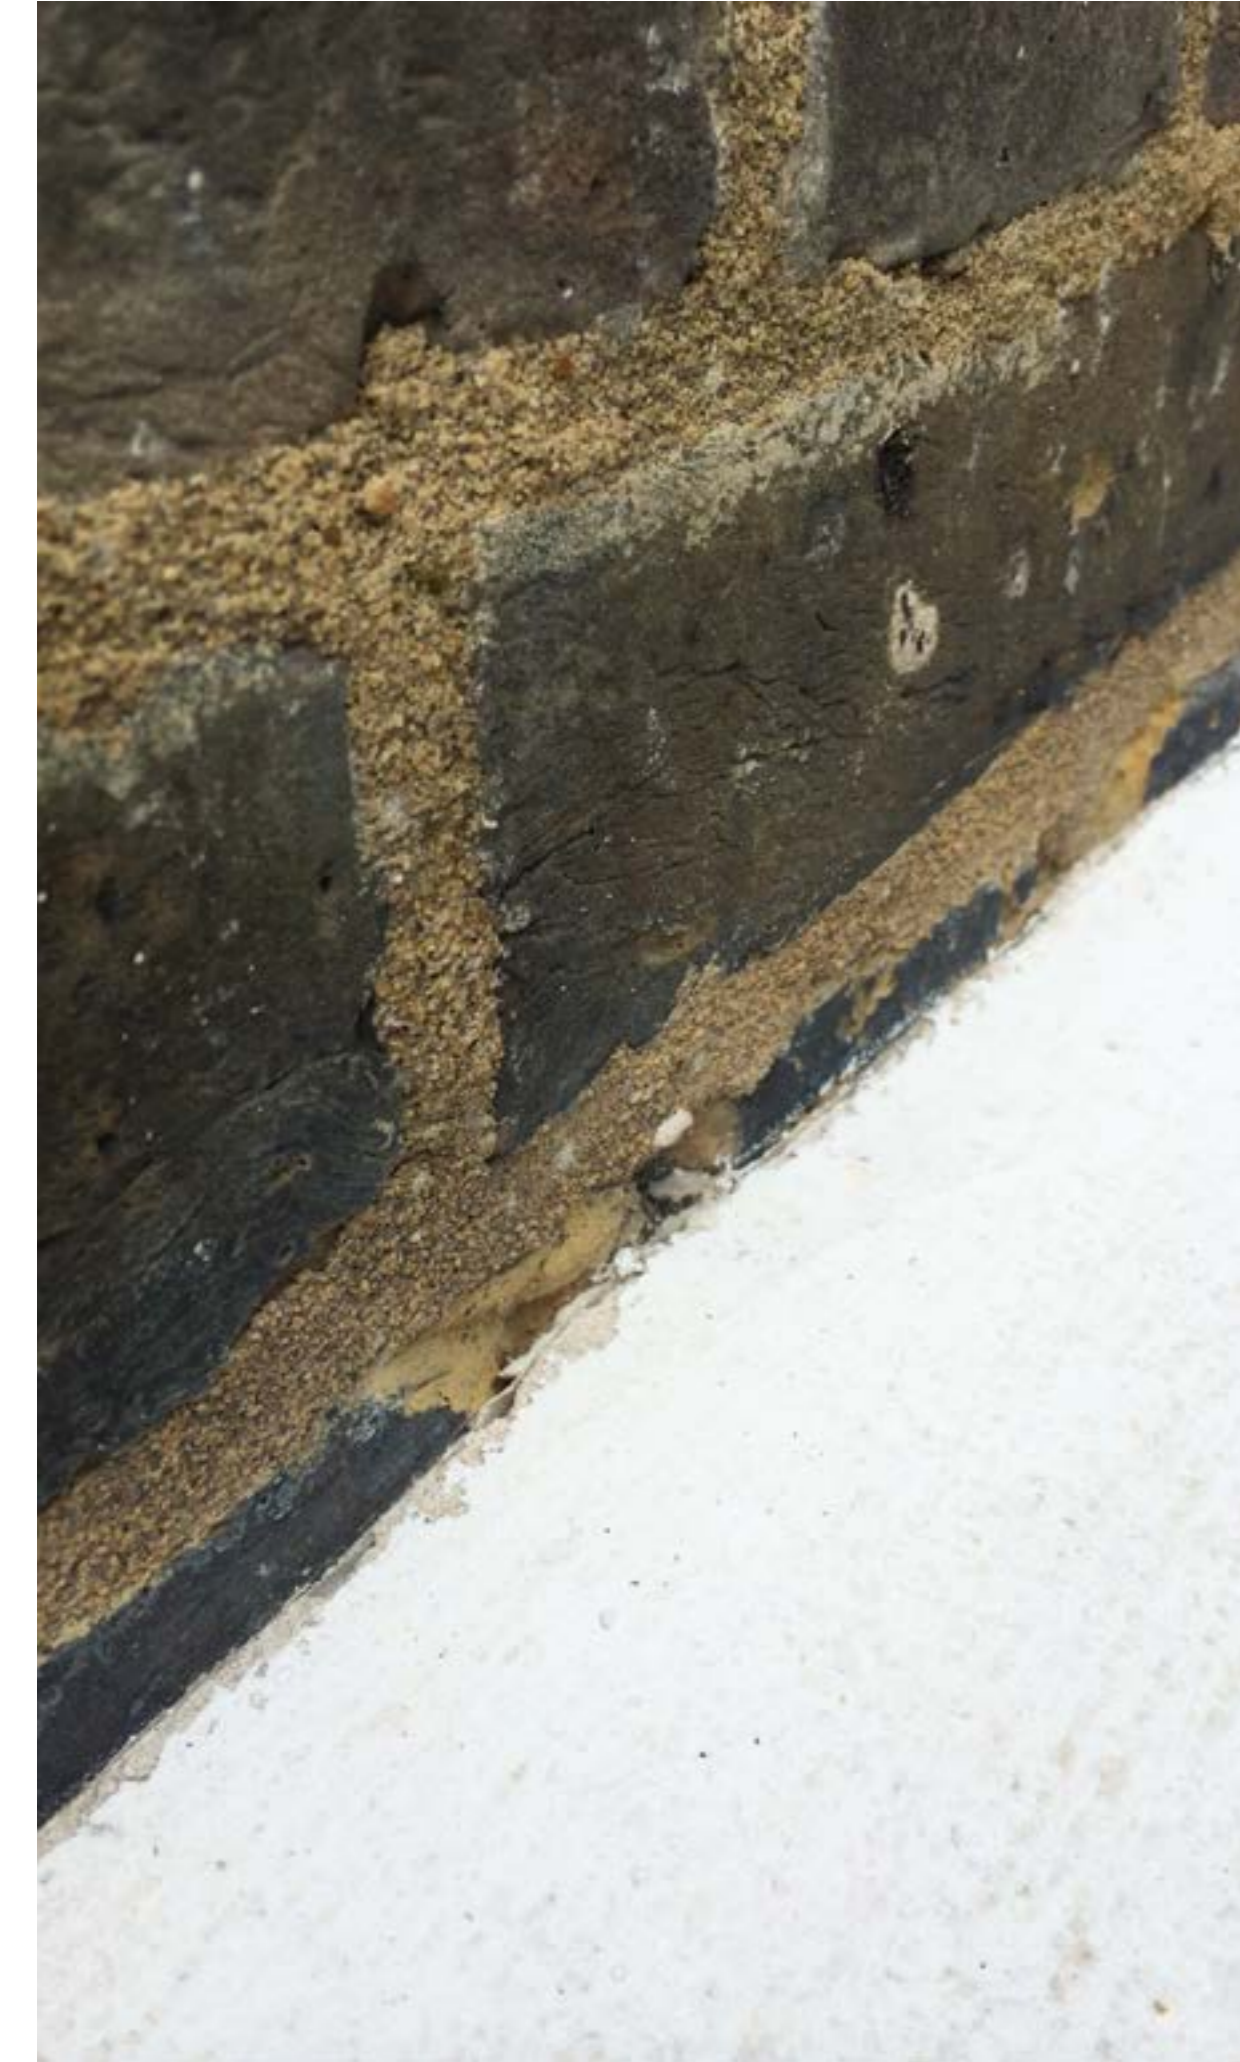
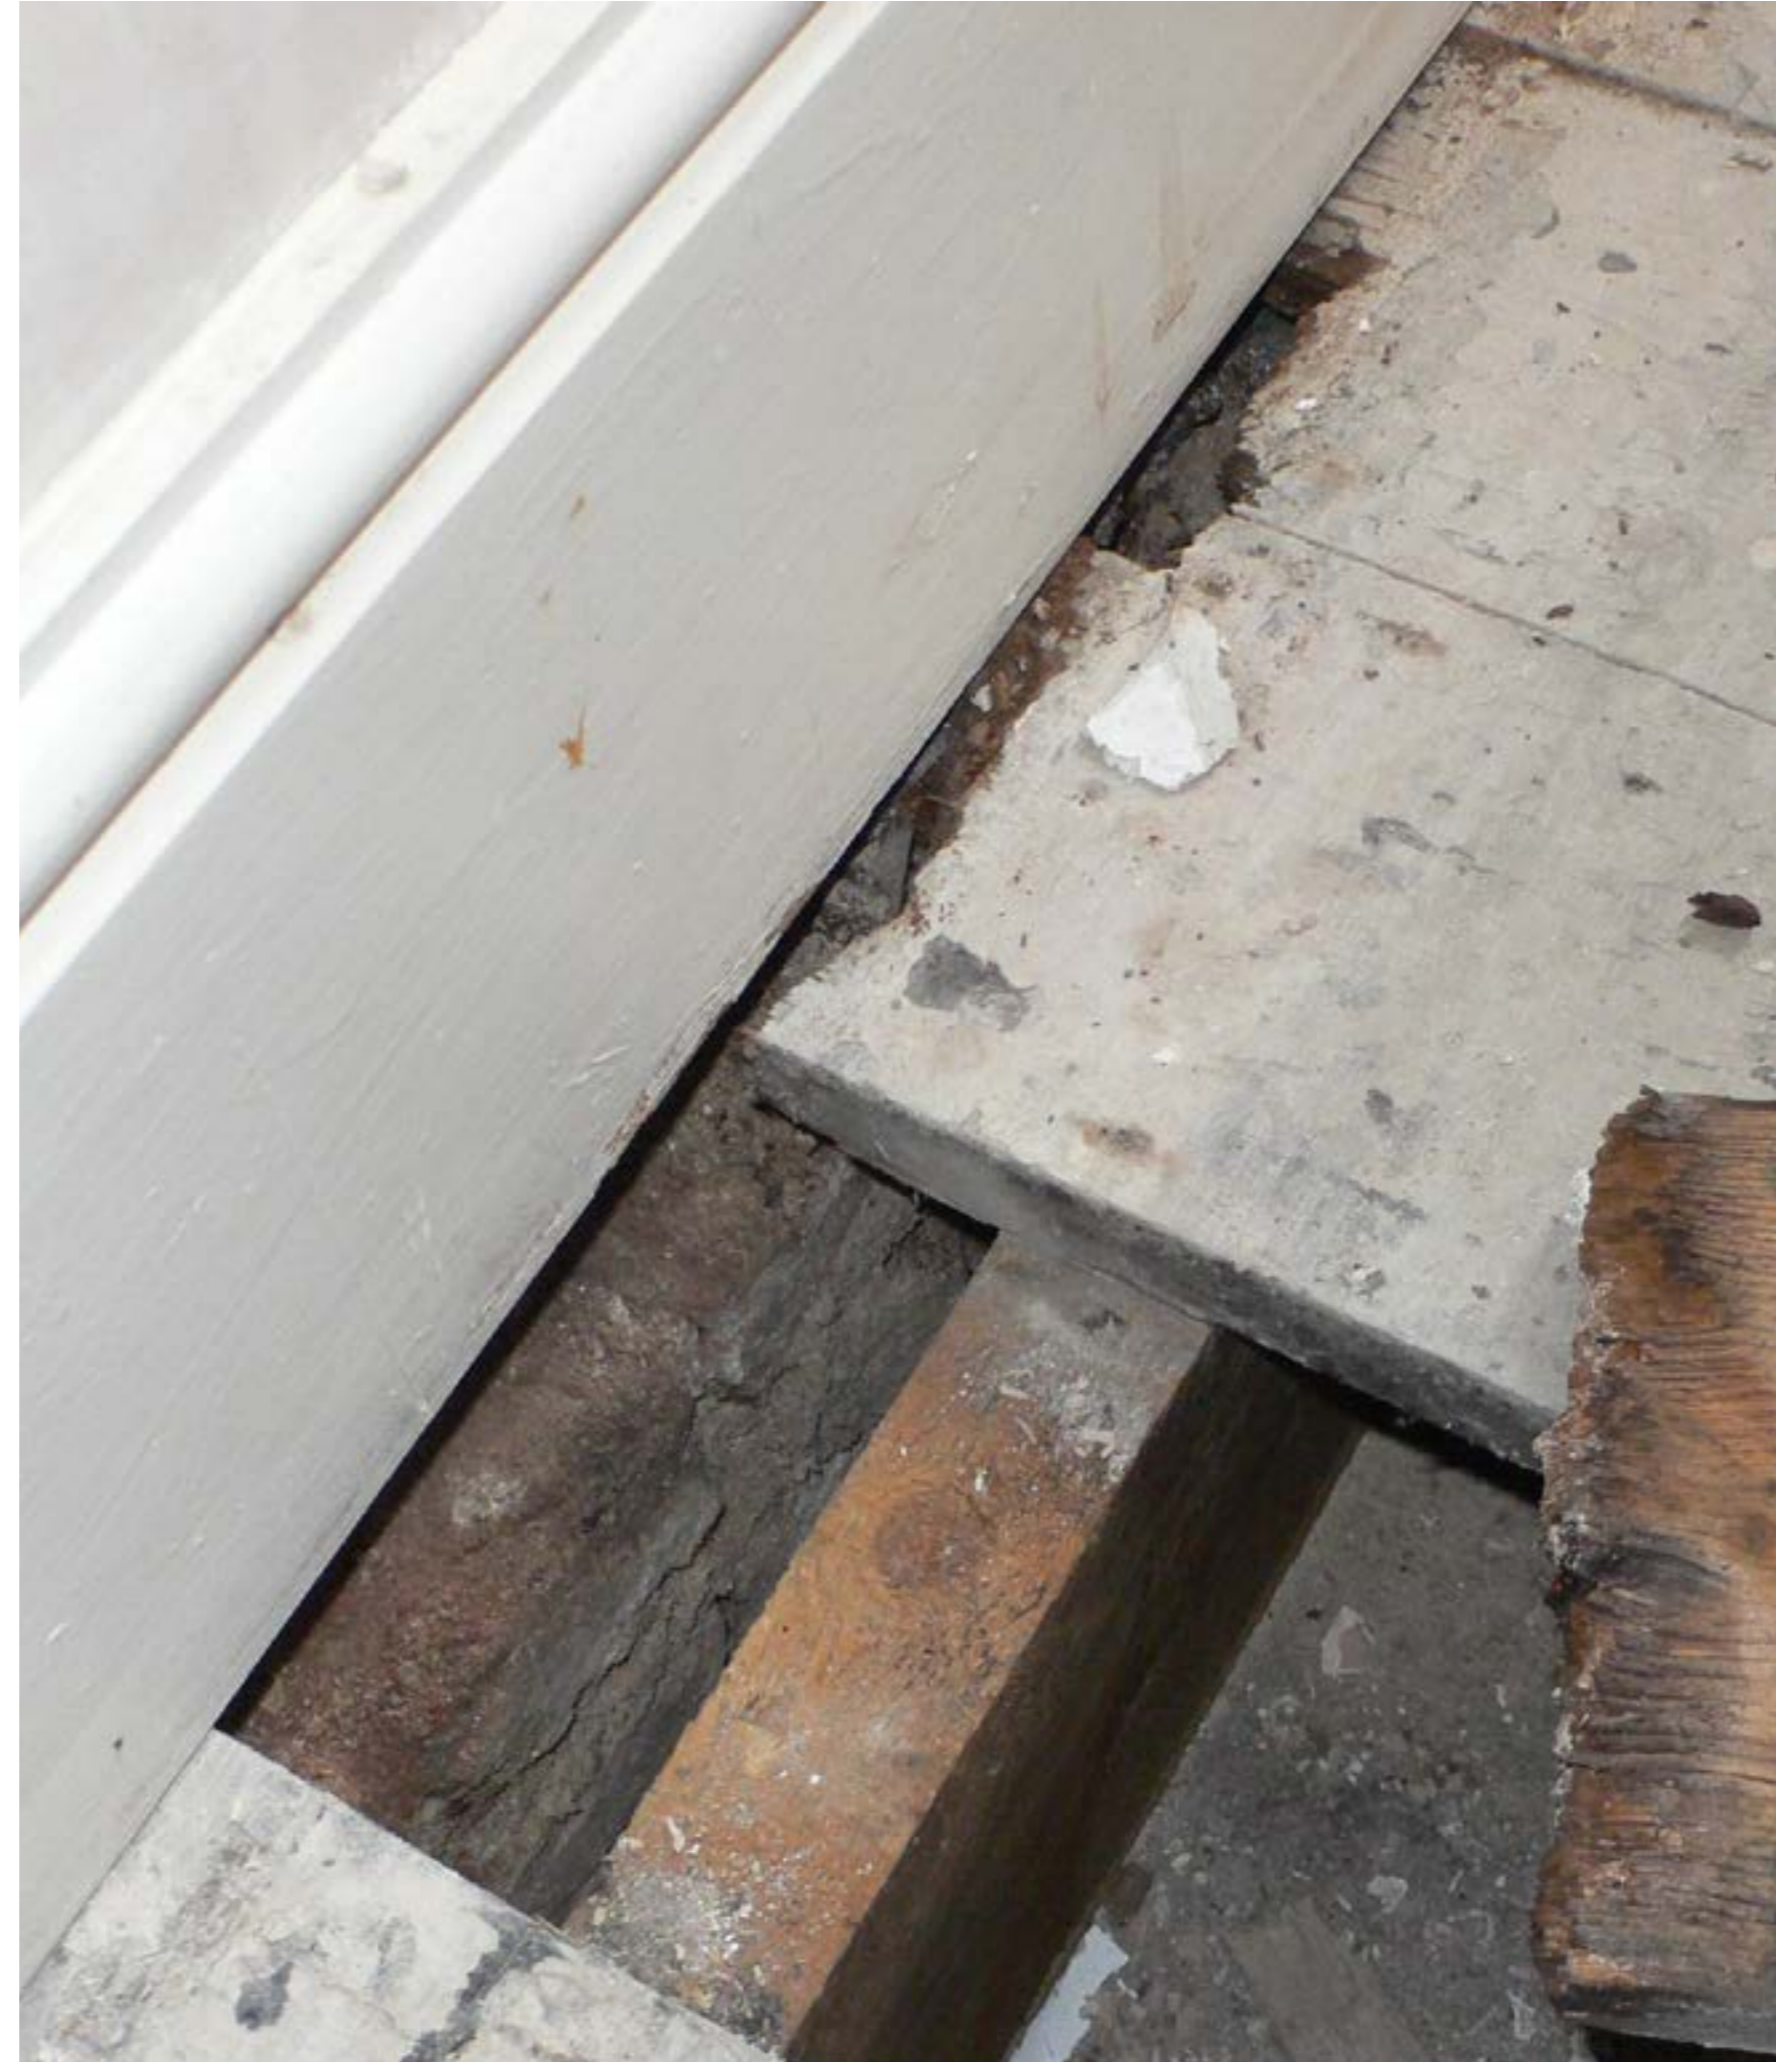
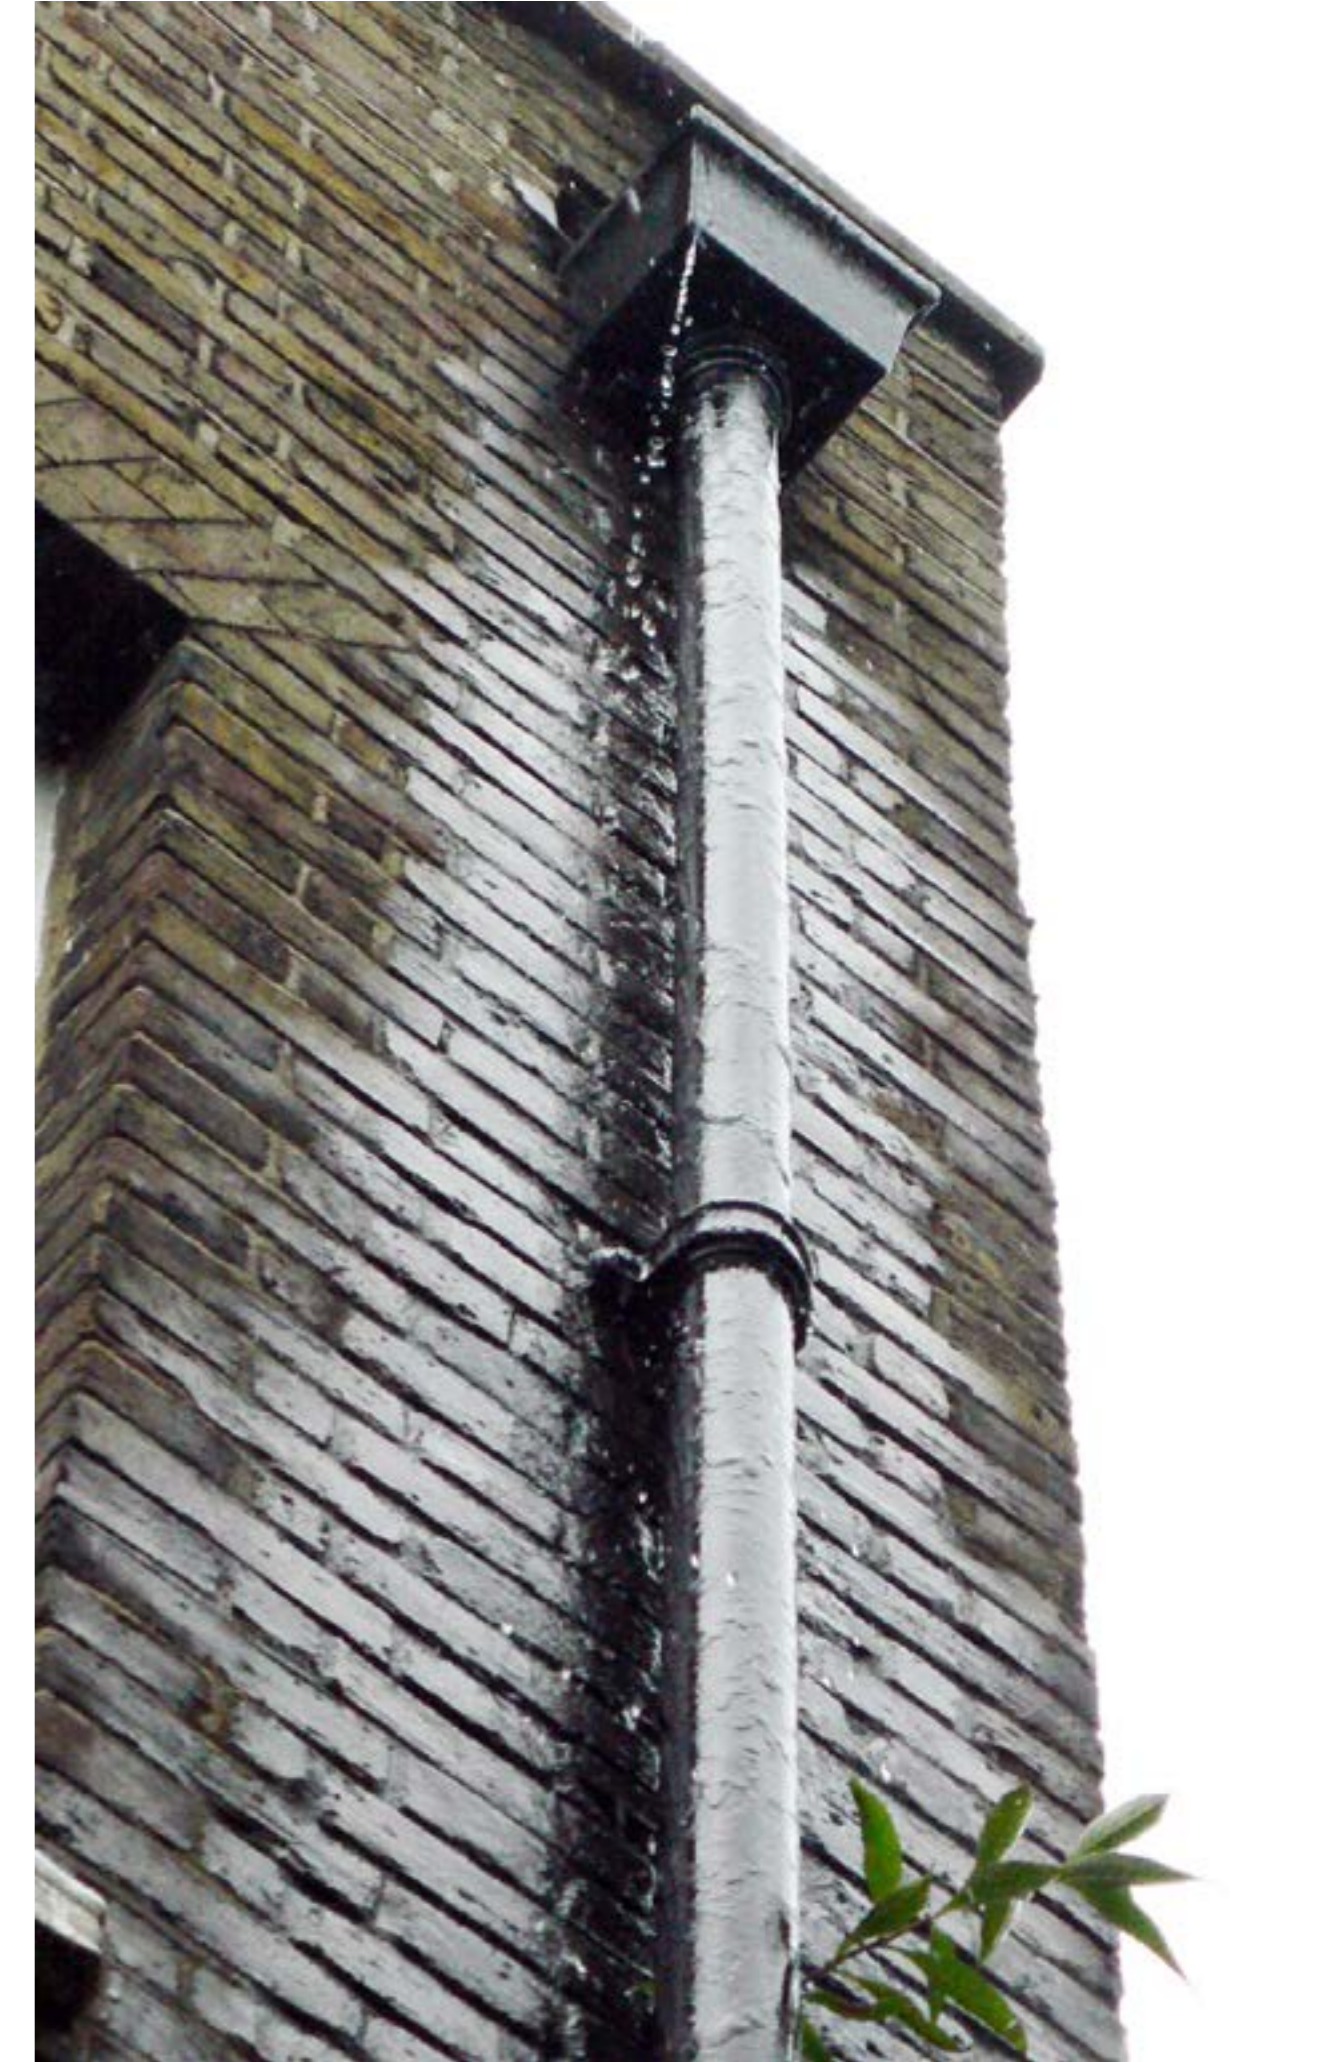
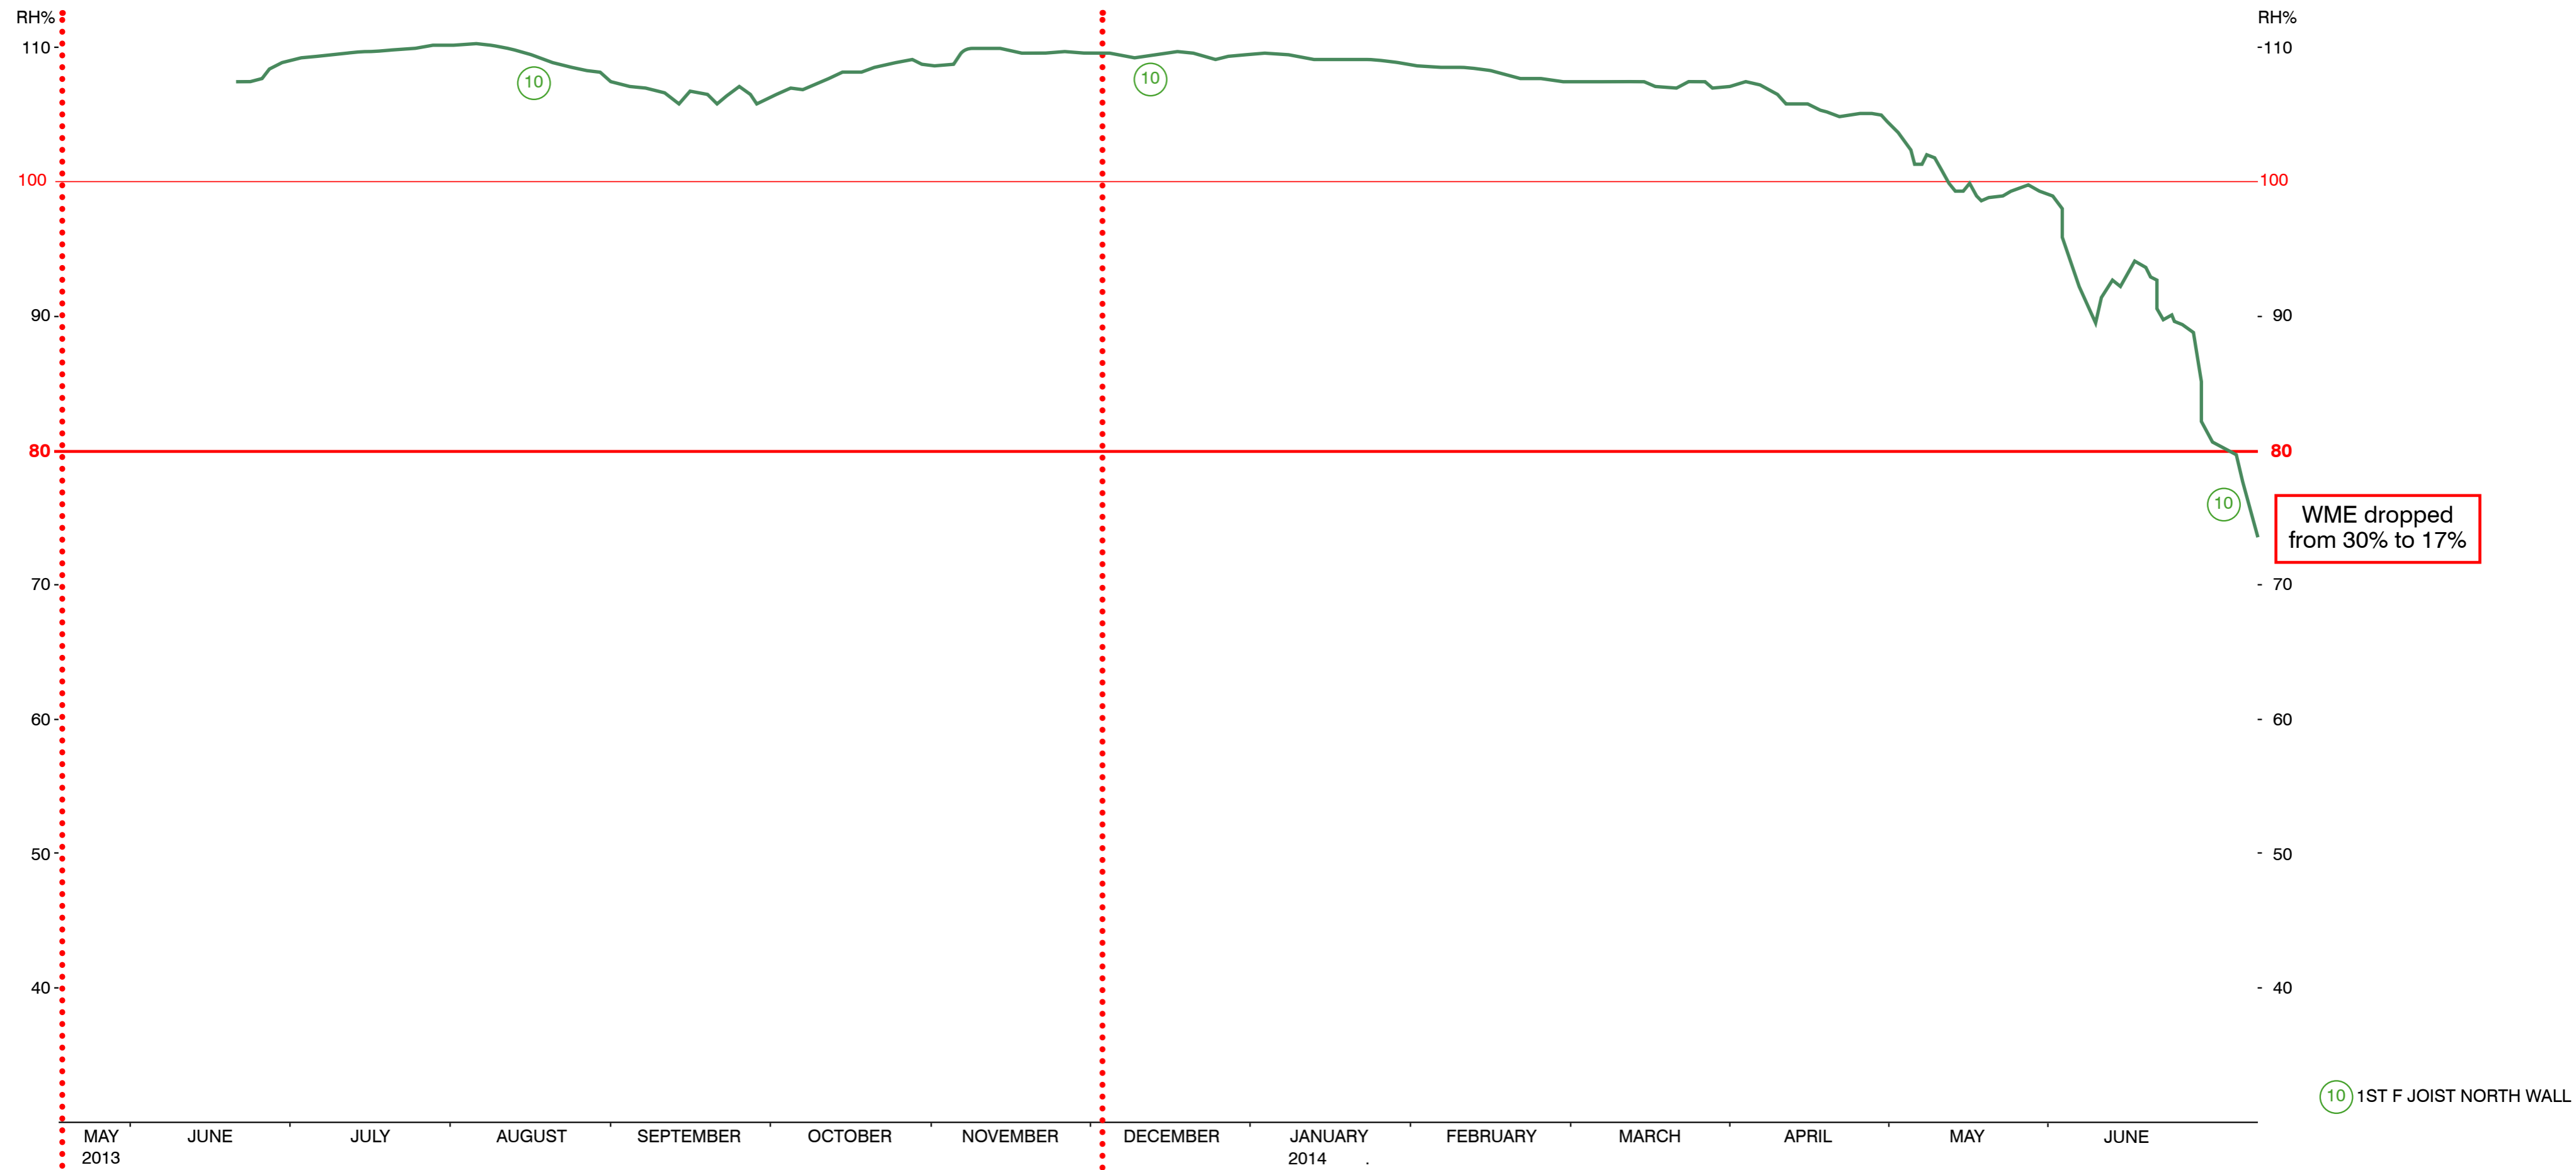
01_THE EXISTING BUILDING_BUILDING DEFECTS

Sensors Installed
22.05.13

Client moved in
14.11.13

WME dropped
from 30% to 17%

10 1ST F JOIST NORTH WALL

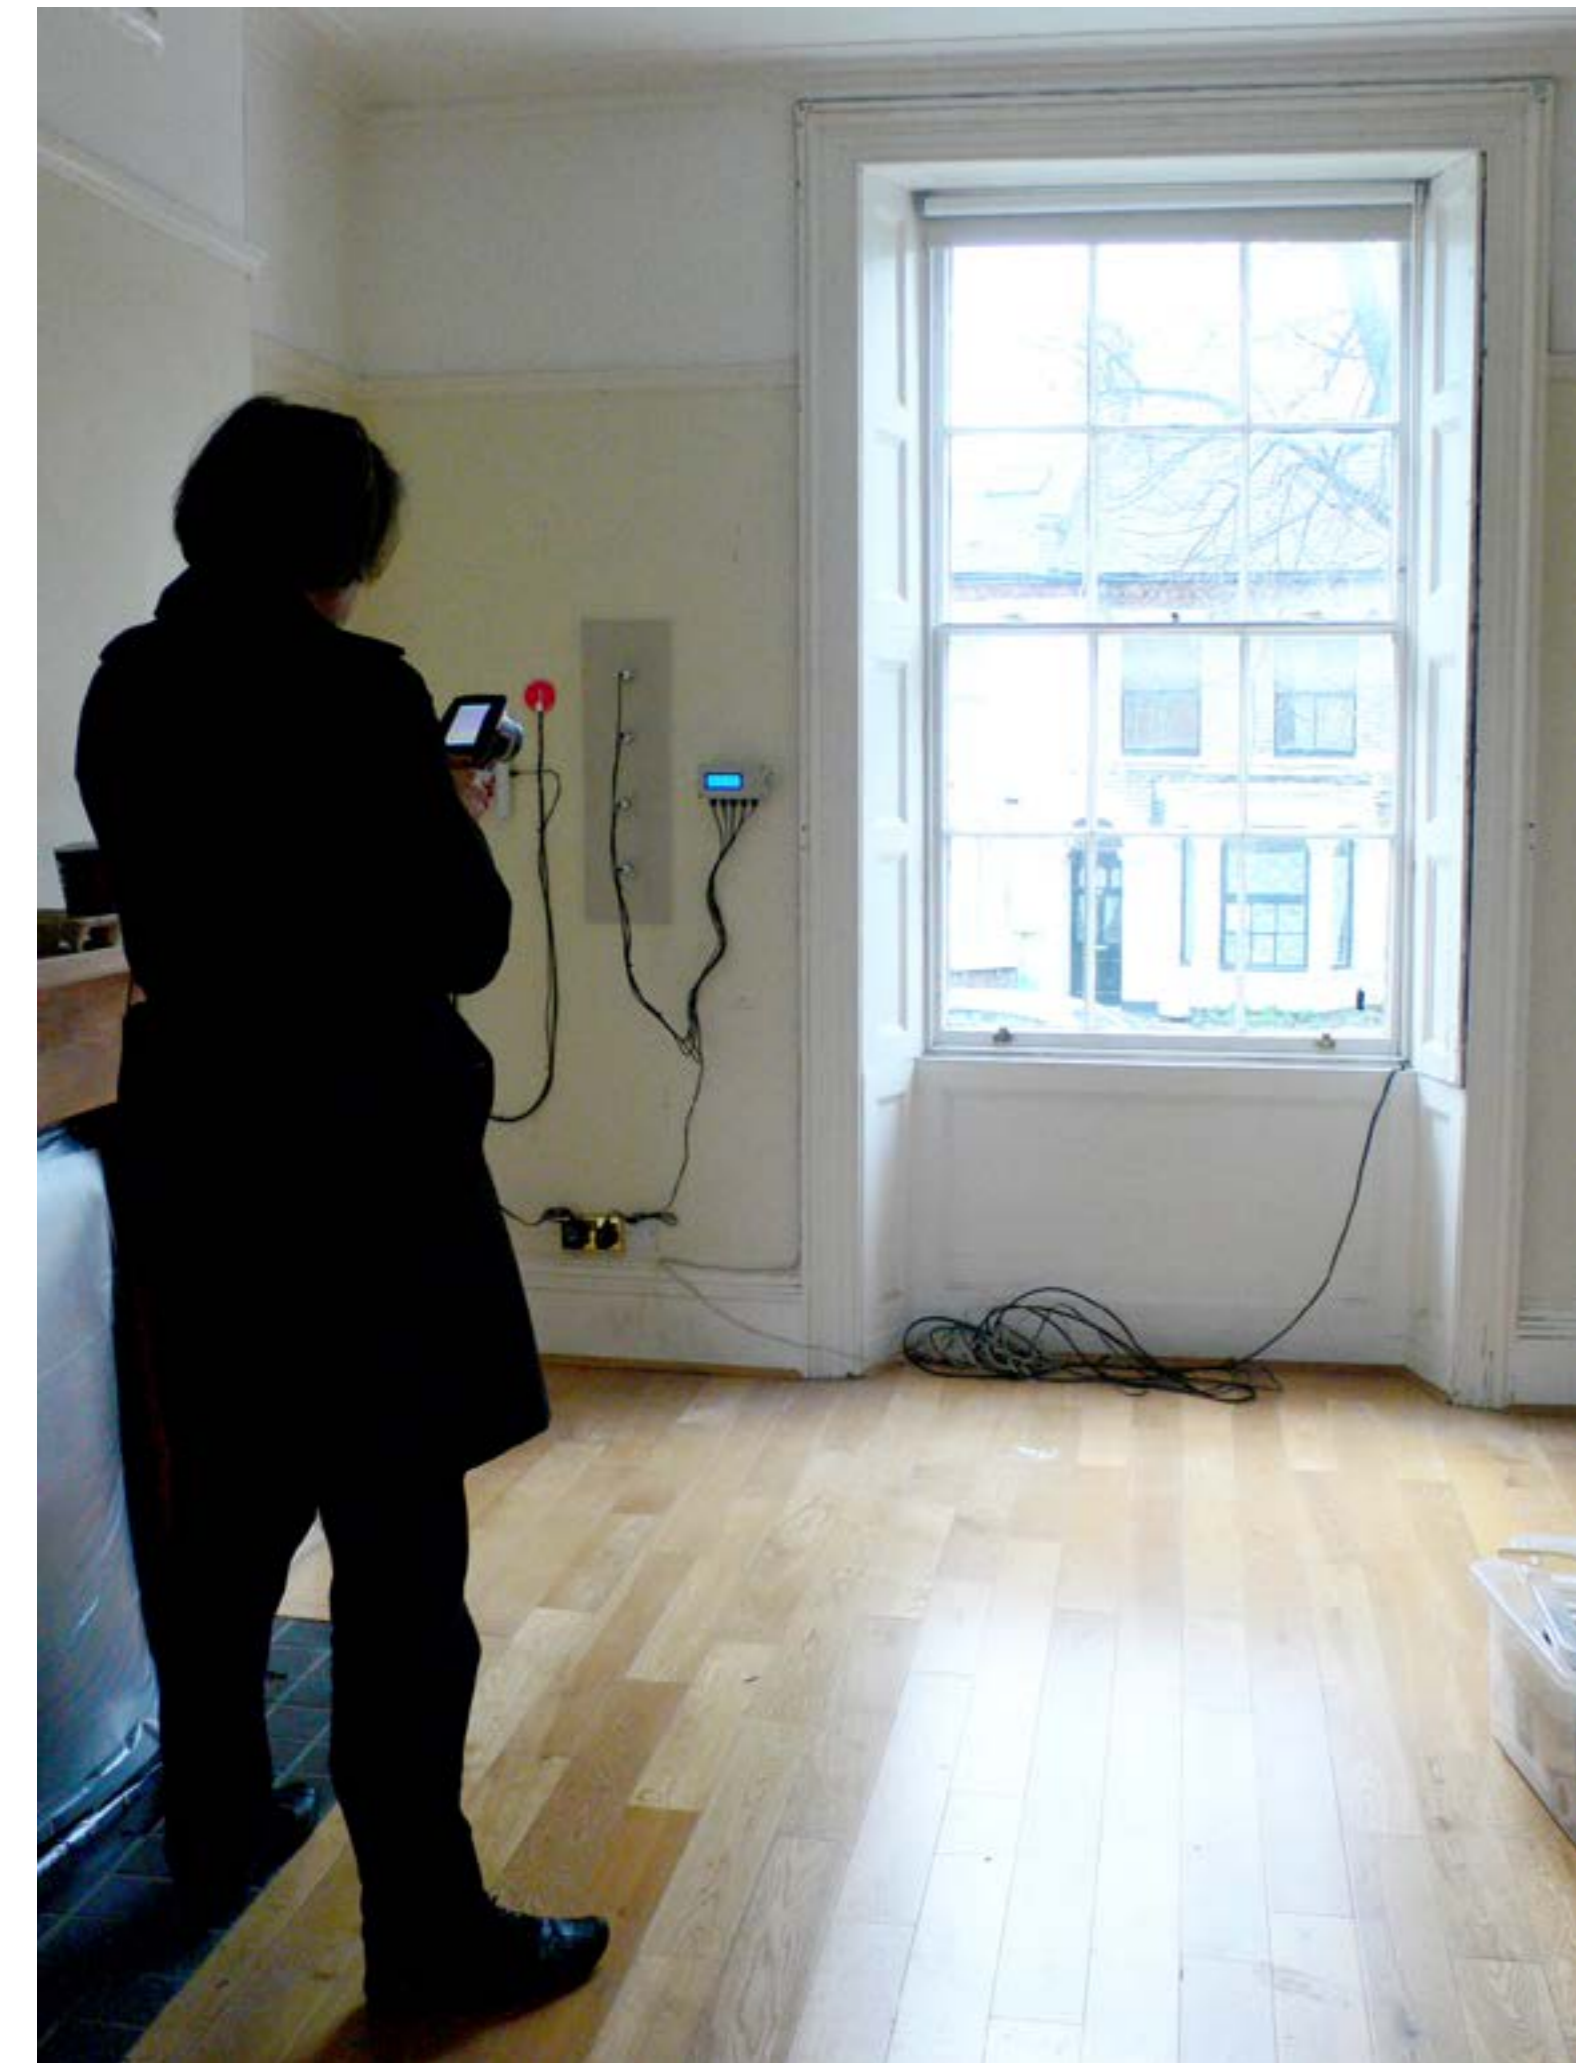
03_PRE-DESIGN INVESTIGATIONS_ARCHIMETRICS

- survey carried out in **February 2012** by Archimetrics
- **u-value monitoring** - based on 2 separate locations the u-value for the brick walls ($0.88 \text{ W/m}^2\text{K}$) was significantly lower than calculated values ($1.14 \text{ W/m}^2\text{K}$).
- **air leakage test** - 9.6 ach (but excluding fixed ventilation points).
- **thermographic survey** - identified weak spots at openings and floor voids.
- **interstitial temperature and moisture gradient monitoring** - identified a reasonable margin of safety between the temperature and dewpoint gradients.

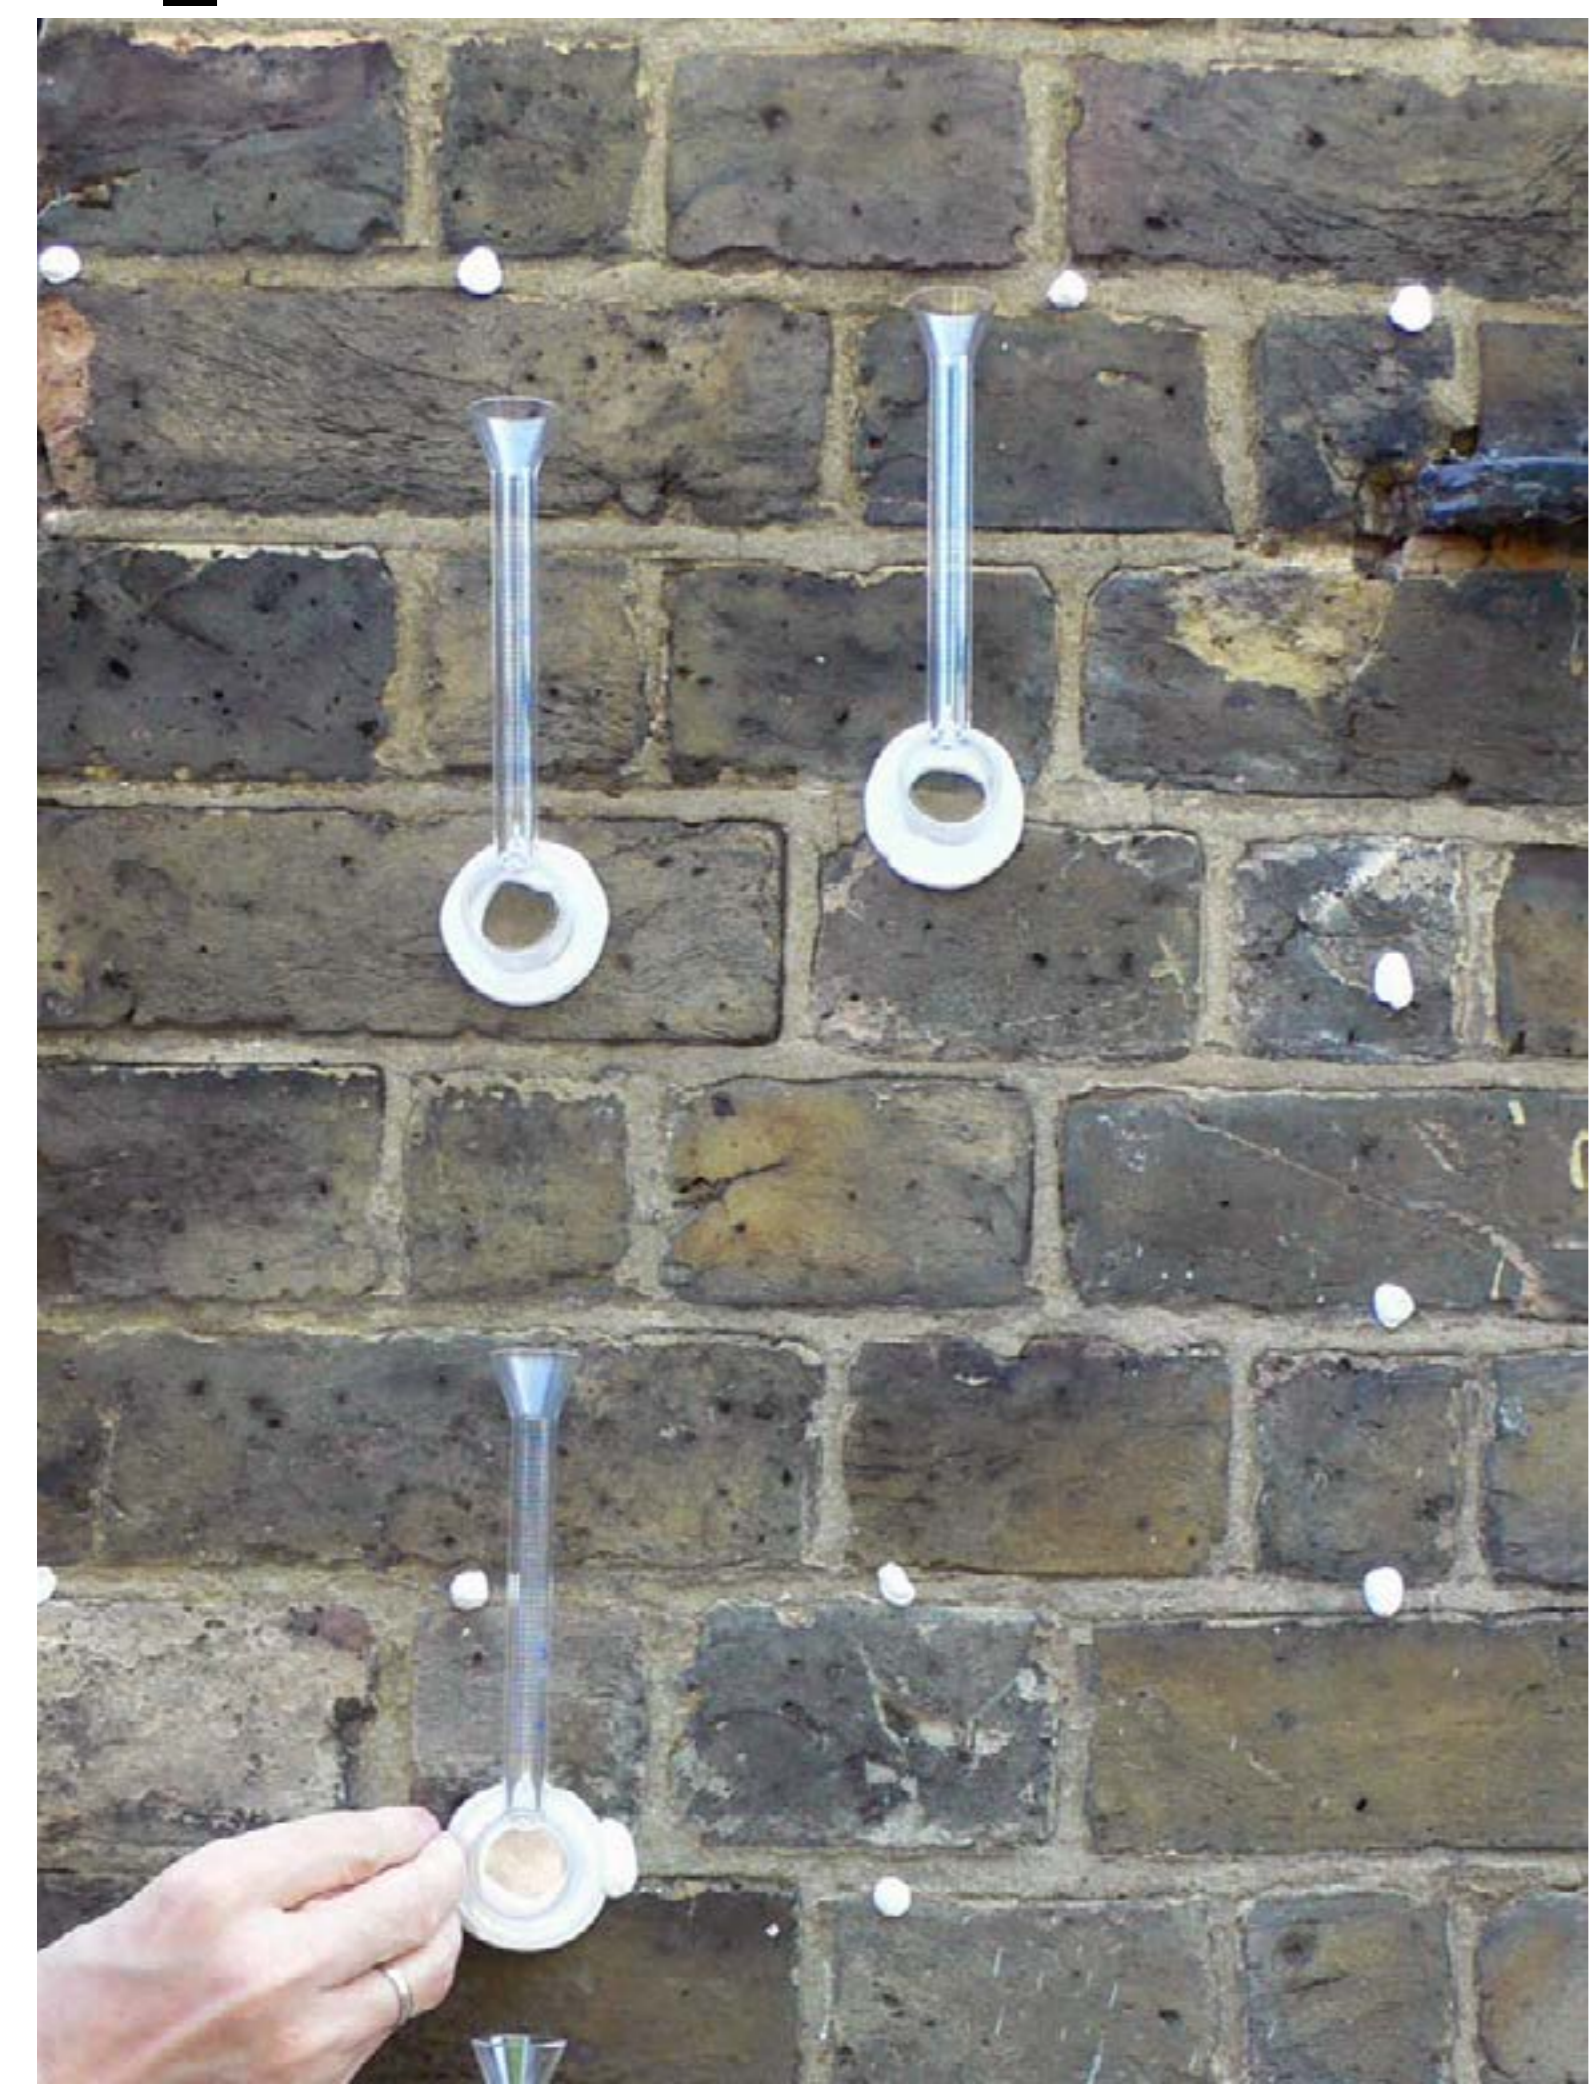
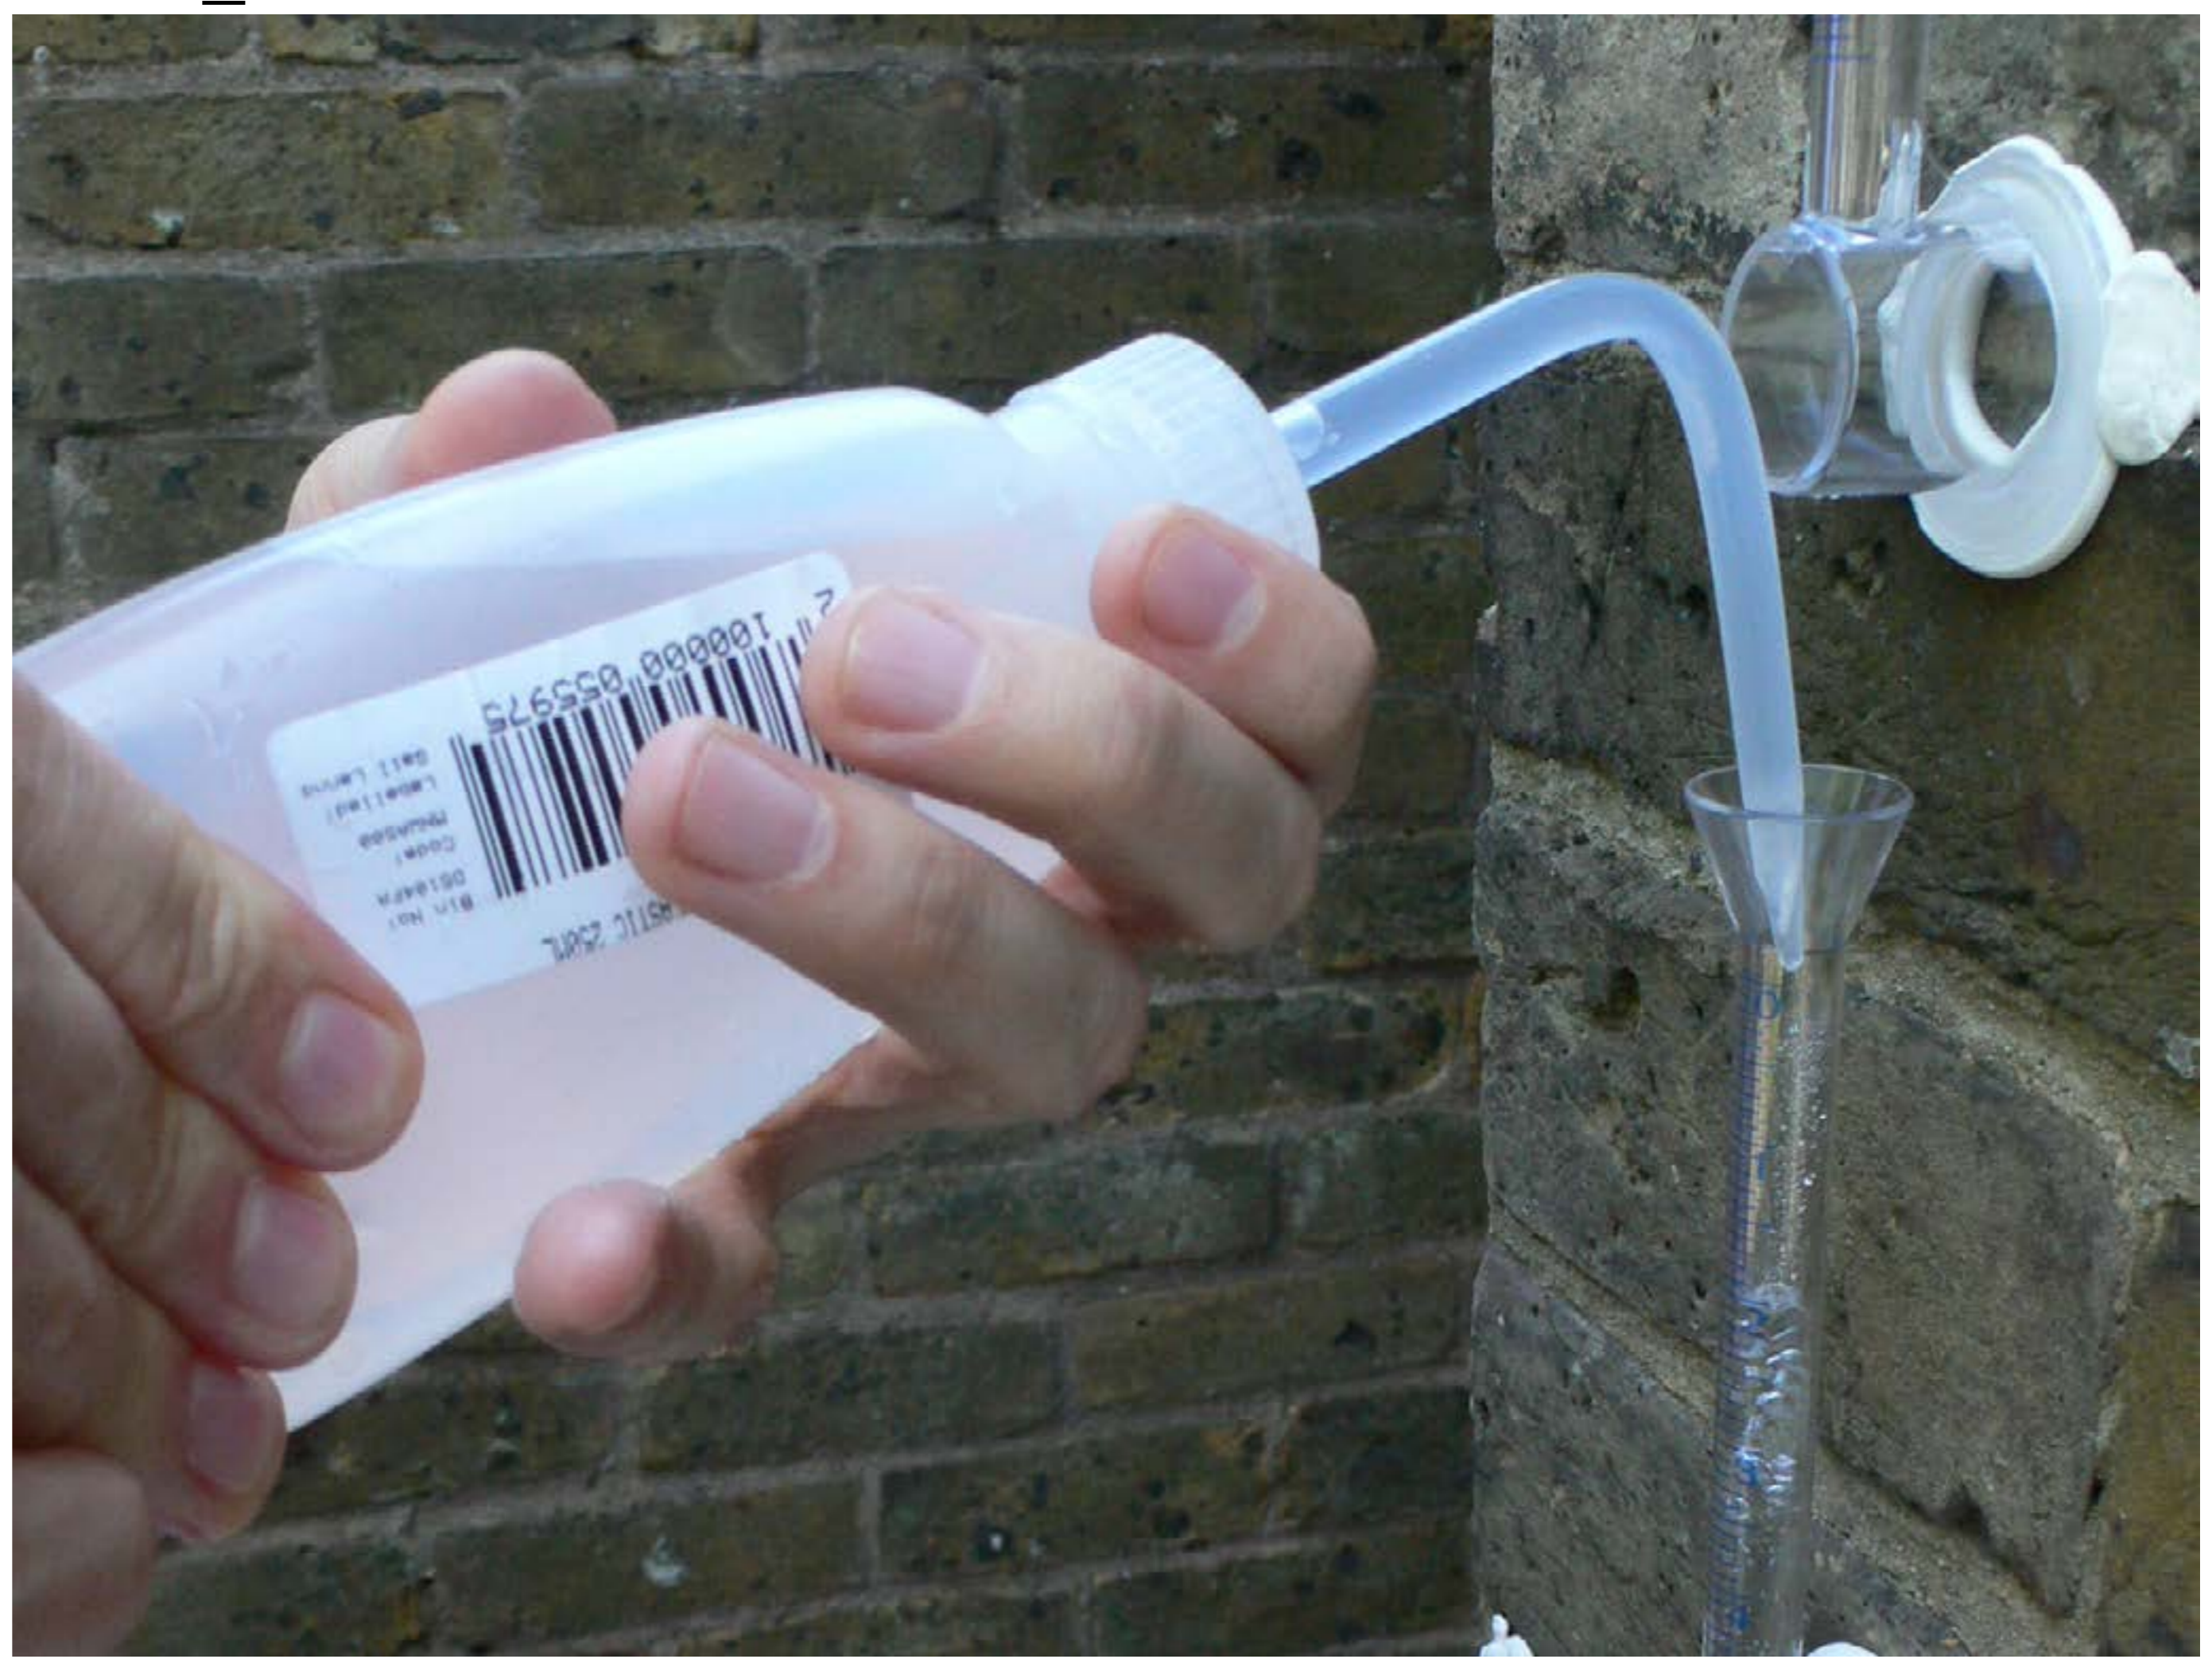
03_PRE-DESIGN INVESTIGATIONS_BRICK PERMEABILITY TESTING

TEST	TYPE	TIME	5MIN	10MIN	15MIN	30MIN	60MIN
T.01	LONDON YELLOW STOCK BRICK	0ML	0ML	0ML	0.01ML	0.025ML	0.05ML
T.02	MORTAR JOINT	0ML	4ML	-	-	-	-
T.03	LONDON YELLOW STOCK BRICK	0ML	0.3ML	0.7ML	1ML	1.8ML	3.5ML
T.04	MORTAR JOINT	0ML	0.7ML	1.3ML	2.8ML	-	-
T.05	LONDON YELLOW STOCK BRICK	0ML	0ML	0ML	0.05ML	0.12ML	0.3ML
T.06	MORTAR JOINT	0ML	4ML	-	-	-	-

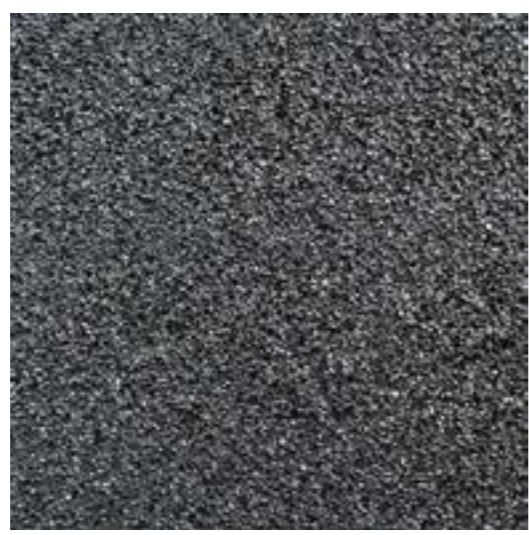
Name: Foamglas Perinsul
Material: high density foamed glass
Location: door and window sills
Thermal conductivity: 0.058 W/m.K
Vapour diff resistance (μ): ∞

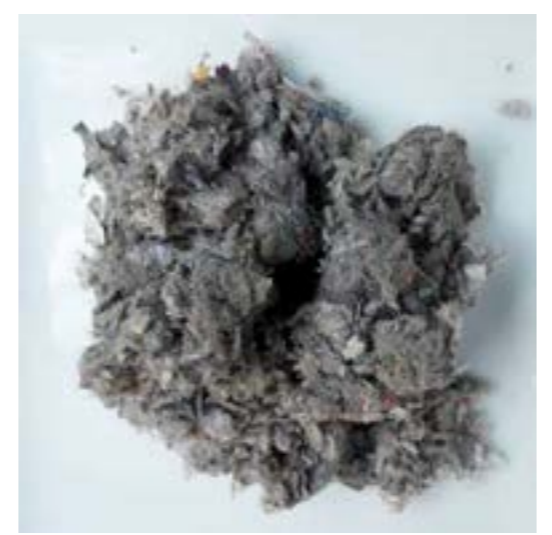
Name: Excel Warmcel 500
Material: blown cellulose
Location: loft floor + shutter boxes
Thermal conductivity: 0.04 W/m.K
Vapour diff resistance (μ): 2
