MONITORING MOISTURE IN HISTORIC BUILDING: A RETROFIT TO THE AECB SILVER STANDARD

Harry Paticas BA BSc AAdipl

Arboreal Architecture Ltd

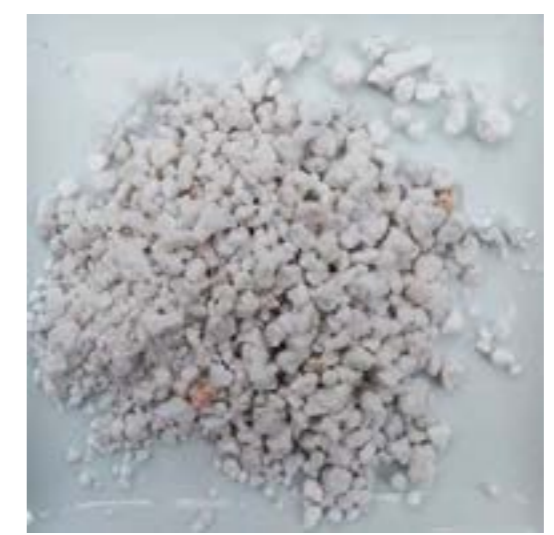
Name: Technopor
Material: foamed glass granulate
Location: external perimeter
Thermal conductivity: 0.08 W/m.K
Vapour diff resistance (μ): low

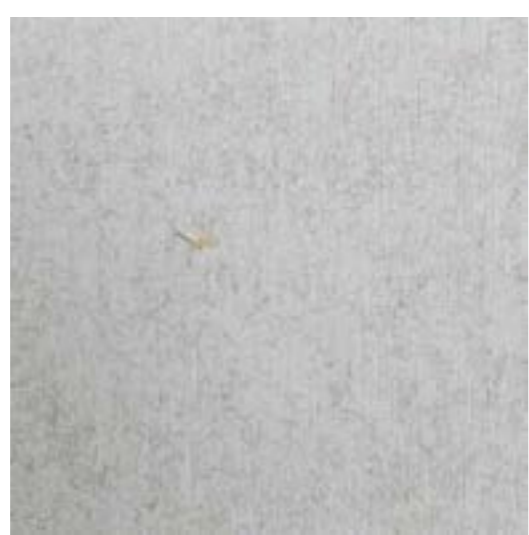
Name: Calsitherm
Material: calcium silicate board
Location: between joists
Thermal conductivity: 0.06 W/m.K
Vapour diff resistance (μ): 6

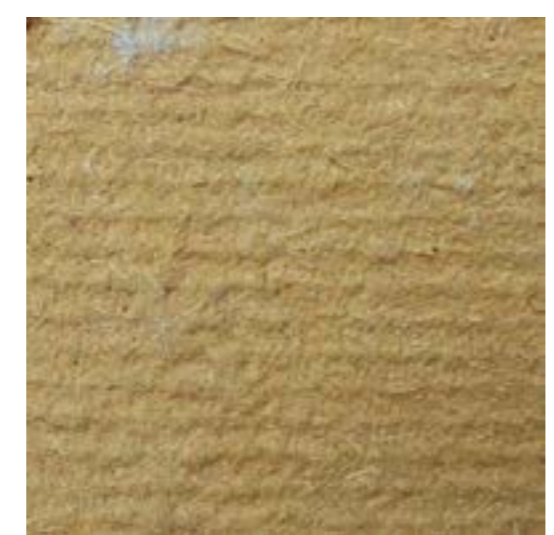
Name: Gutex Thermoroom
Material: woodfibre
Location: internal wall insulation
Thermal conductivity: 0.04 W/m.K
Vapour diff resistance (μ): 3

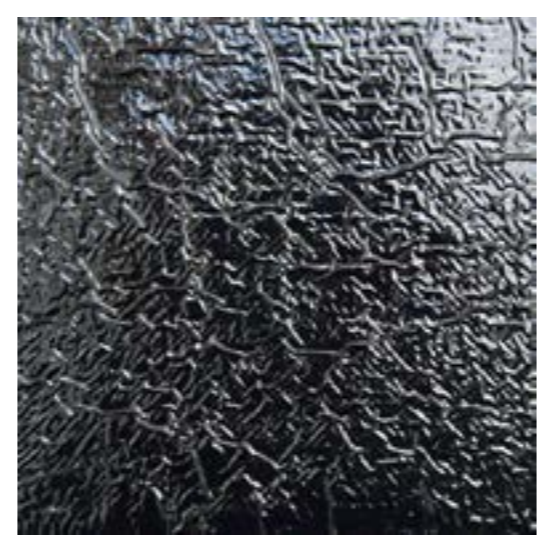
Name: Kevothermal VIP
Material: vacuum insulated panel
Location: ground floor below screed
Thermal conductivity: 0.007 W/m.K
Vapour diff resistance (μ): ∞

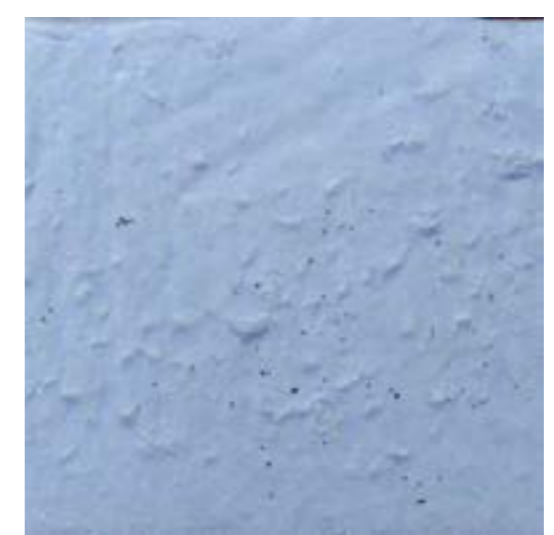
Name: Kingspan Styrozone N300R
Material: extruded polystyrene
Location: below ground external
Thermal conductivity: 0.038 W/m.K
Vapour diff resistance (μ): high

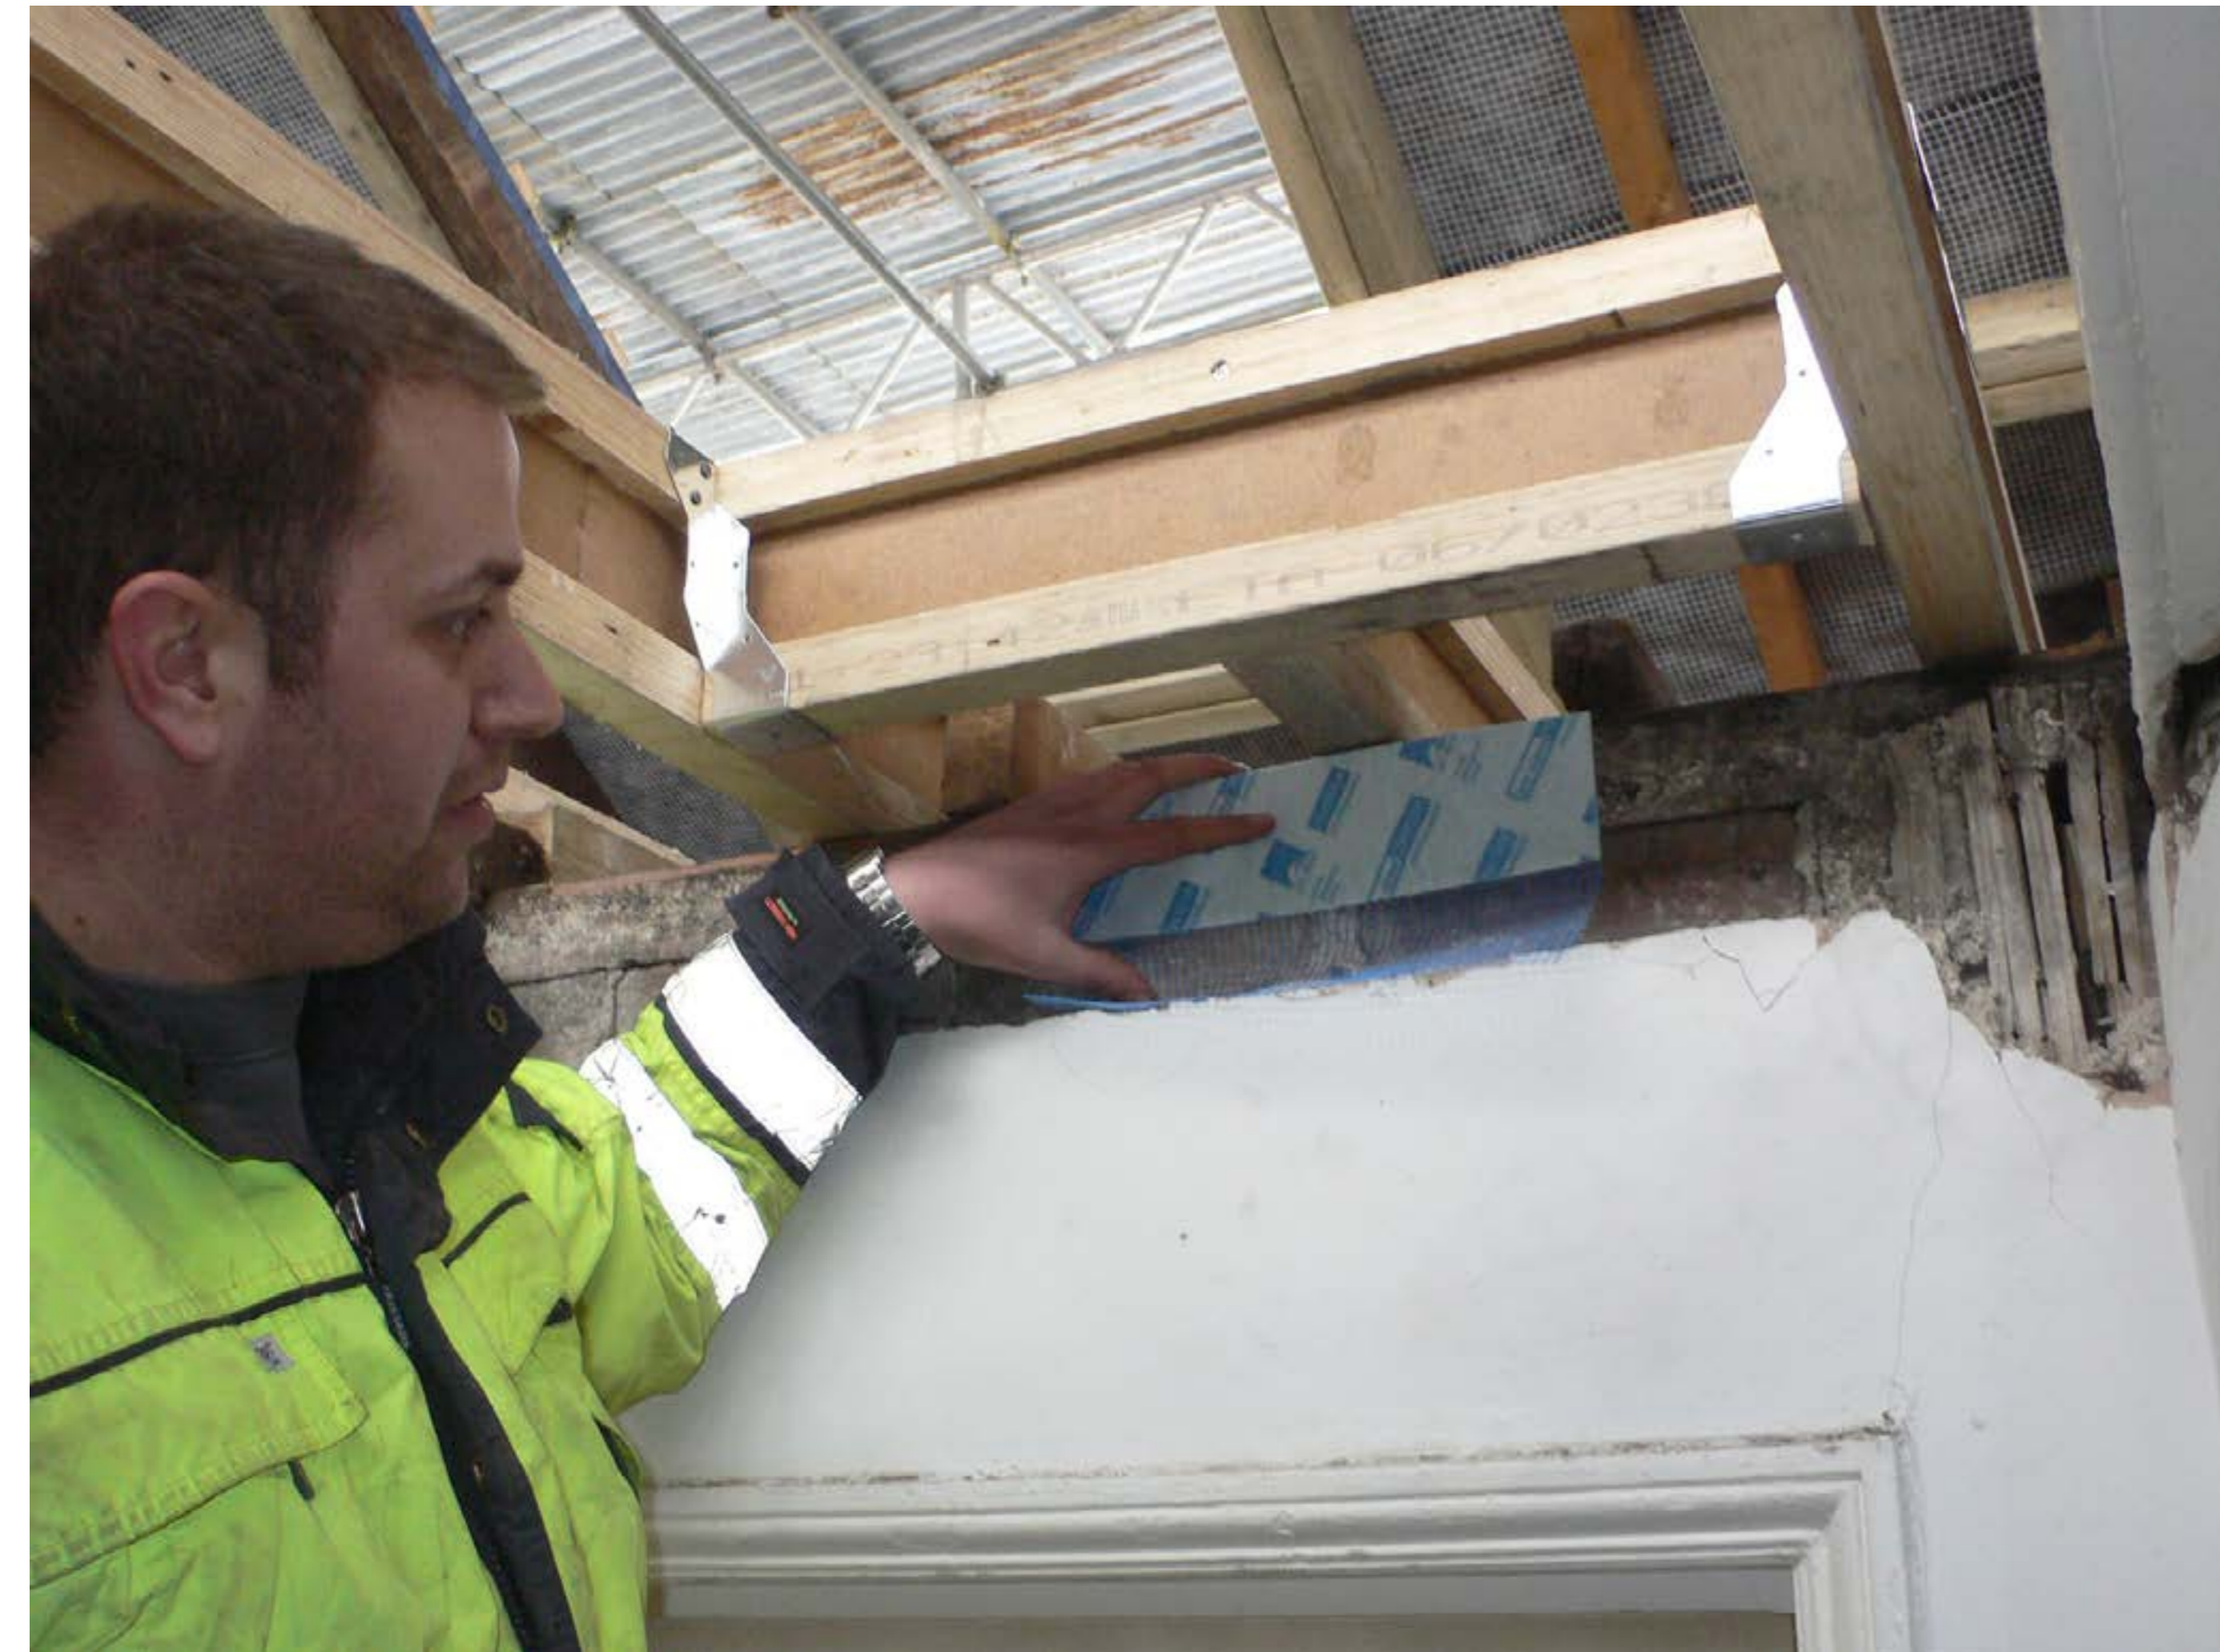
05_OVERVIEW OF PROPOSAL_VENTILATION AND AIRTIGHTNESS

- continuous air barrier formed by lime plaster on all internal masonry walls.
- taped intello plus membrane dressed into all walls with plaster sealing tape.
- joist ends and door/window frames sealed with tapes.
- services penetrations with grommets.
- continuous mechanical extract ventilation system (MEV) installed extracting air from each wet room total 0.4ach.
- air intake through natural leakiness of building.
- warm internal air thus pulled away from building fabric reducing risk of interstitial condensation.

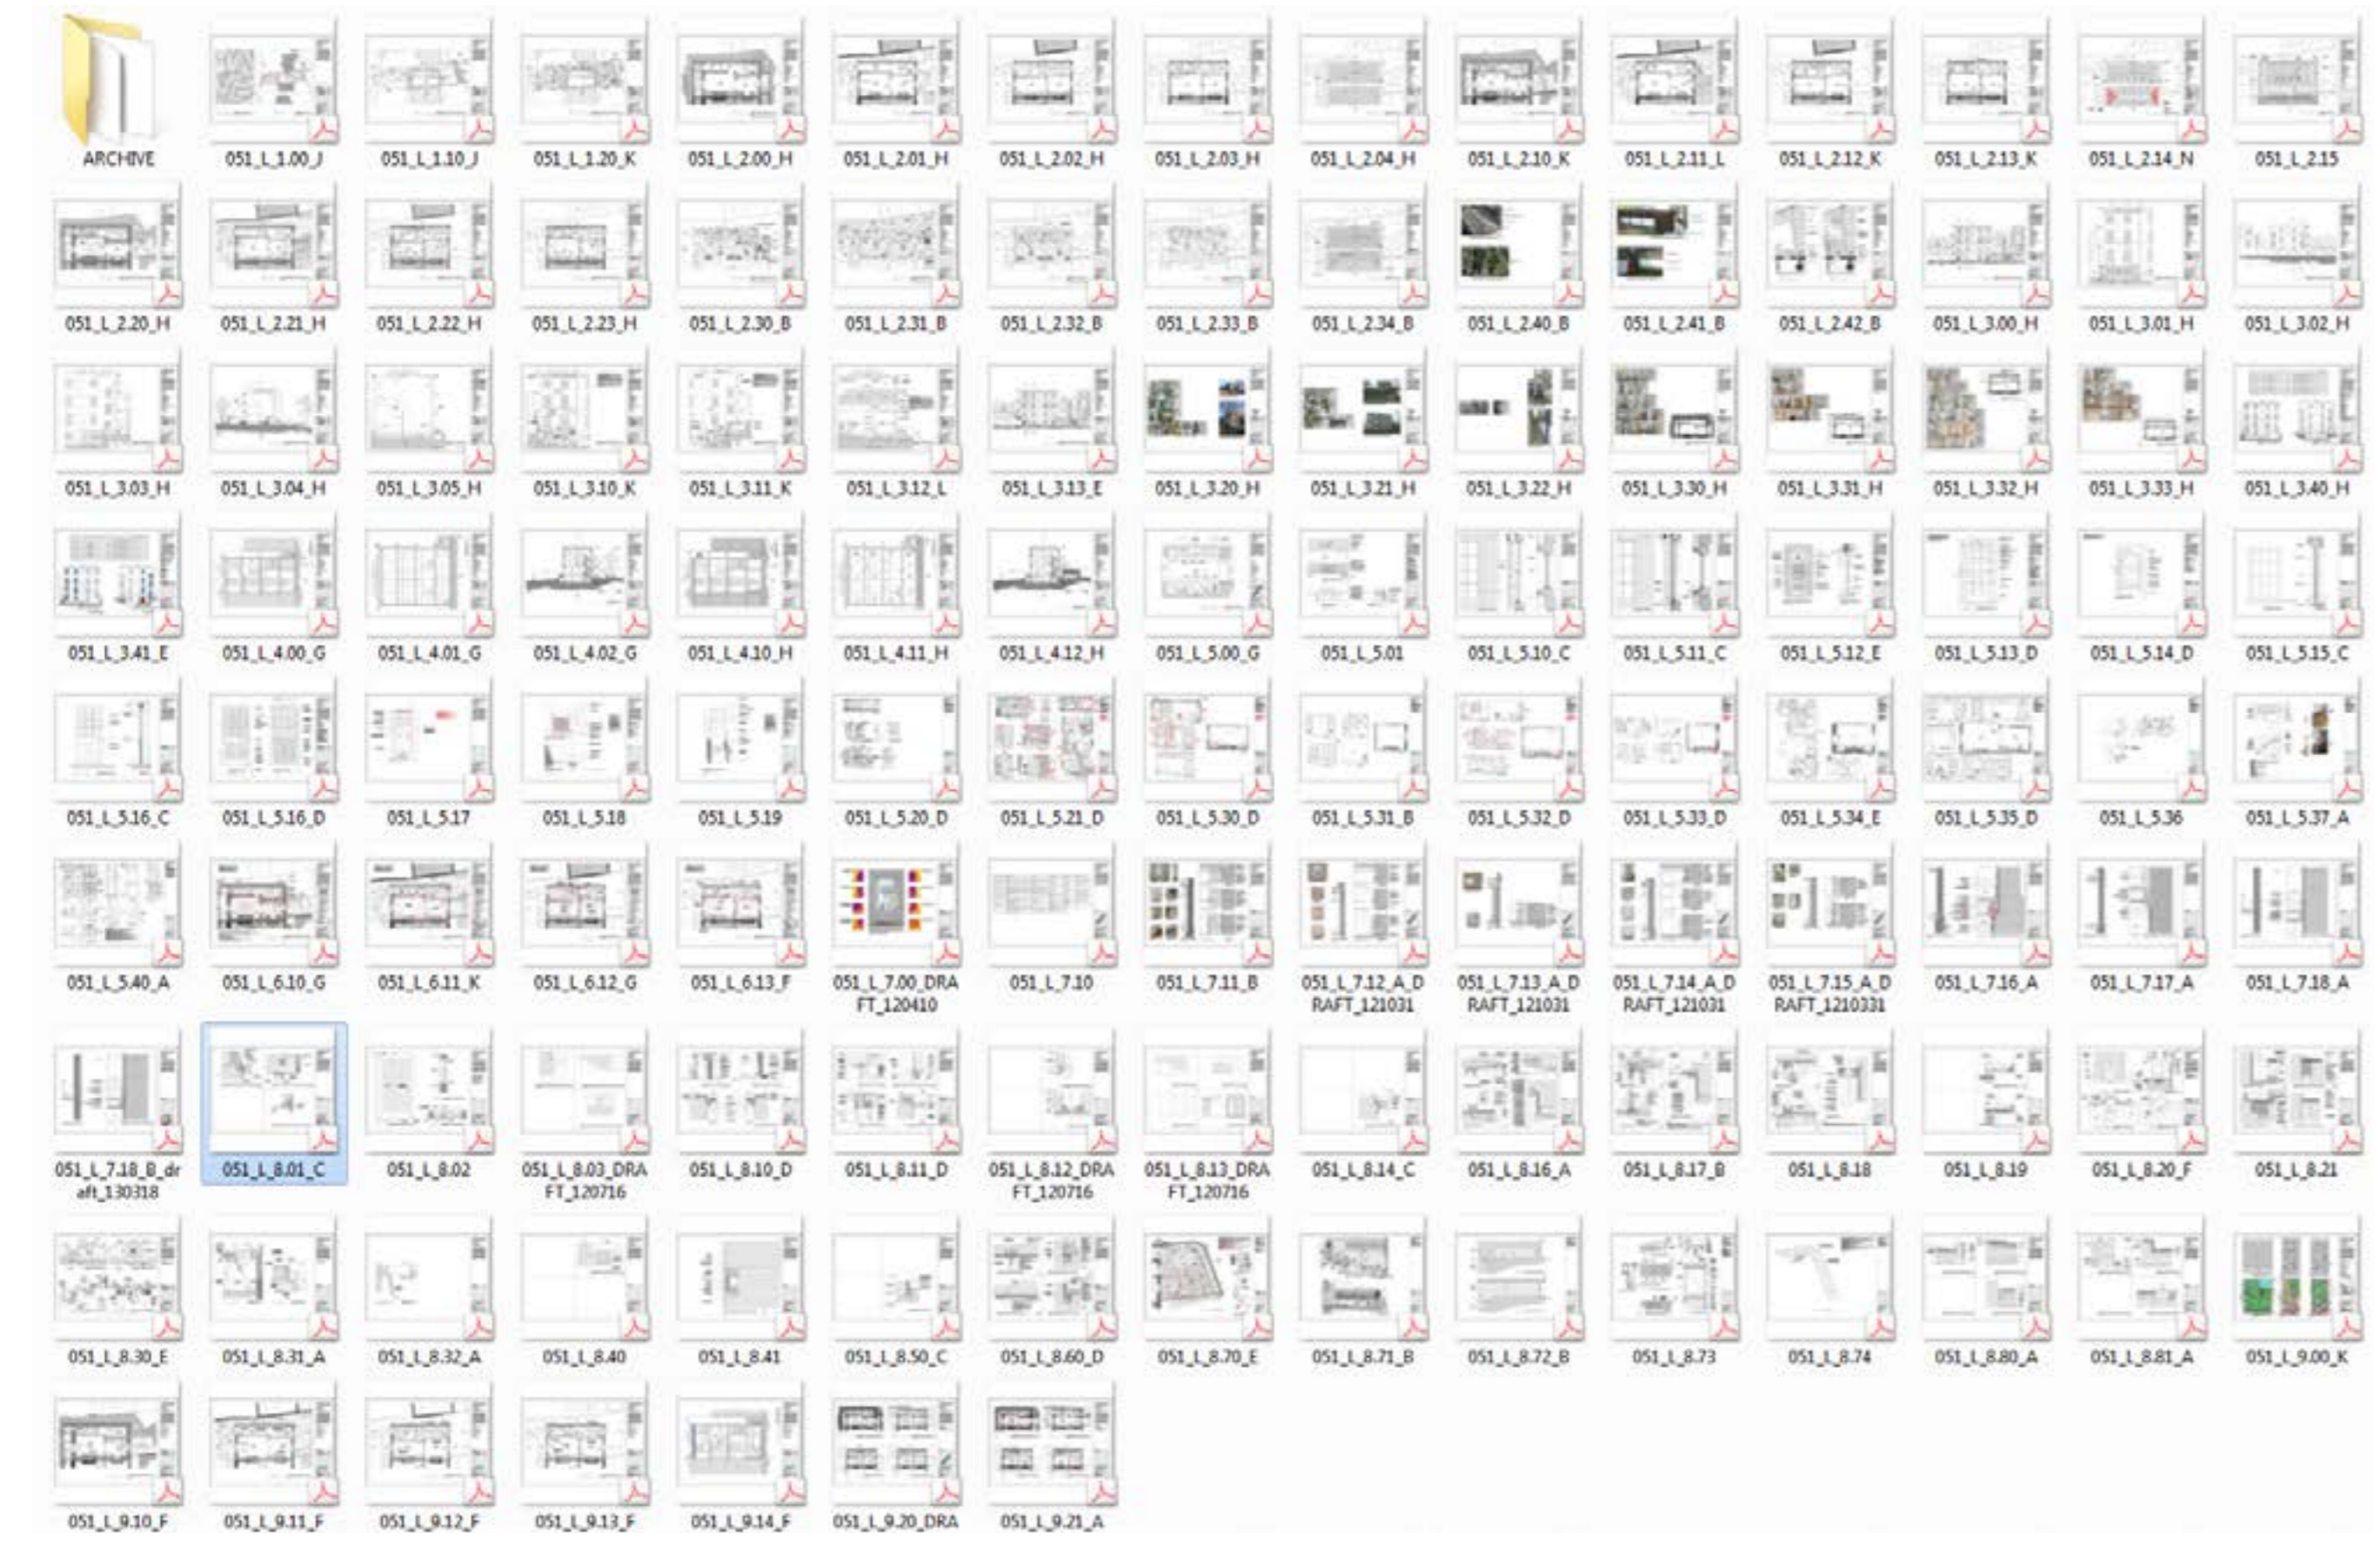
05_OVERVIEW OF PROPOSAL_PROJECT DRAWINGS

CONSTRUCTION: SECONDARY GLAZING

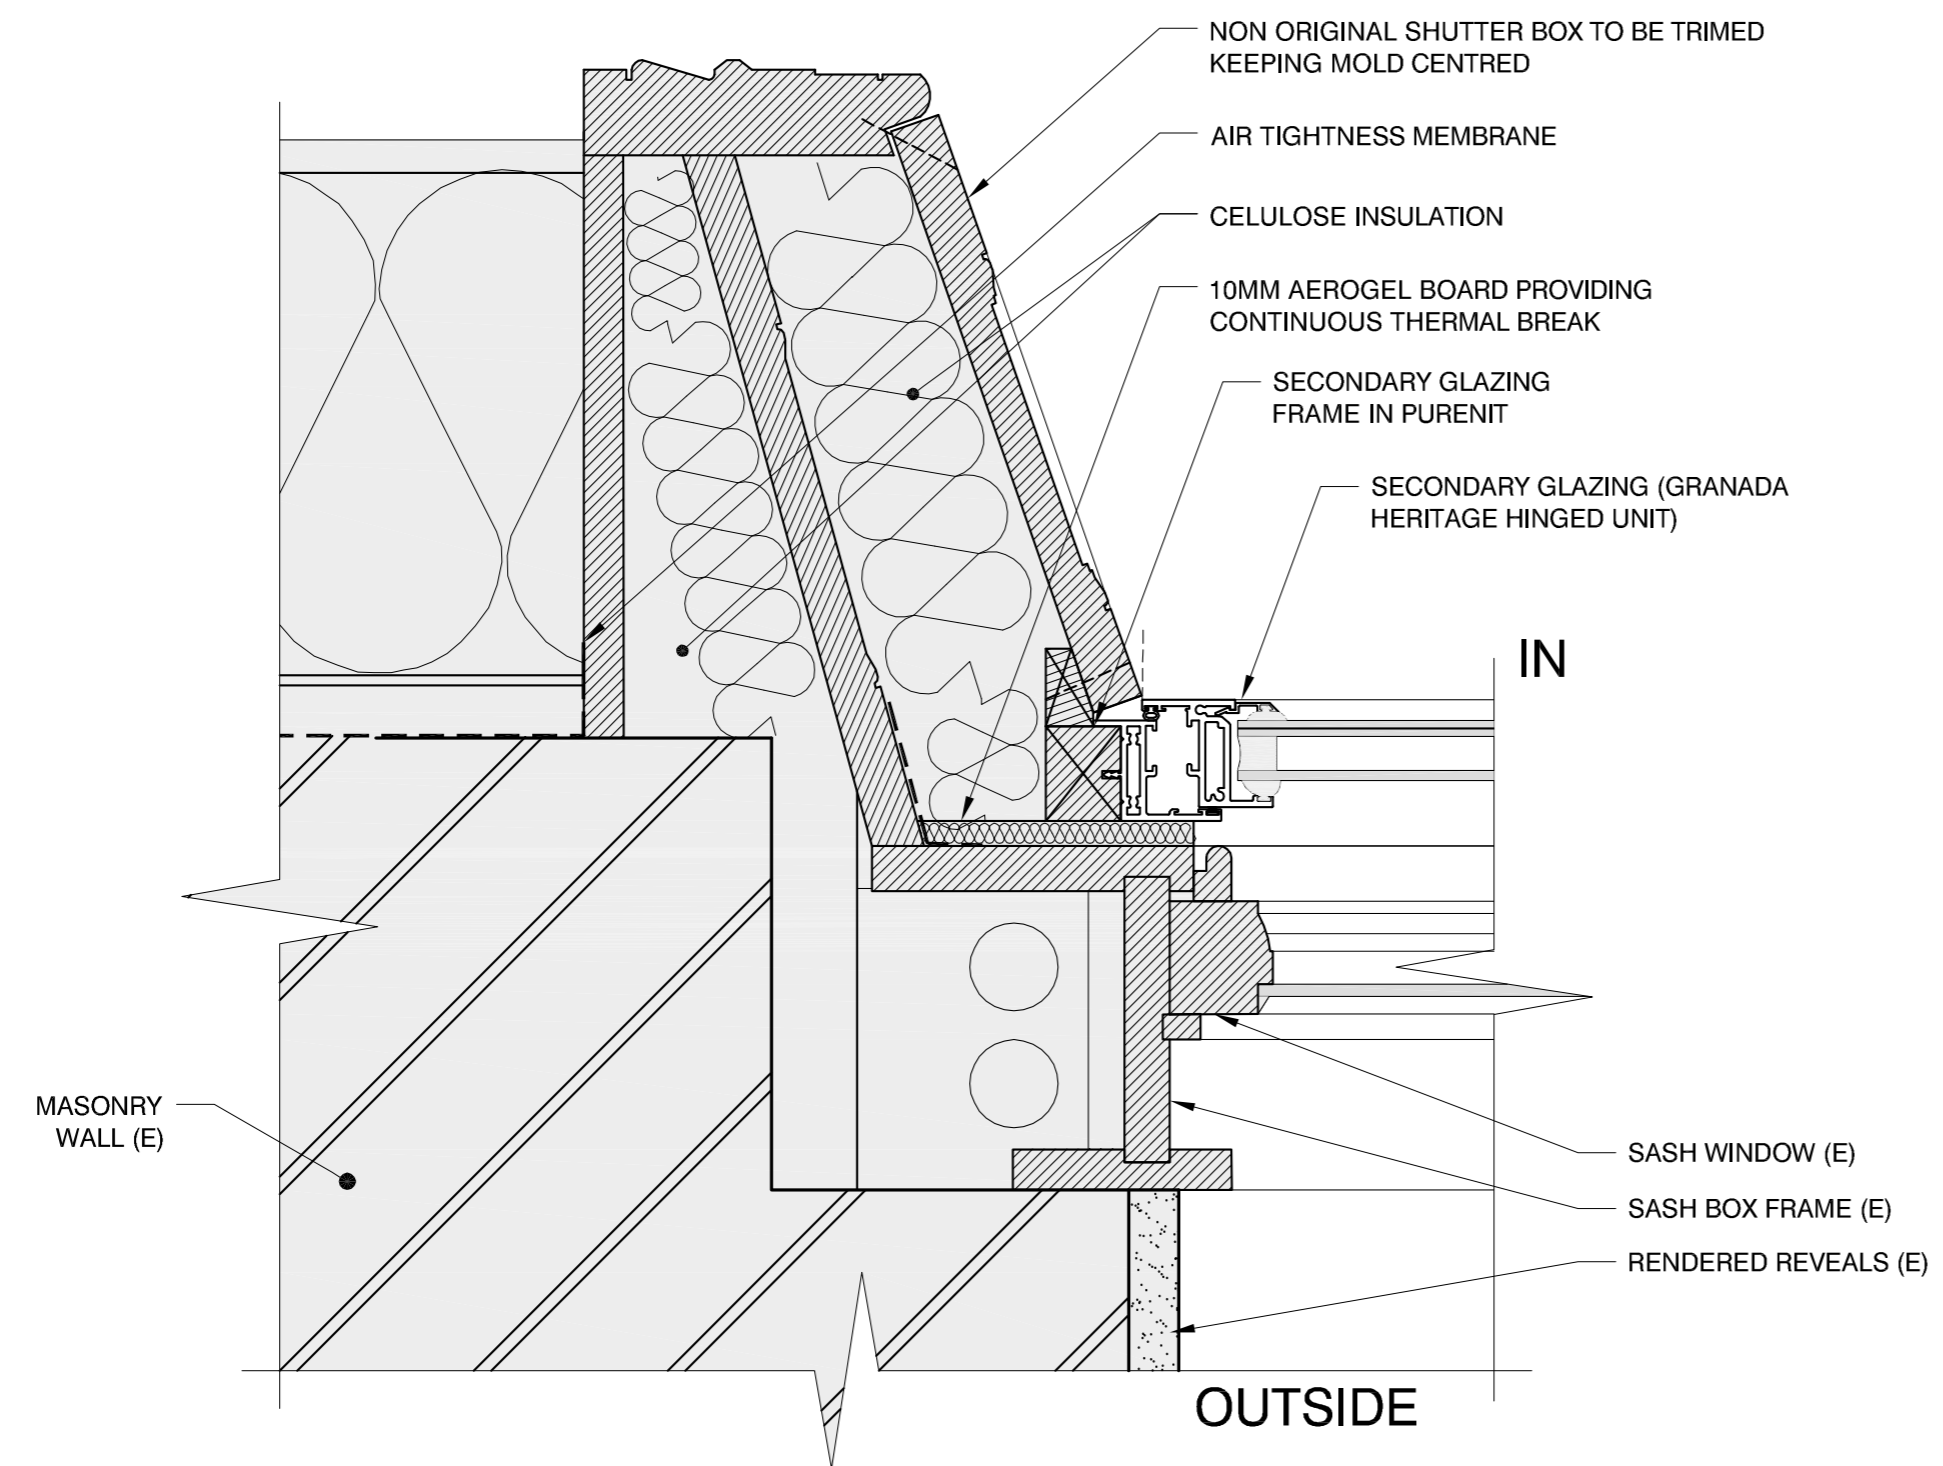
PLAN @ SECONDARY GLAZING WITH SHUTTER BOXES (W.04) D3
SCALE = 1:5

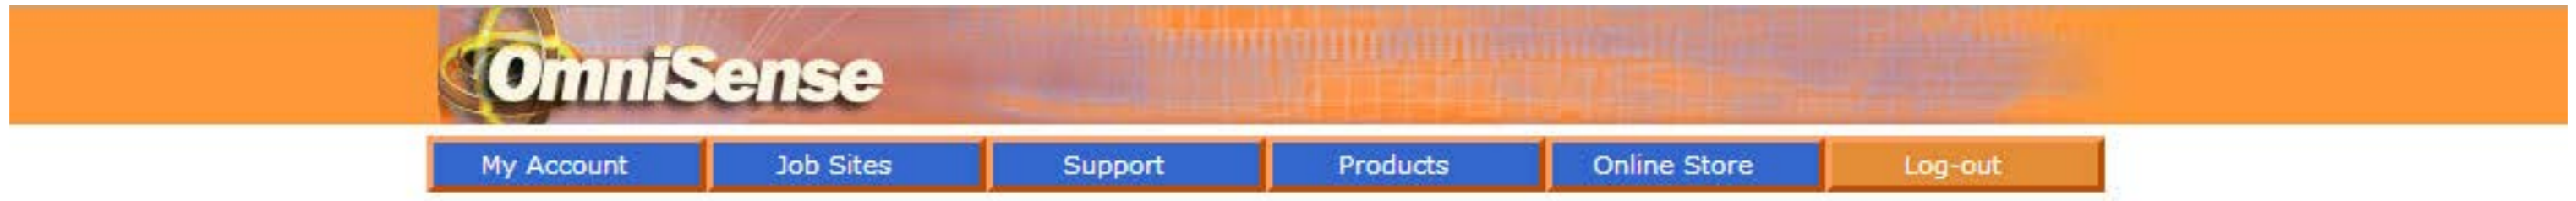
07_INSTALLATION OF SENSORS_HYGROTRAC INTERFACE

Sensor Type 1 - T, RH and Wood Moisture										
Sensor Id	Description	Last Activity	Sts	T(°C)	%RH	AH(g/kg)	DP(°C)	%WME	Vbatt(Vdc)	<input checked="" type="checkbox"/>
1695036E	01 - North Wall 2nd Floor +1500 glass shower screen	14-04-20 09:48:56	I							<input checked="" type="checkbox"/>
1695006B	02 - Ground Floor - Interior Ambient	14-04-24 10:41:34	A							<input checked="" type="checkbox"/>
16950077	03 - West Wall - Ground Floor +1200 - cold side brick	14-04-24 10:35:52	A							<input checked="" type="checkbox"/>
16950064	04 - West Wall - Ground Floor +1200 - warm side ins	14-04-24 10:40:02	A							<input checked="" type="checkbox"/>
1695011D	05 - West Wall - Ground Floor - cold side between joists	14-04-24 09:55:00	A							<input checked="" type="checkbox"/>
169503C1	06 - West Wall - Ground Floor - warm side between joists	14-04-24 10:47:08	A							<input checked="" type="checkbox"/>
1695008A	07 - West Wall - 1st Floor +1200 - cold side brick	14-04-24 10:11:12	A							<input checked="" type="checkbox"/>

1695009A	08 - West Wall - 2nd Floor +1200 - cold side brick	14-04-24 10:41:36	A							<input checked="" type="checkbox"/>
169503D2	09 - North Wall - Ground Floor +1200 - cold side brick	14-04-24 10:44:16	A							<input checked="" type="checkbox"/>
16950010	10 - North Wall - 1st Floor landing - cold side joist end	14-04-24 10:41:22	A							<input checked="" type="checkbox"/>
169503BC	11 - East Wall - 2nd Floor - corner joist end	14-04-24 09:56:52	A							<input checked="" type="checkbox"/>
1955024C	12 - West Wall - External Ambient	14-04-24 10:31:20	A							<input checked="" type="checkbox"/>
195500B2	13 - 1st floor south wall - chimney flue	14-04-24 10:06:12	A							<input checked="" type="checkbox"/>
19550068	14 - 2nd floor ceiling - cold side	14-04-24 10:42:04	A							<input checked="" type="checkbox"/>
195503A0	15 - Cold loft - ambient	14-04-24 10:04:58	A							<input checked="" type="checkbox"/>

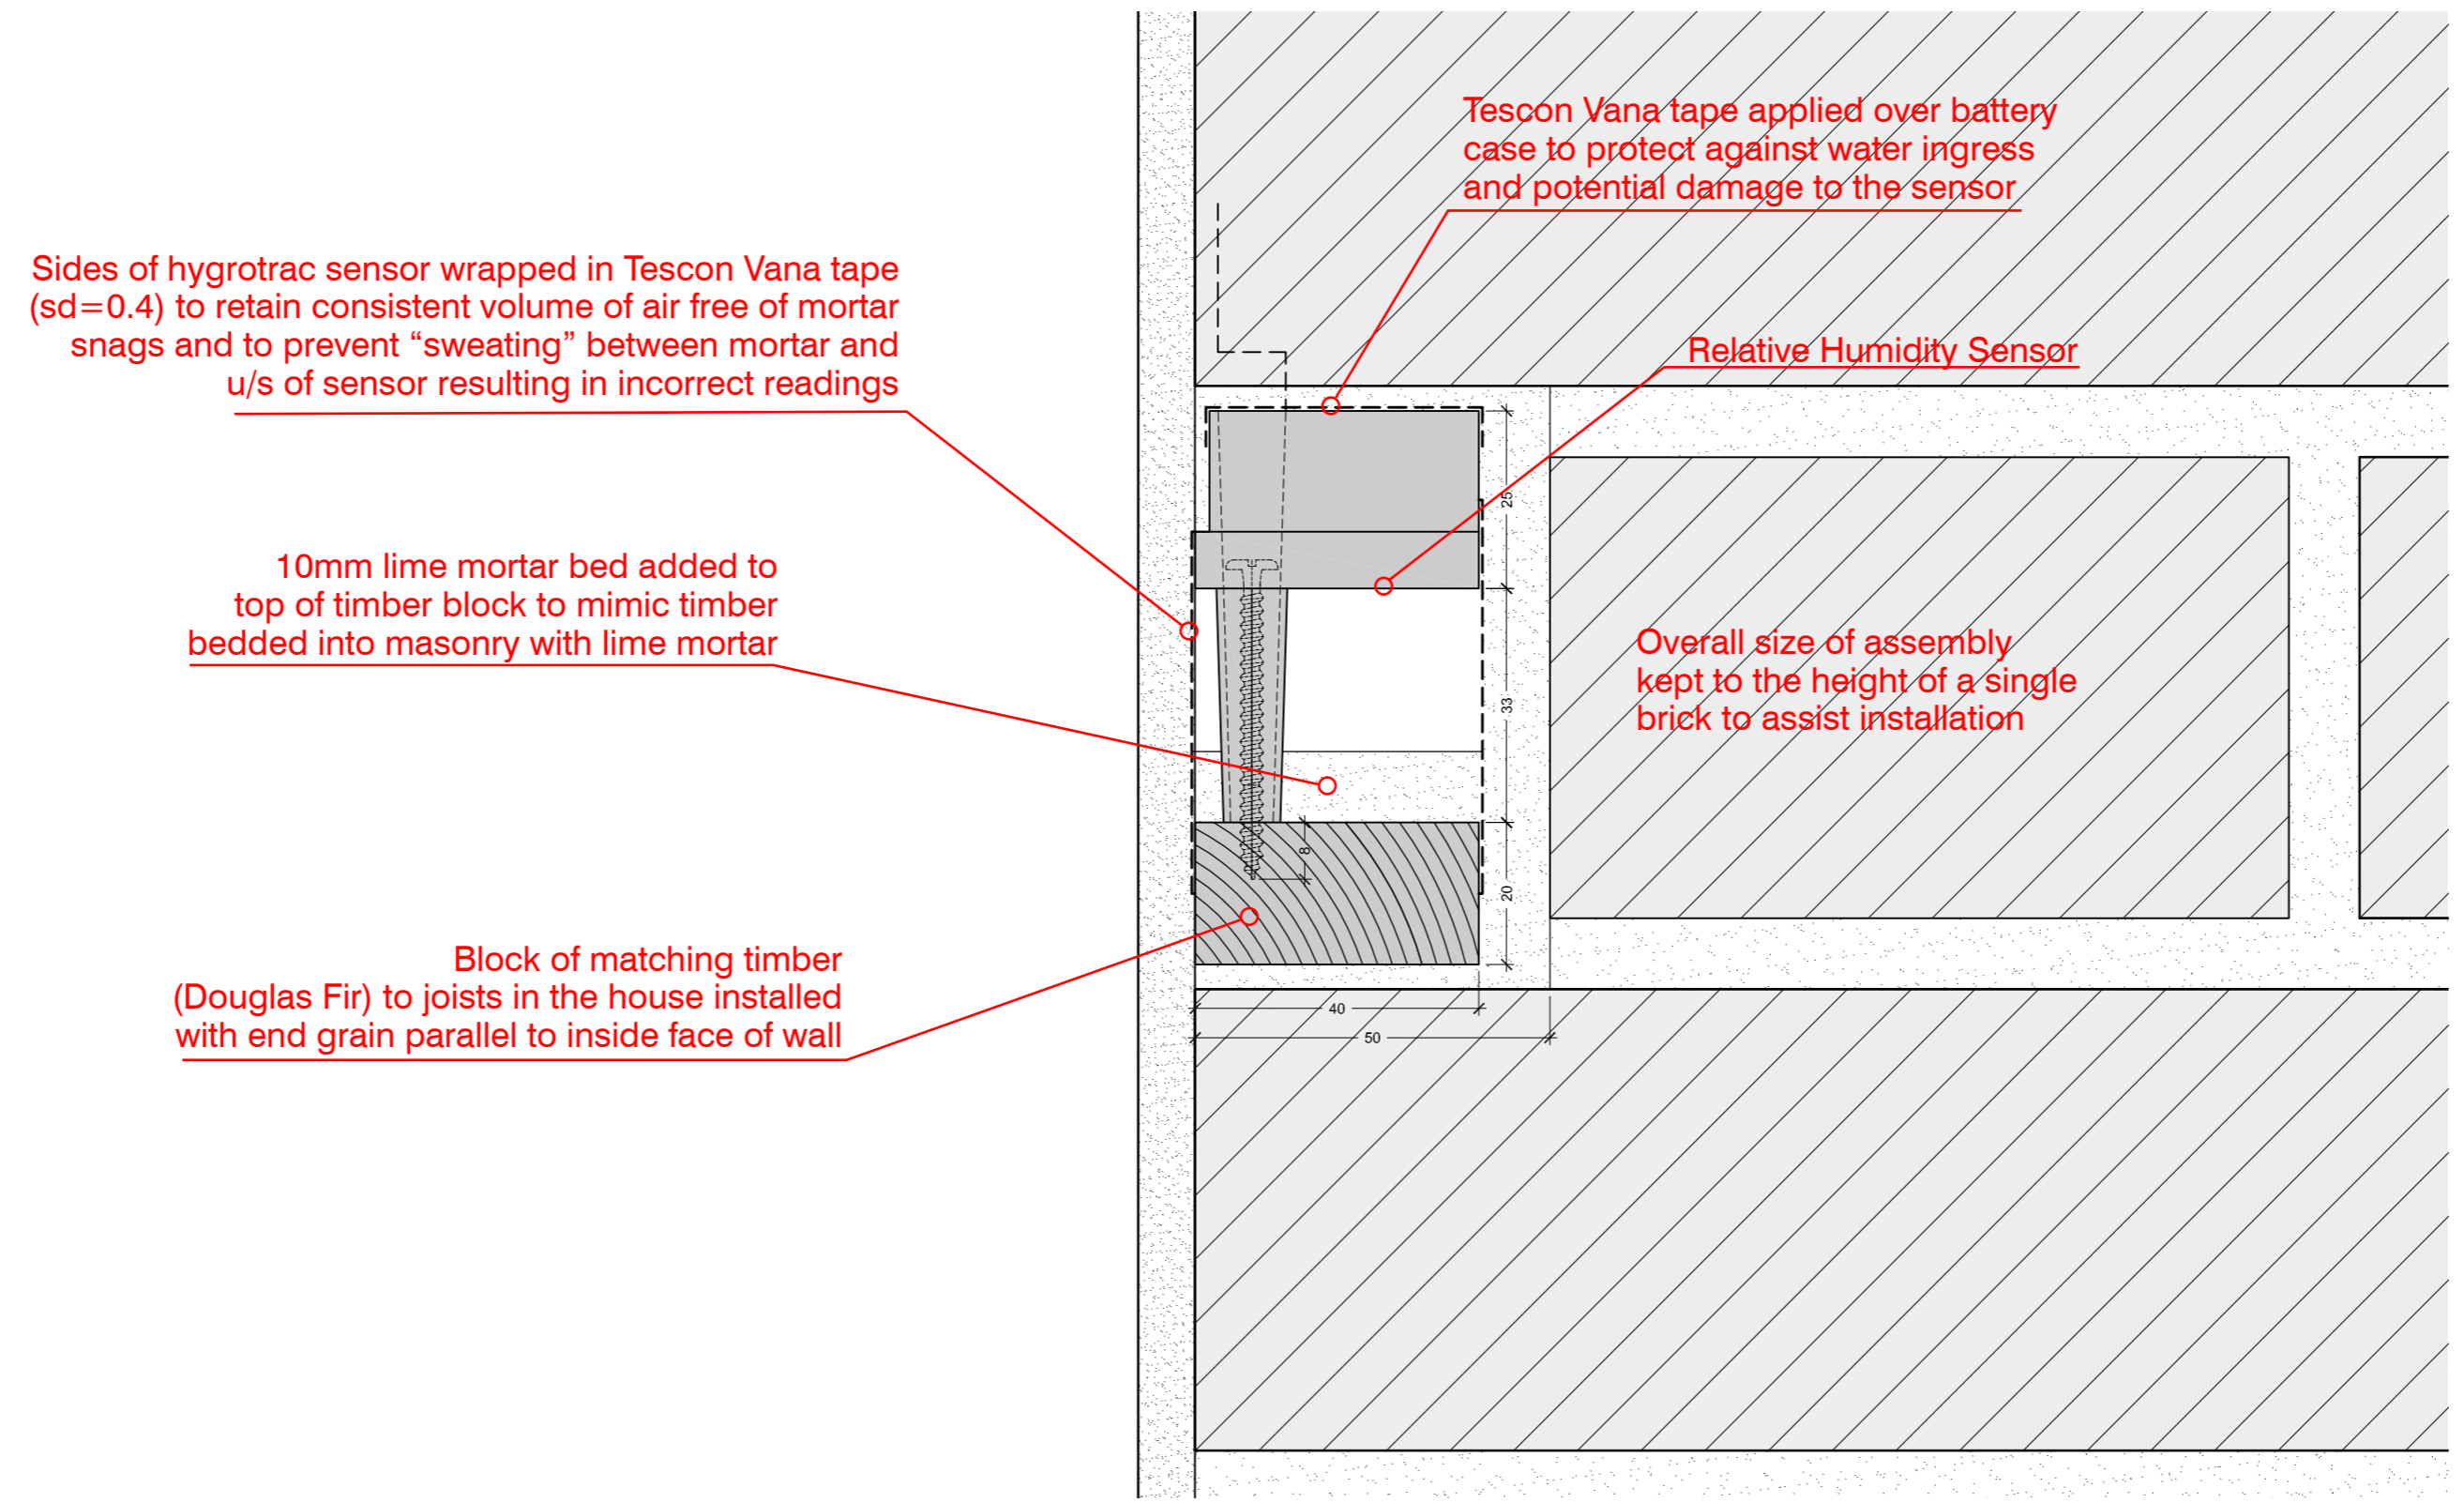
D1

SECTION @ MASONRY WALL (INSULATION NOT SHOWN)
SCALE = 1:1
