MONITORING MOISTURE IN HISTORIC BUILDING: A RETROFIT TO THE AECB SILVER STANDARD

Harry Paticas BA BSc AAdipl

Arboreal Architecture Ltd

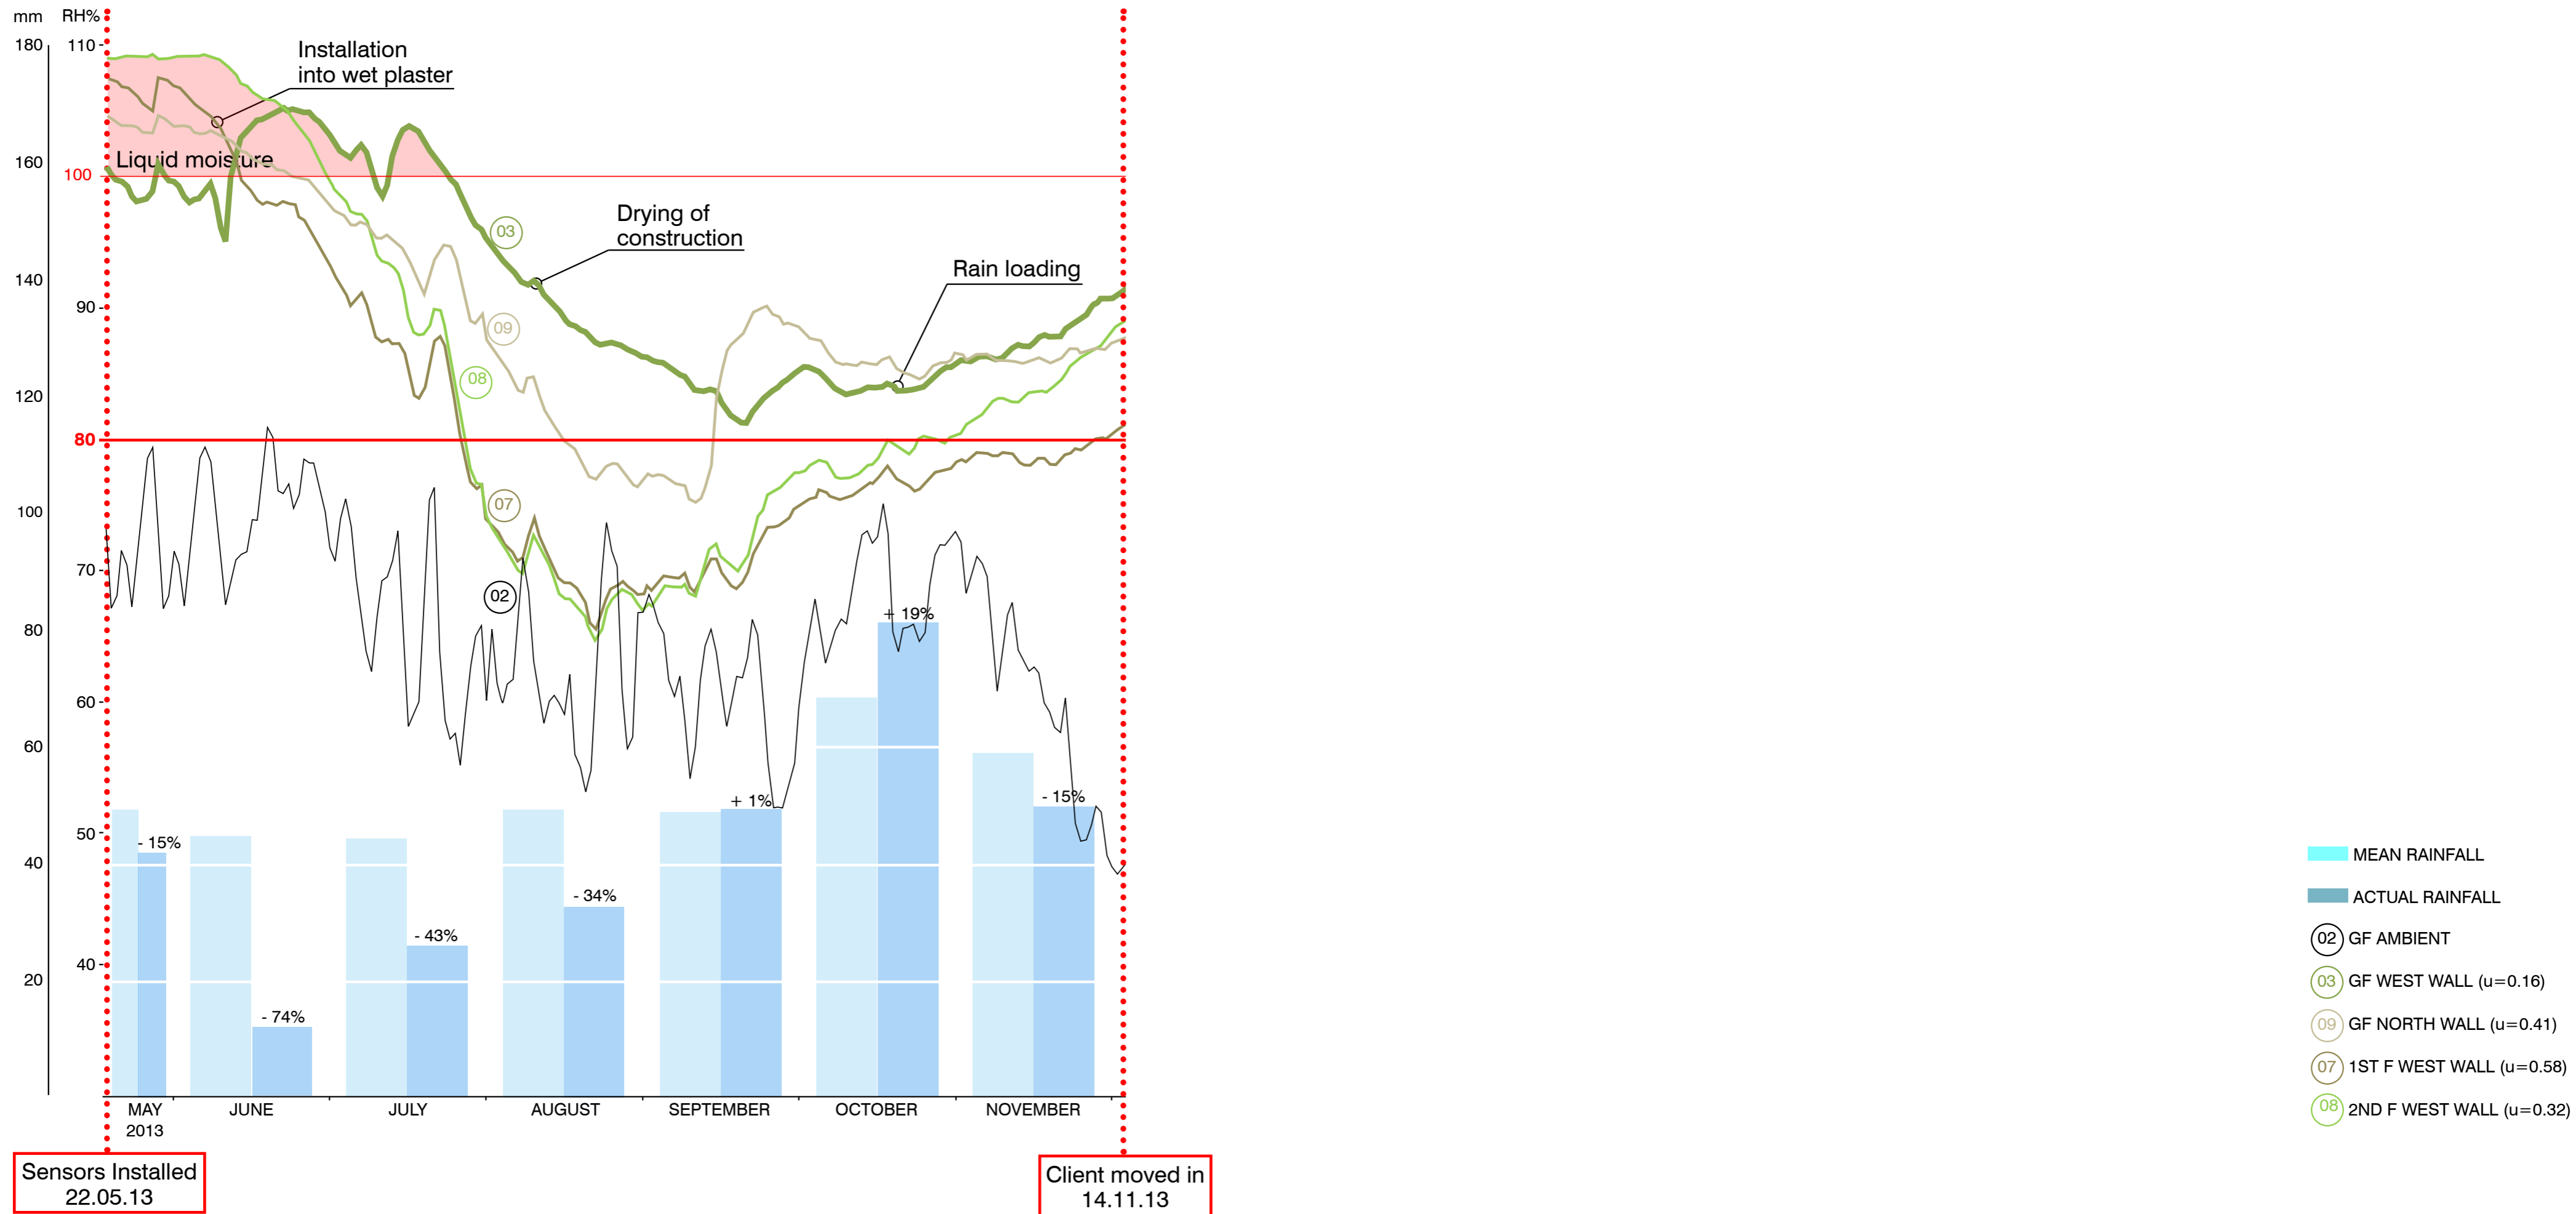
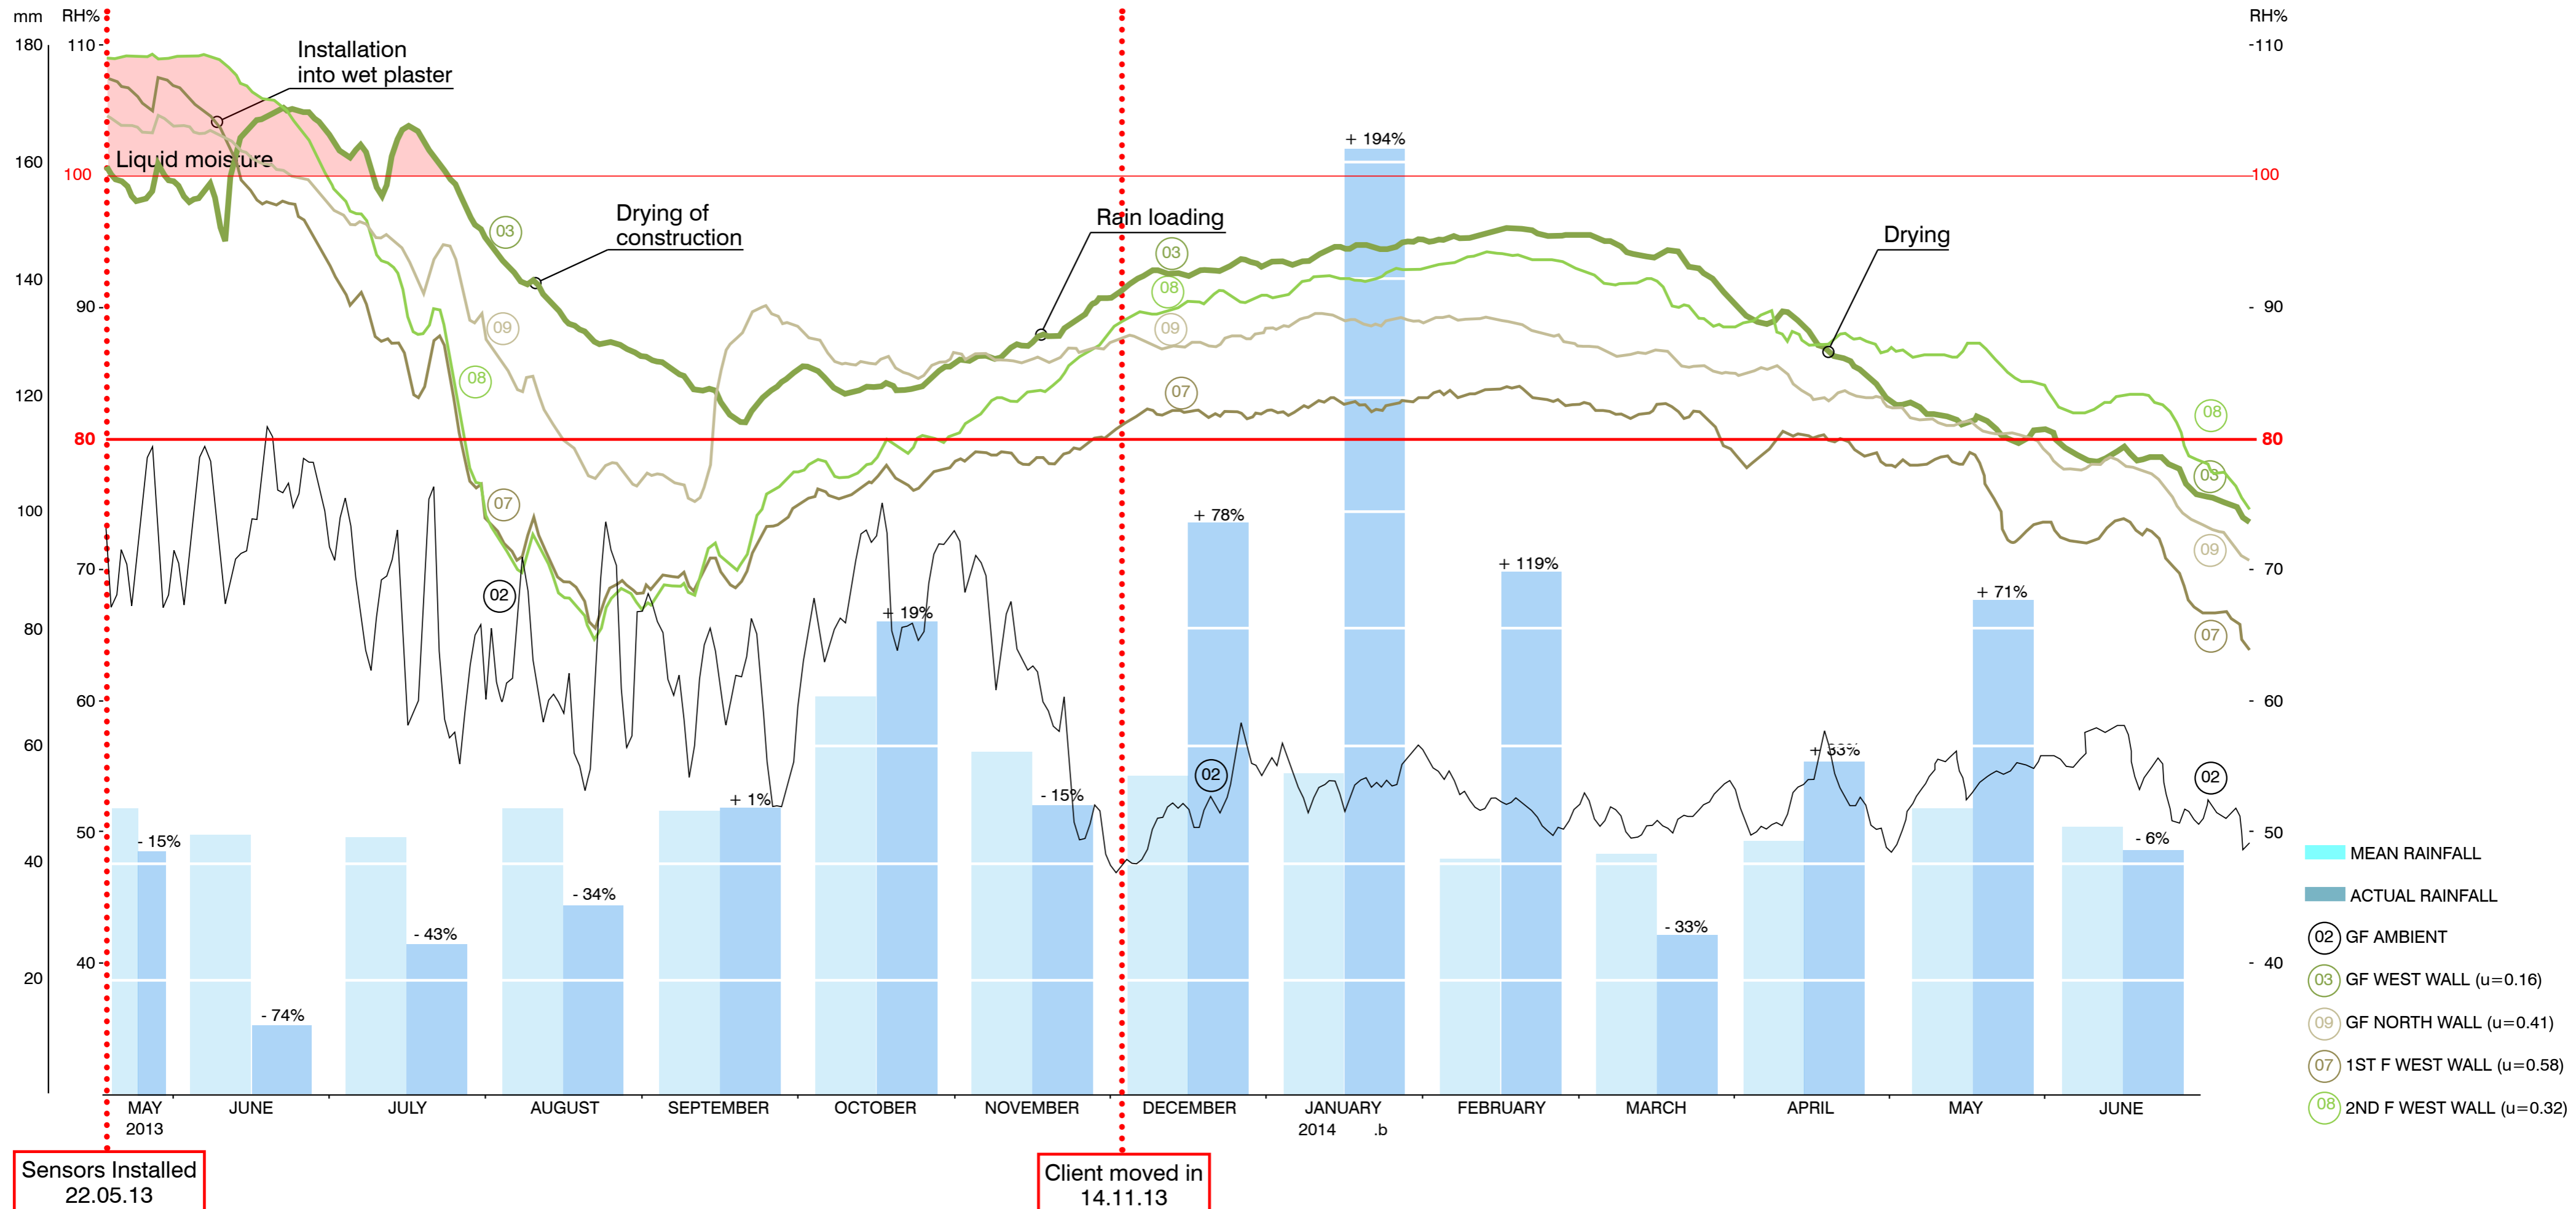
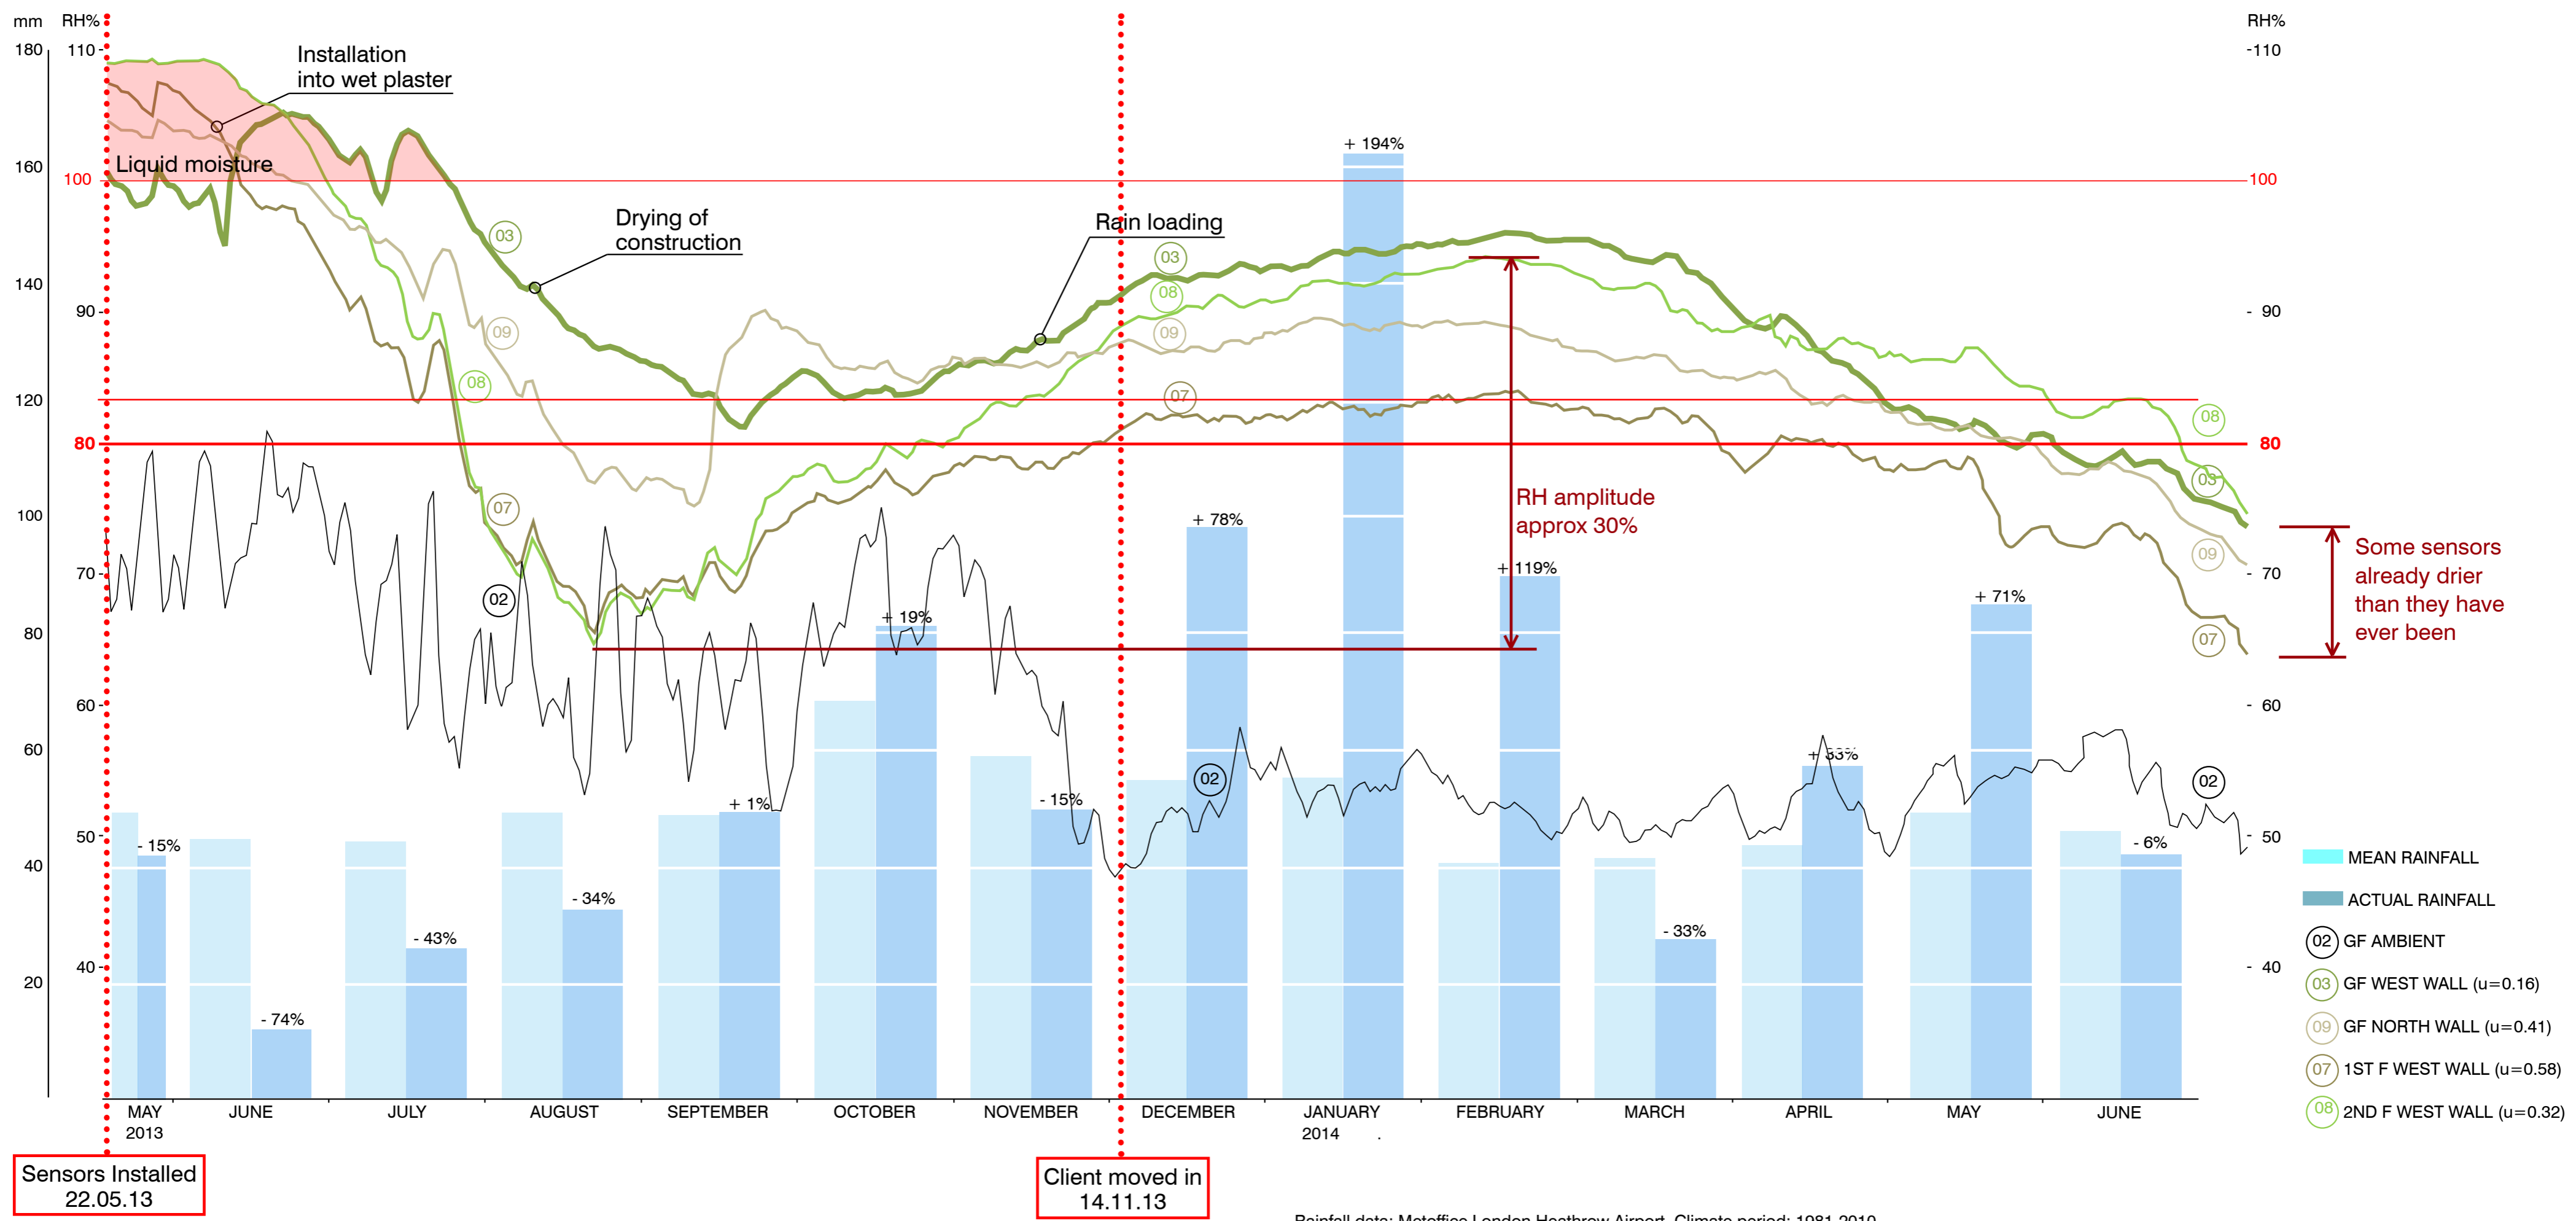
08_RESULTS FROM SENSORS_RELATIVE HUMIDITY

- Data collected from mid-May 2013 (mid-construction) to July 2014 (on-going)
- Temperature, Relative Humidity and WME data collected
- 15no. sensors installed in a range of locations:
 - Internal and external ambient sensors
 - Uninsulated airtight chimney flues and windtight loft space
 - Early warning sensor installed adjacent to rainwater downpipe
 - Remaining sensors built into fabric of building
- 4 sensors monitoring building fabric have been selected for analysis
 - woodfibre and aerogel insulation with a range of u-values
 - west and north elevations

Rainfall data: Metoffice London Heathrow Airport. Climate period: 1981-2010

- The highest amplitude in RH occurs in the most exposed wall with a median u-value of $0.32\text{W/m}^2\text{K}$.
- The primary cause of high levels of moisture in the wall appears to be from rain driven moisture.
- Active absorption and desorption of moisture at sensors is proves vapour permeable construction but annual amplitude and maximum values will need to be carefully monitored.
- Sensors are helpful in highlighting problems.

- **How much of the moisture in the walls was “construction” moisture?**
 - Sensor 03 RH didn't get below 80% indicating that a significant proportion of moisture may be yet to dry out from the construction period (this is likely to occur during the summer, weather dependent).
- **Was the wettest winter on record in England the cause of high levels of moisture?**
 - Likely to have had some effect but difficult to assess after only one year's worth of data and time lag.
- **What effects might seasonal variations in weather have on the moisture levels?**
 - How might a warm but wet winter compare to a dry but very cold winter?
- **Should the west elevation (and others) be treated with hydro-phobising cream?**
 - The effect of drying through the summer and subsequent autumn/winter wetting should be observed over at least another two annual cycles before any conclusions can be made.
