Carbonlite Retrofit Demo

Tim Martel and Bill Butcher

AECB Conference 2016

This presentation covers two examples from case Study 10, one of these is explained as an example in 5.16 of the course.

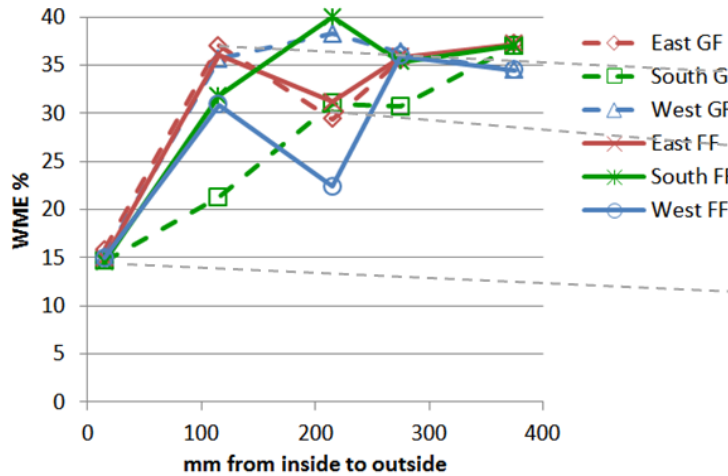
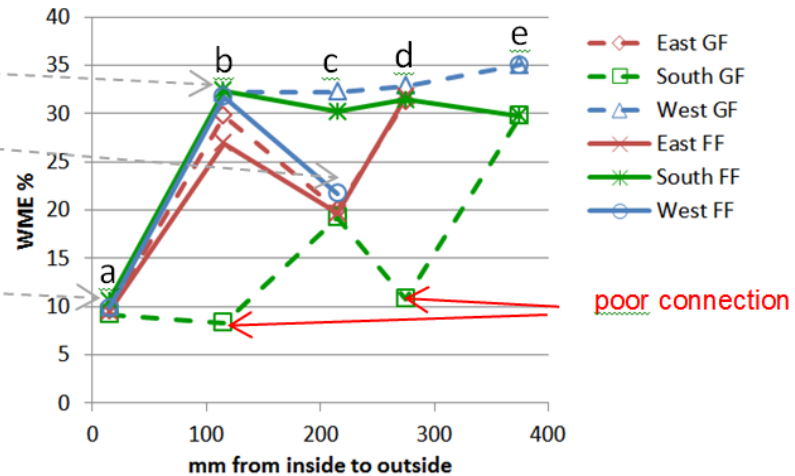
thickness	mm
Inside	Plasterboard/skim	15
	VVR membrane	-
	mineral wool	90
	plaster	10
	blockwork	100
	EPS attached to blockwork	25
	ventilated cavity is "exterior"	~50
Outside	Solid stone exterior wall	~400

- a. Moisture content inside the wall is 20-28%WME, 29-32% at suspected leaks, higher than we would like, but it will probably dry within the next year or two.
- b. Rot risk for any joists and OSB generally minimal, slight risk for 2 joists.
- c. May be some risk of mould, generally where there are suspected leaks.

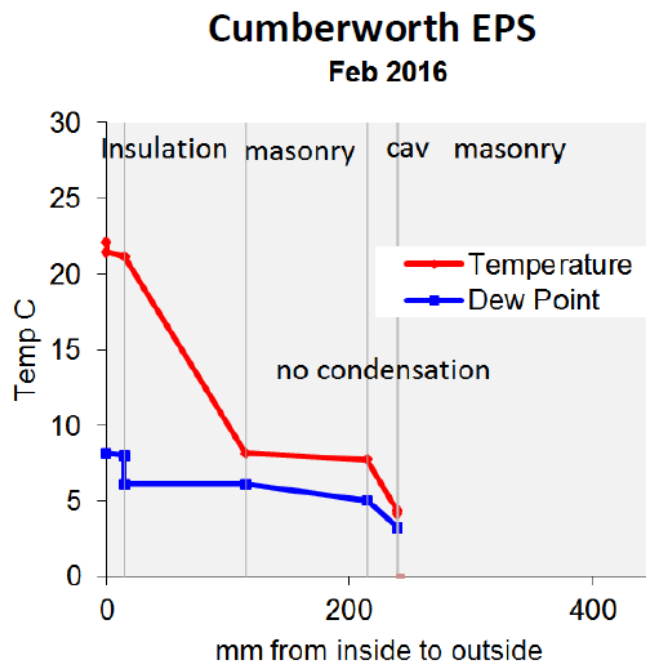
Typical results for Cumberworth when the EPS is included.

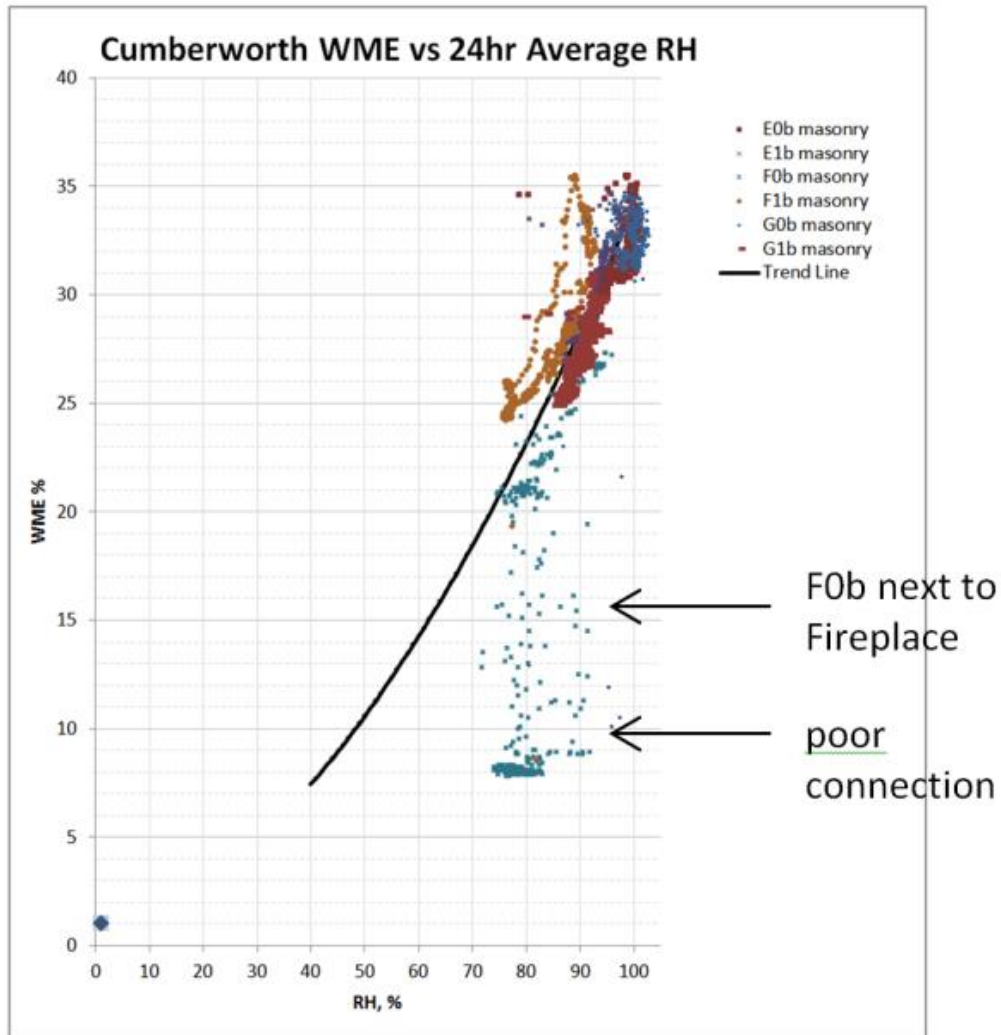
- WME and RH affect each other in a curve
- F0b excluded because it has intermittent data
- F1b is excluded because it has an odd shape and is a proven leak.

- When RH's for E1b are predicted from WME's using this curve there is a good correlation
- This means the initial moisture content of the brick combined with hygroscopic effects (equilibrium of WME with RH) explain the RH much better than vapour (Glaser) effects.

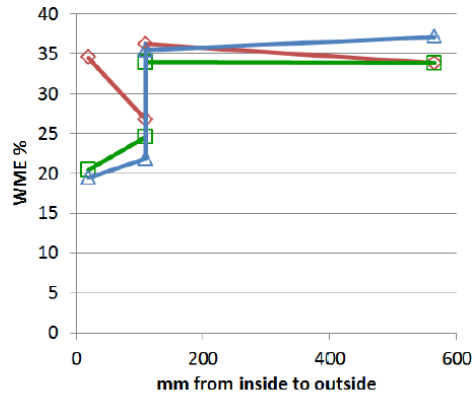
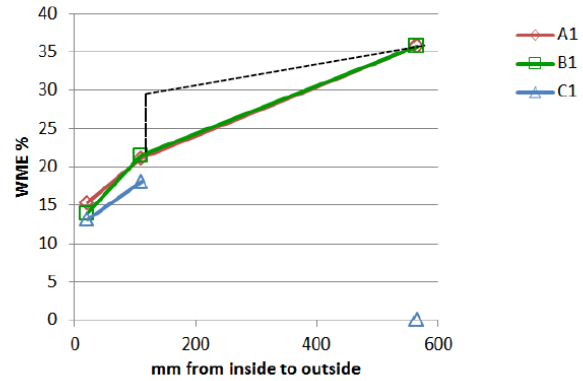
Masonry (blue) is quite high, all 3 have failed.

- Masonry sensors have failed, and one in tectem external, they have had a rather high RH, near 100%.
- There is a mould risk but it is not particularly high

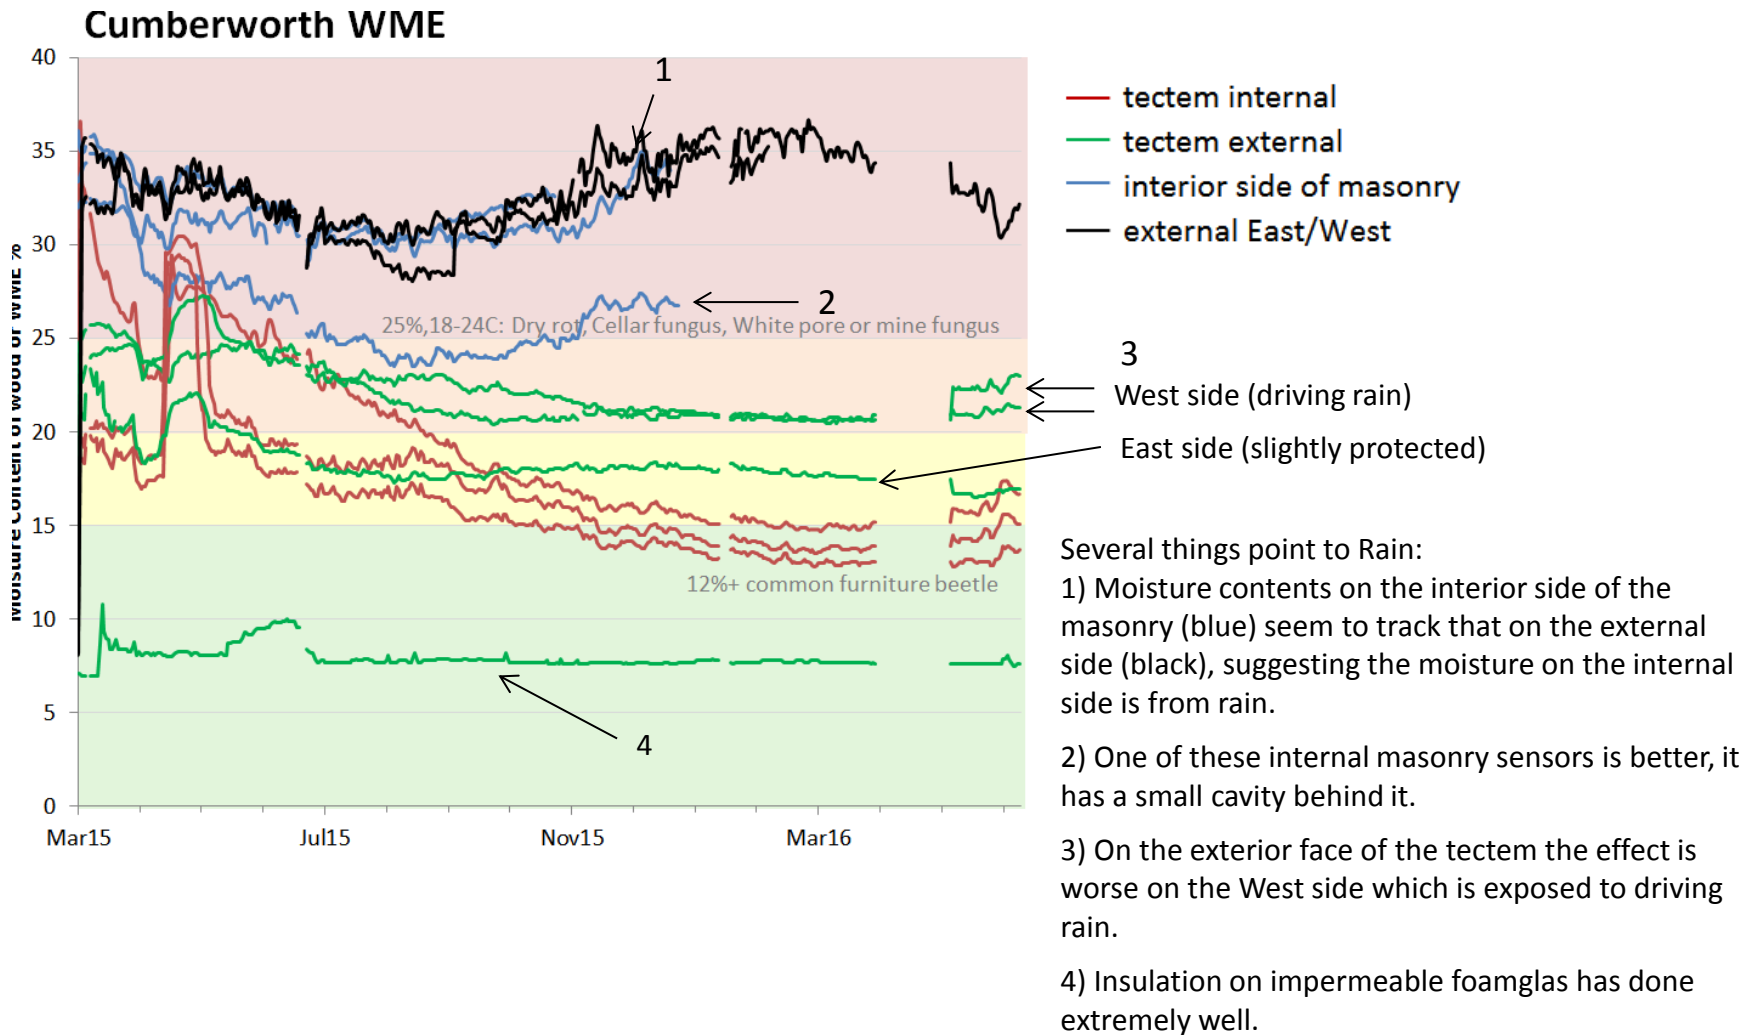
- a. Rain moisture is coming through the wall, particularly on the West.
- b. Some is via diffusion from the inside, but tectem is designed to cope with that.
- c. We haven't looked specifically for hygroscopic effects but we know tectem is a capillary active material.
