Common Leakage Sites no.6

Along the top and bottom edges of skirting boards.

Building Fabric Leakage 6: Along the top and bottom edges of skirting boards

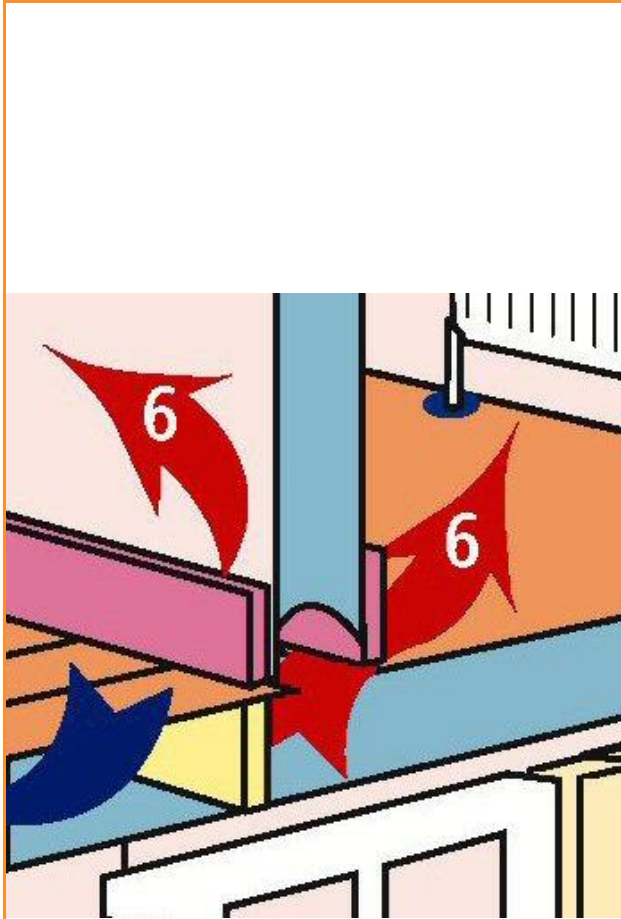
In this instance air is normally leaking from the floor void, although it could be from an unheated wall cavity, into the room around the top or bottom edges of the skirting board. This is usually due to inadequate sealing of the wall to floor joint allowing air through which then manifests itself at the edges of the skirting board which has been placed over said joint, but it can be from penetrations through the wall where the skirting board has been attached. This will also apply to the skirting board equivalent at the top of the wall, pre formed coving, which will hide flaws in the wall to ceiling joint. Another example would be where wood panels are used to clad a wall or ceiling and the air from the wall to floor / ceiling joints emerges through joints in the wood panelling. From an external perspective this kind of leakage can manifest as warm air escaping around the external edges of floors where they overhang or join the external walls.
